Type A Accident Investigation Report

THE JULY 27, 2007
TANK 241-S-102 WASTE SPILL
AT
THE HANFORD TANK FARMS

Volume 1

September 2007

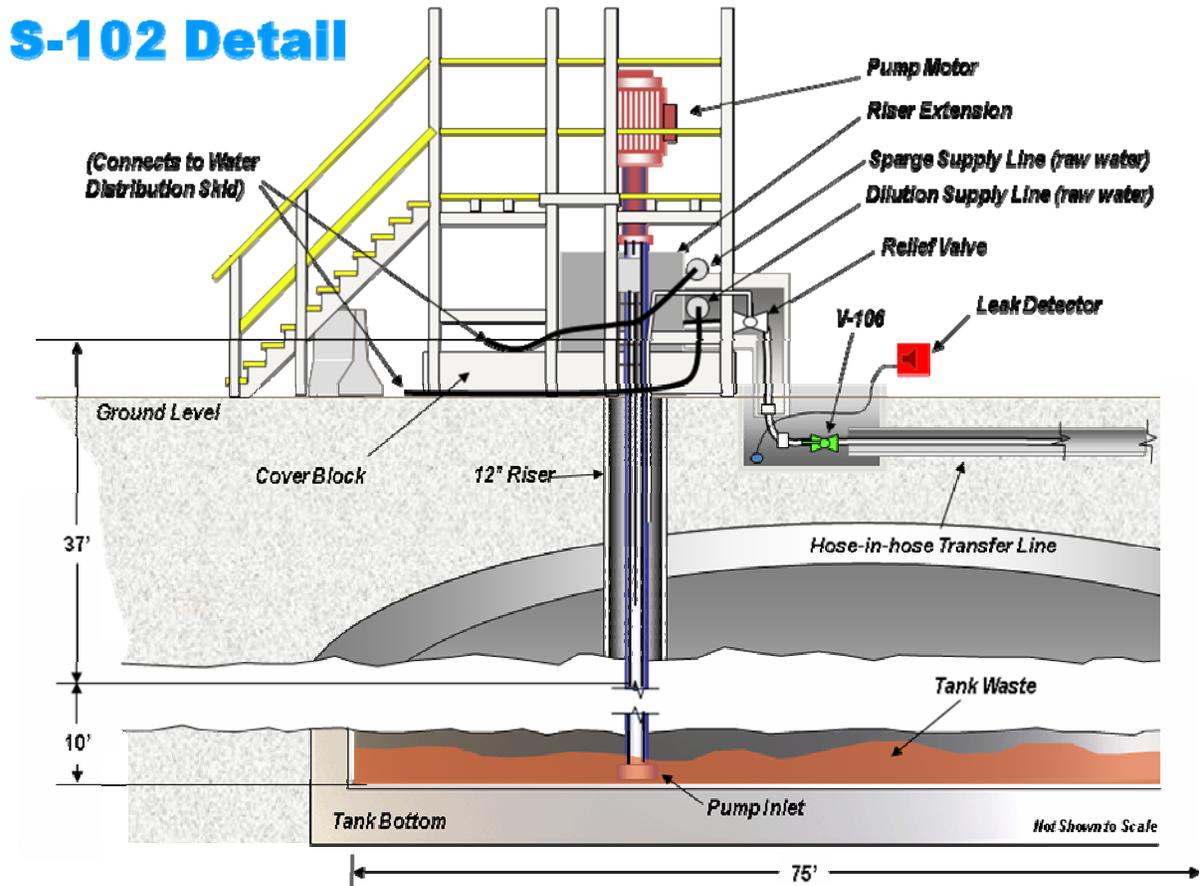
Figure 1-2. Tank and Pump Configuration

The waste in S-102 is a phosphate-laden sludge with a dense gummy consistency, which must be mobilized and suspended in a slurry to be pumped out of the tank. The waste removal pump is mounted on top of Tank S-102 and extends into the tank through a 12" diameter riser down to near the bottom of the tank, as shown in Figure 1-2. The pump is a reversible, positive displacement, progressive cavity type pump which is driven by a reversible, variable speed, 480 VAC motor located above the tank riser extension on a platform.

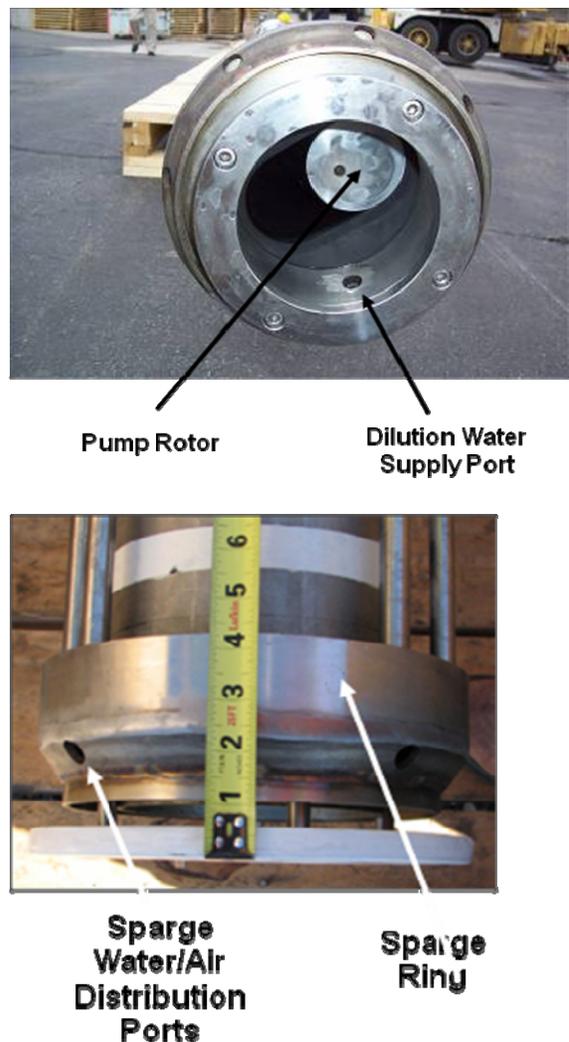
Figure 3-1. Pump Components

Background. The Tank Farms are a category 2 nuclear facility. The tanks, pumps, and related safety systems are covered by a Documented Safety Analysis (DSA) and a set of Technical Safety Requirements (TSRs). As discussed in Section 2, CH2M HILL had experienced a number of technical challenges in pumping the hardened sludge from the S-102 Tank. Various designs had been tried and some pump failures had occurred as a result of clogging of the pump and auxiliary systems. The pump that was involved in this accident was installed in mid July 2007 and was only operated for a few days before the accident. The dilution water and sparge water nozzles located on the pump suction are shown in Figure 3-1.

Engineering Design Causes. The Accident Investigation Board concluded that the direct cause of the spill was an overpressure of a hose connected to a dilution line on the retrieval pump system. The hose overpressure and spill occurred because of the absence of an isolation device, such as a backflow preventer, between the dilution water system (service water), which was a non-waste transfer system, and the waste transfer route. Such a device is required by the DSA and the TSRs. The sparging water system (also service water), also met the DSA definition of a non-waste transfer system "physically connected" to the waste transfer route, and also was not protected by such an isolation device. A few other engineering design factors contributed to the overpressure event. First, the transfer

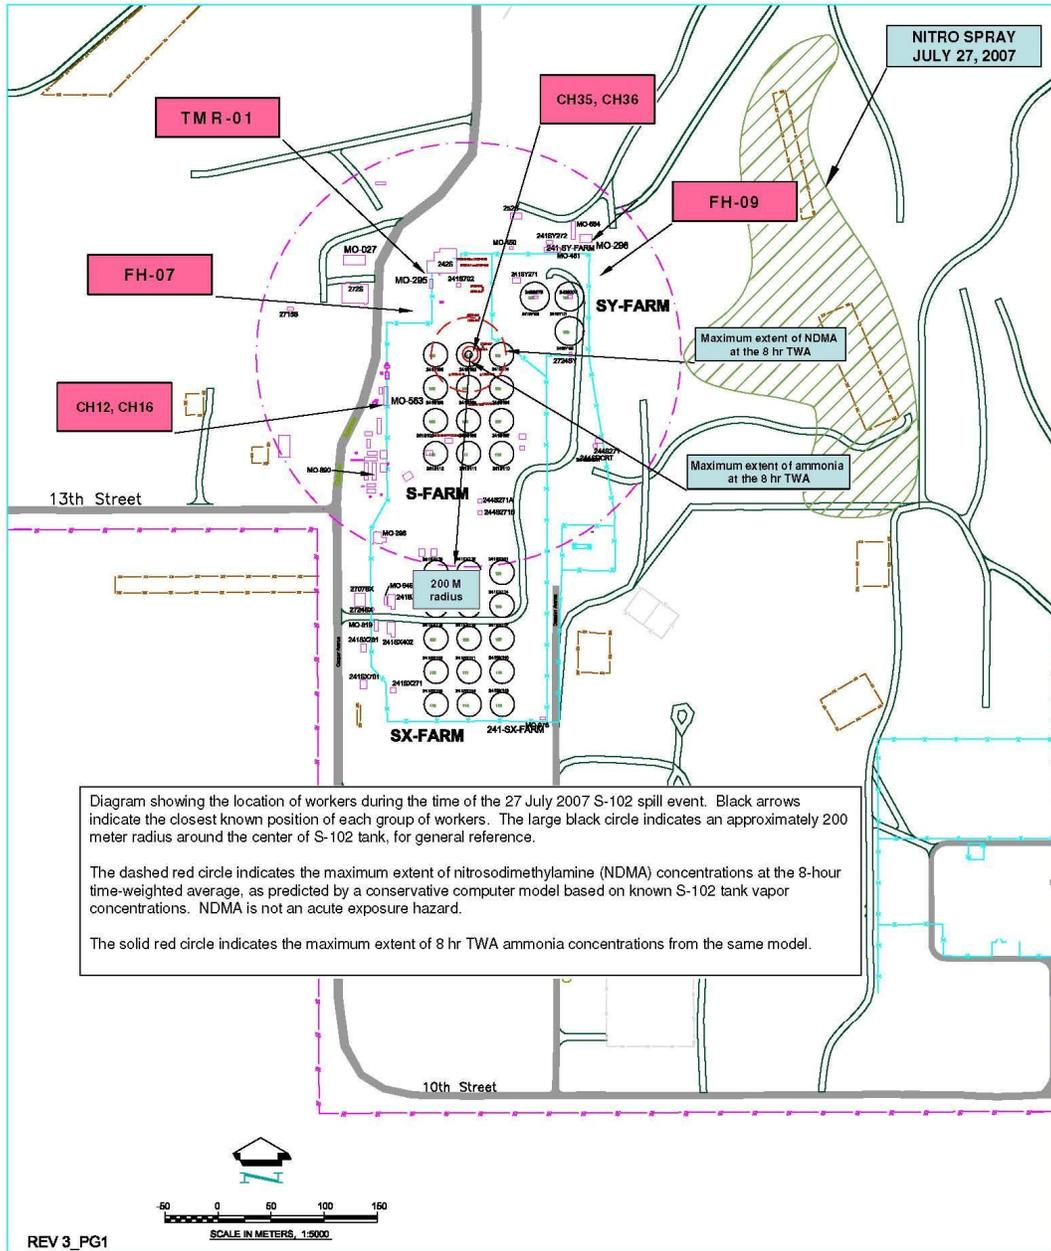
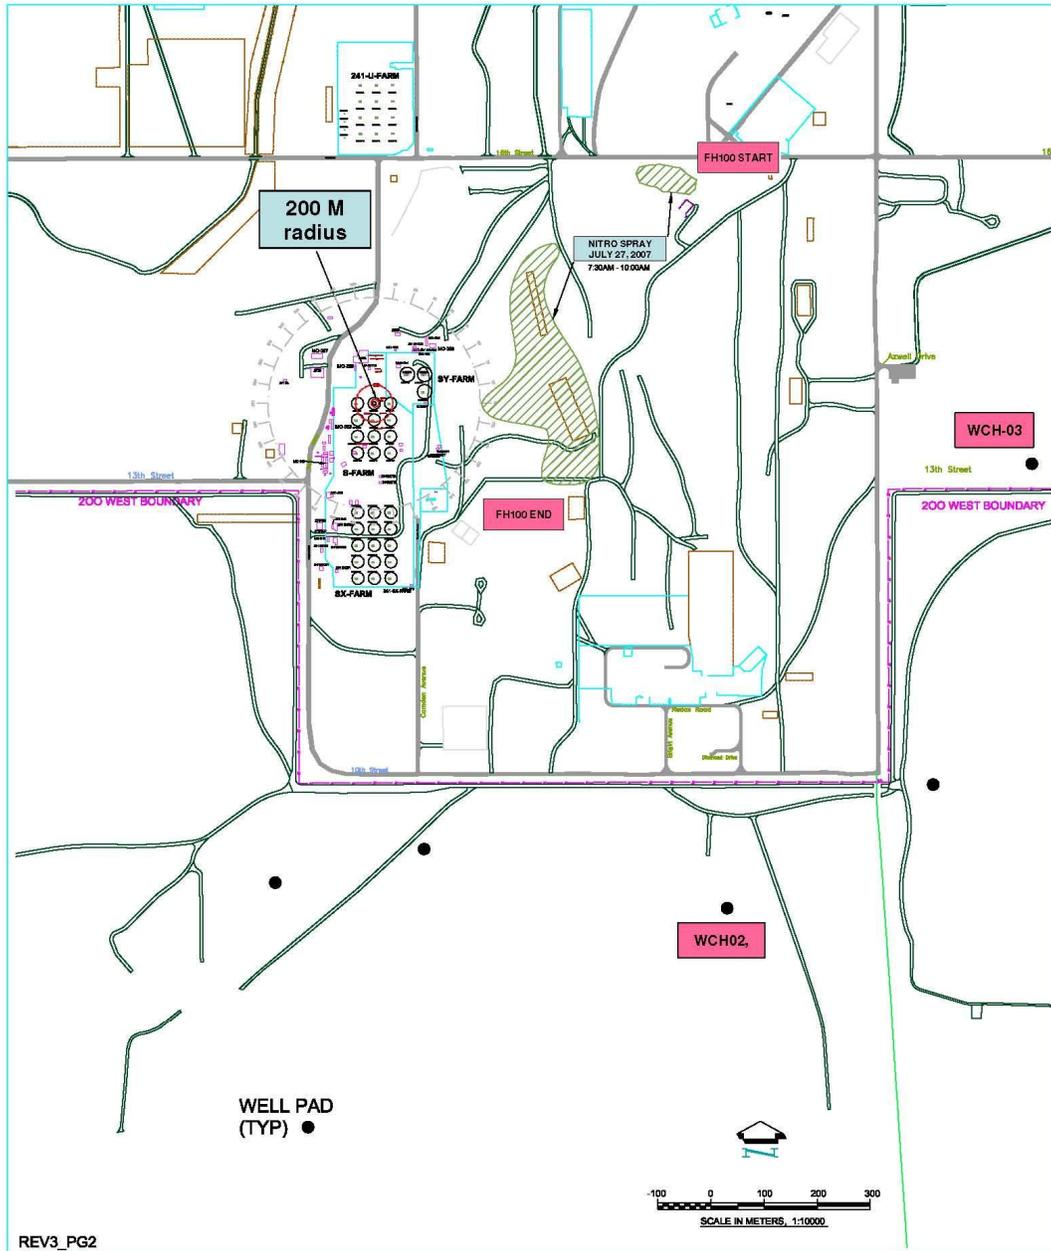
S-102 Tank Spill Exposure
July 27, 2007
Figure 4-1, Page 1 of 2

Some of the individuals who reported symptoms could have been exposed to aerosols from an herbicide spray that was occurring the morning of July 27. Figure 4-1 also shows the area where the herbicide was applied.
