# **Investigation of Beryllium Exposure Cases Discovered at the North Las Vegas Facility of the National Nuclear Security Administration**

**August 2003**

**National Nuclear Security Administration  
United States Department of Energy  
Washington, DC 20585**

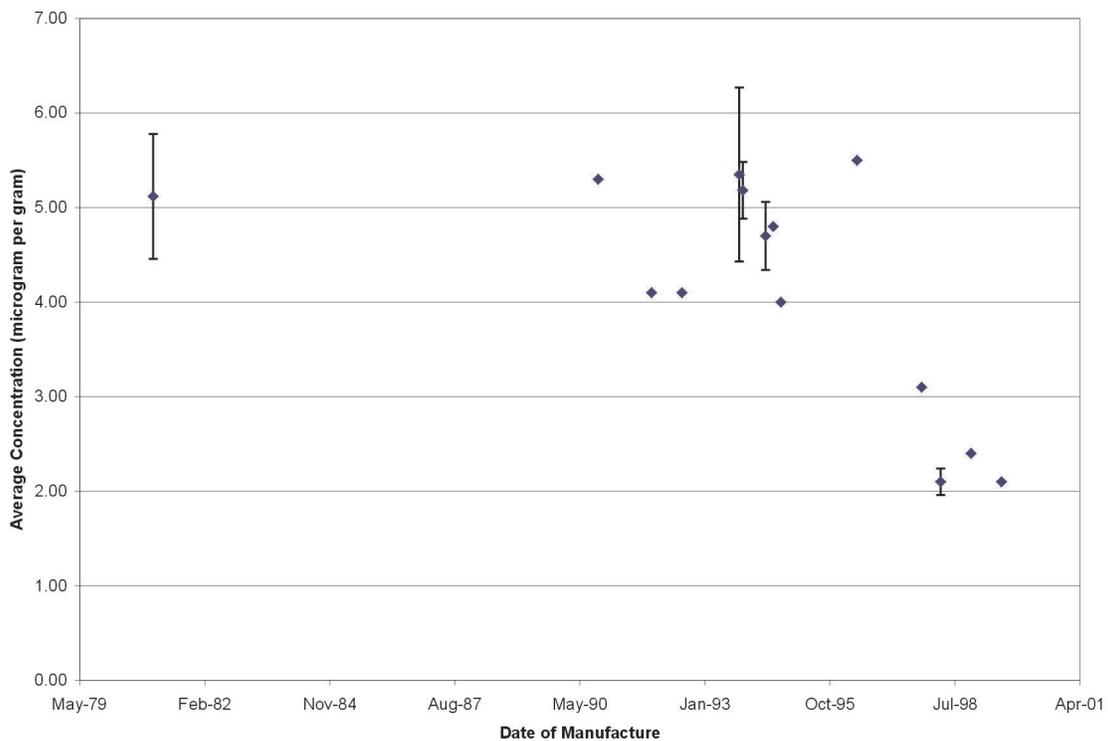
*Figure 2.2.1-1: Concentration of beryllium in ceiling tiles according to tile age.*

The beryllium contamination of the acoustic ceiling tiles was found to be due to naturally occurring beryllium within the materials used to fabricate the tiles, and was determined to be unrelated to the rest of the contamination in the buildings. Therefore, the team focused on the IT/SHAW high bay area and the

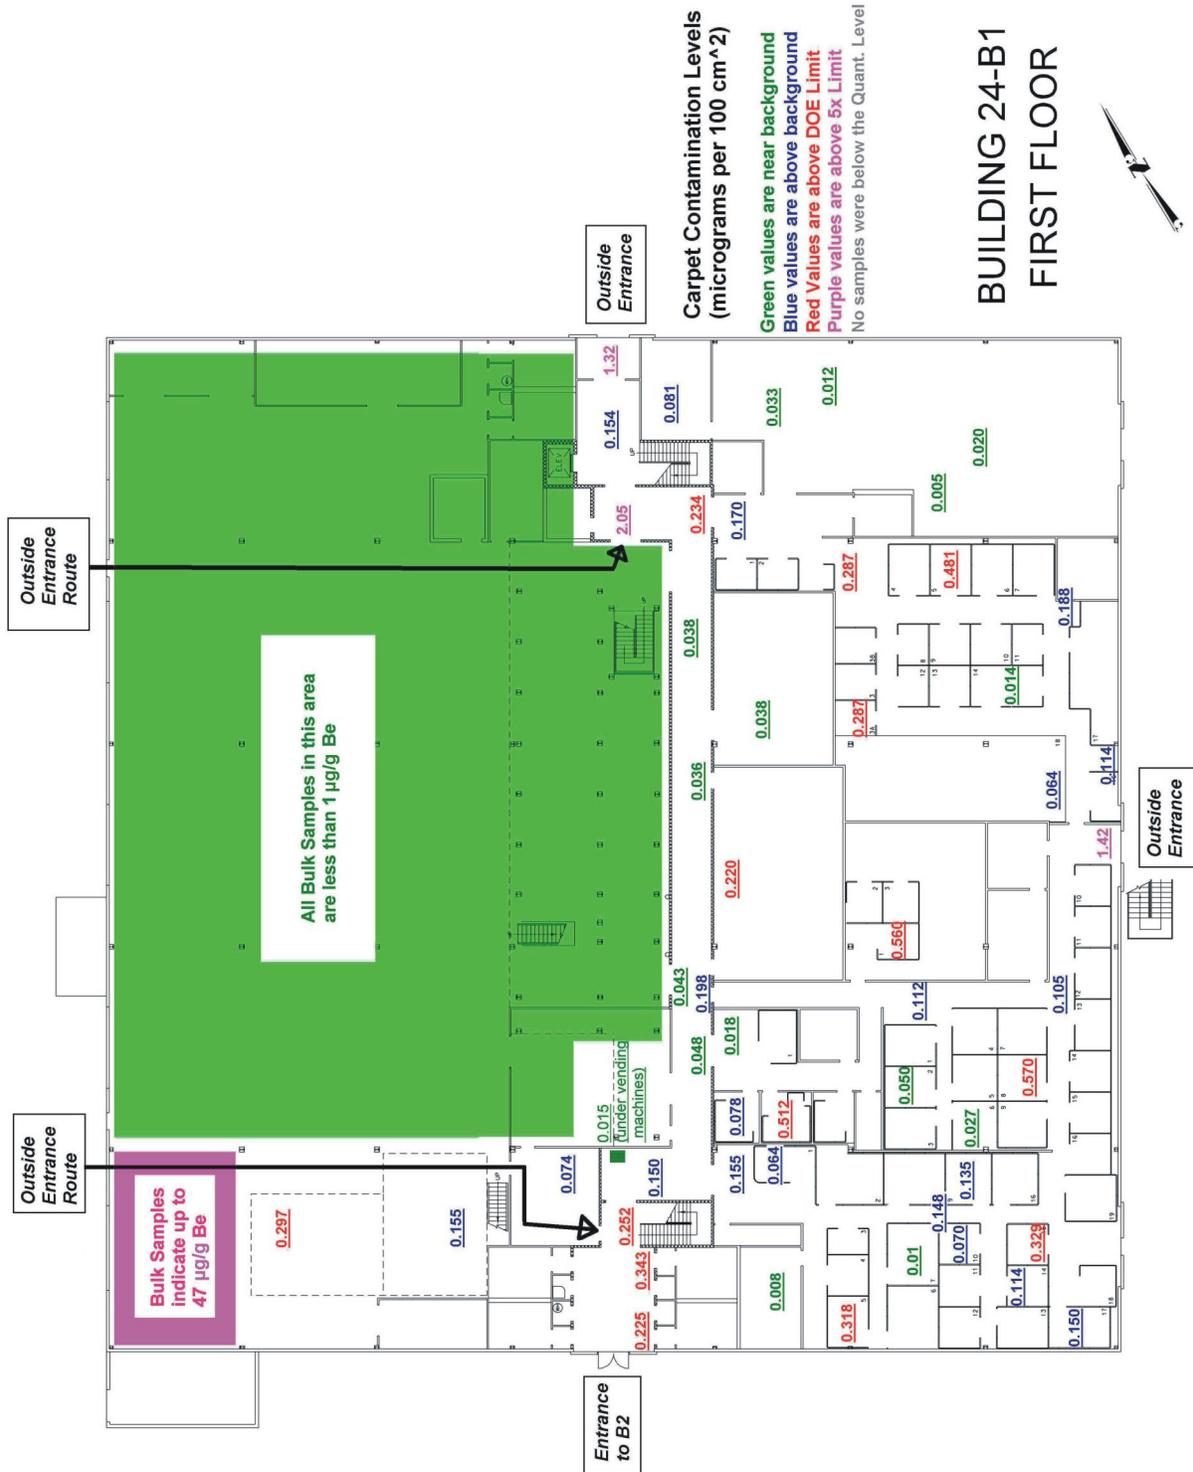
Figure 2.2.2-1: Beryllium contamination in the first floor of B1.

In the concrete areas of the high bay, beryllium contamination was found in the southern end as shown on Figure 2.2.2-2. Several samples were found to have beryllium concentrations ranging from 0.77 to 47.0 µg/g, with the highest levels in the immediate vicinity of a loading or staging area. This area was a small shipping/receiving area for IT/SHAW (see Figure 2.2.2-3). As can be seen from Figure 2.2.2-1, the carpeted section underneath the mezzanine area at the south end of the high bay also contained elevated levels of beryllium, with one sample slightly below and the other above the 0.2 µg/100 cm<sup>2</sup> comparison value.

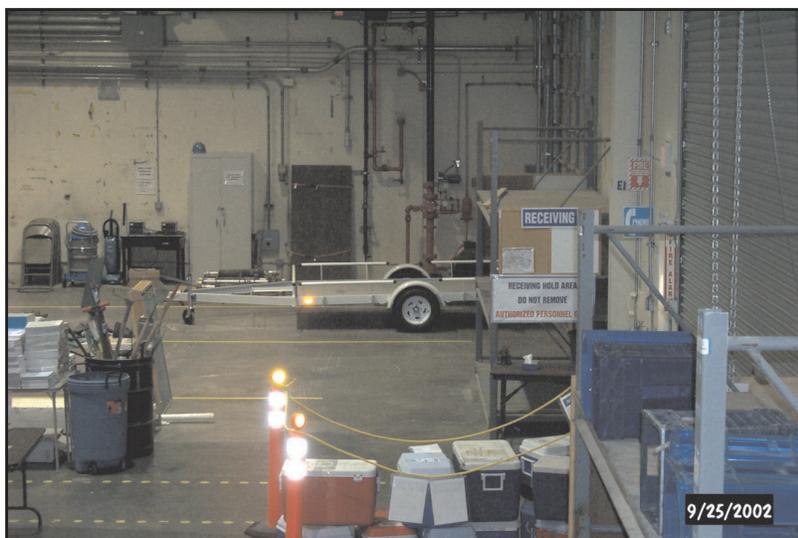
Figure 2.2.2-3: IT/SHAW shipping/receiving area in the B1 high bay.

In the high bay area there are a large number of exposed conduits and pipes that contain a heavy level of dust loading. Some bulk samples were collected on these surfaces for analysis. The only samples found to be elevated were in the south end of the high bay near the IT/SHAW shipping area. The highest result was 2.6  $\mu\text{g}/\text{g}$ , roughly 8 times the soil background value.

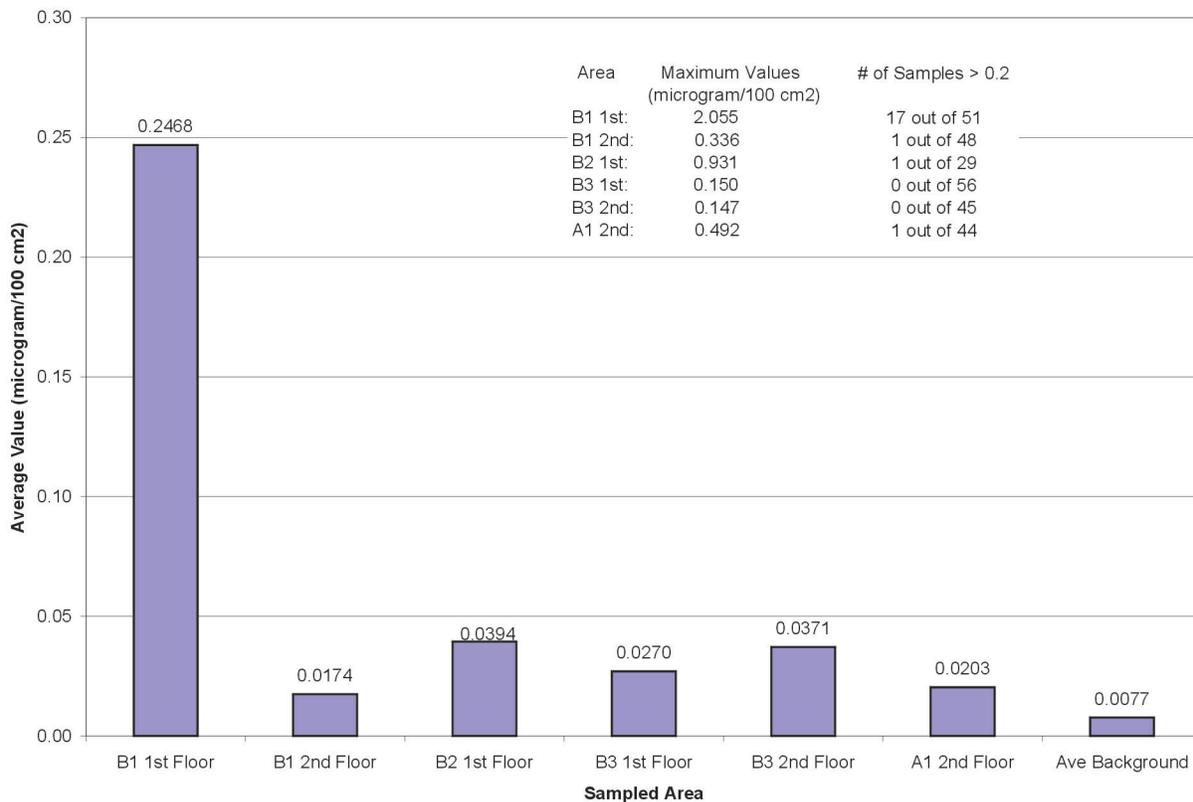
Figure 2.3-1: Comparison of the average beryllium contamination levels in the buildings.

comparison between all of the samples and their individual anticipated background values. While the standards for beryllium contamination are absolute values, i.e., they are not to be corrected for background, it is clear from this figure that the observed values represent levels that are elevated above what would normally be expected in the carpets. Although the concrete high bay area of B1 is not included in these figures, it is also clear from Figure 2.2.2-2 that beryllium levels in the southern end of the high bay are elevated by factors of up to 134 times greater than the background levels in area soils.
