## Department of Energy

### MARSHALL ISLAND PROGRAM SUPPORT

Purpose of the Inspection	1
Description of the Site and Facilities	2
Trailers (all DOE owned)	2
Permanent Buildings (property of the Enewetak Council)	7
Vehicles (property of DOE, DOI and unknown)	7
Excess Material Storage	7
Electrical Power	7
Water supply	8
Sewage	8
Safety Considerations	8
Environmental Findings	8
Fire Protection	9
Electrical Safety	9
Sanitation	10
Chemical Safety	10
Mechanical Equipment Safety	11
Actions Taken	11
Concluding Remarks	11
Appendix 1	13
Specific Inspection Findings and Current Status	
Appendix 2	41
Secondary Containment Systems

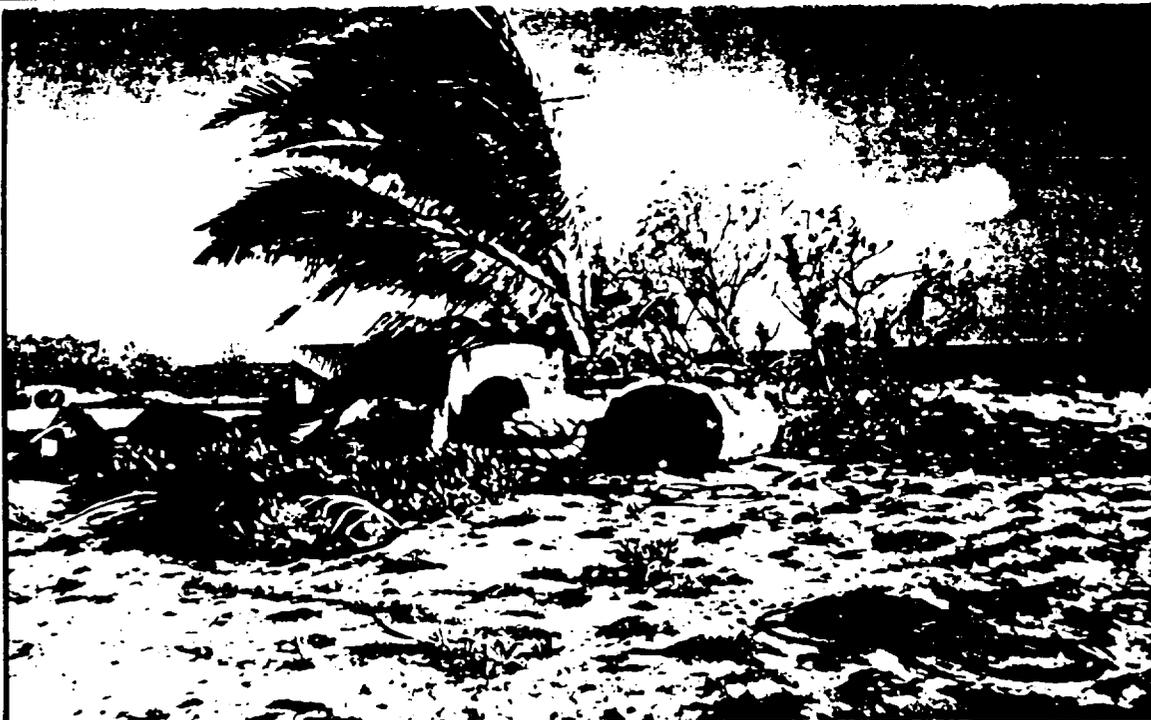
**Figure 1.1**  
**Some of the Excess Tanks and Material**

4. There are several tanks on site that could create a confined spaces hazard. In most cases the entries are not readily accessible. Should they become accessible, physical barriers should be installed to ensure that children do not climb into them and become asphyxiated. See Figure 1.1.

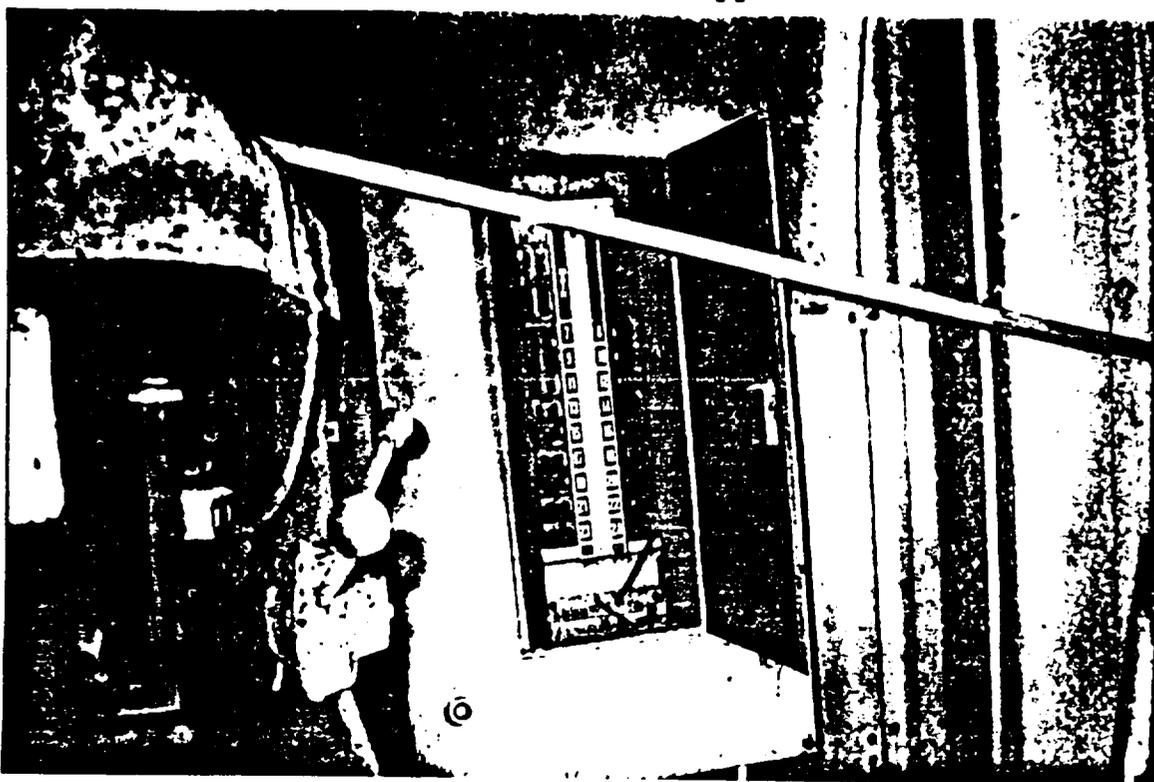
**Figure 1.4**  
**Electrical Distribution Panel in the Boat House**  
Note the Absence of Any Cover Below the Breakers.

- 1.\* The electrical distribution panel is not completely closed, presenting an imminent danger if a person were to stick his/her hand in.
- 2.\* Some outlet boxes do not have covers. All should, if they contain energized wires.
- 3.\* There are chocolate chips and other food stuffs that have spoiled. They should be disposed of.
- 4.\* The polarity is reversed on the air conditioner outlet plug. It also should have a cover plate.

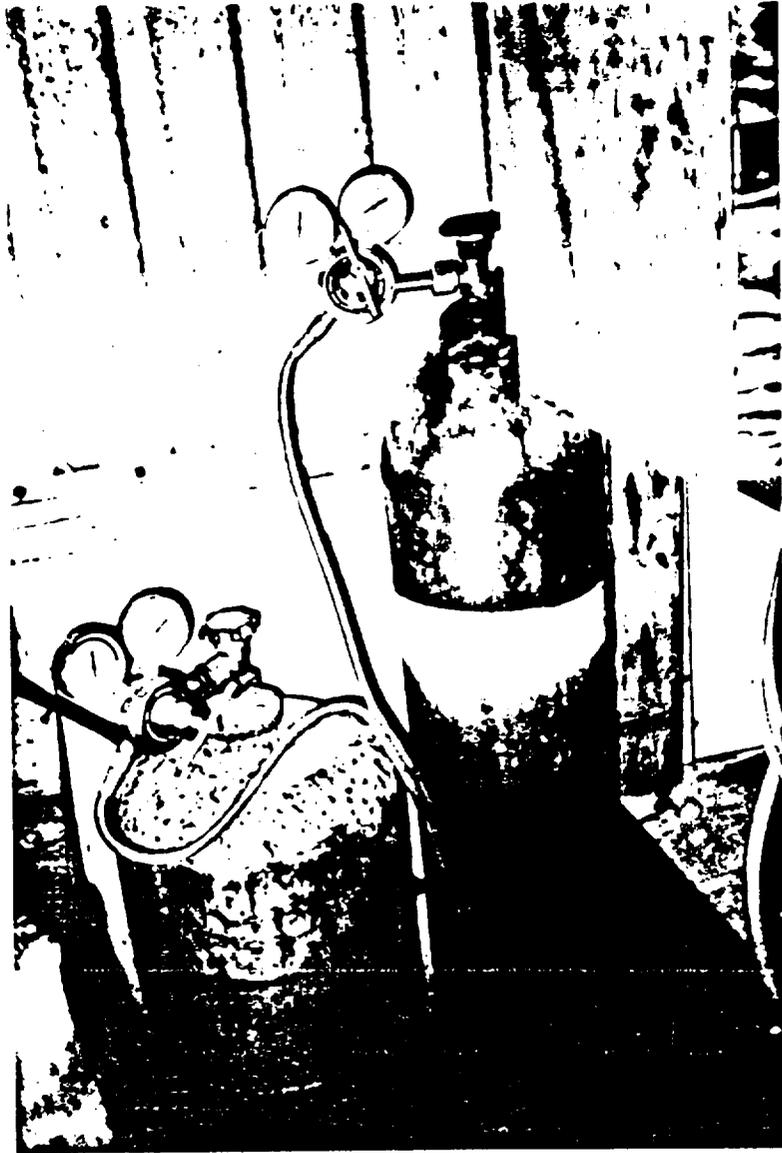
**Figure 1.5**  
**Oxygen and Acetylene Cylinders in Boat House**

These were latter chained to prevent falling

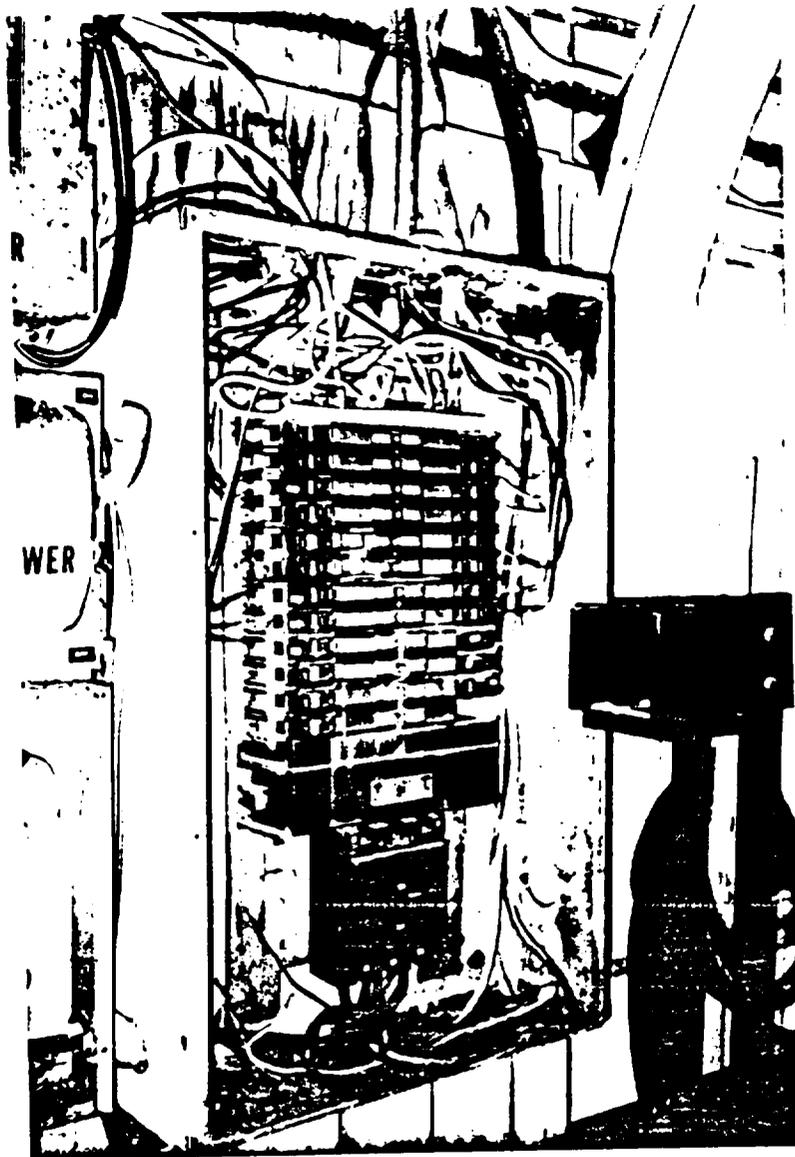
**Figure 1.7**  
**Motor Pool Maintenance Shop Electrical Distribution Panel with the Site-**  
**Fabricated Cover Removed**

Several of the main electrical distribution boxes were extremely corroded and a few had been replaced with site-fabricated wooden boxes. This deficiency had been noted by Raytheon, DOE's contractor, and replacement boxes were on order and due to arrive on the vessel that took the inspection team off the island. Many facilities had additions to the original wiring in the form of surface run Romex cable. Many of the electrical distribution panels within the facilities were missing breakers or portions of the box covering exposed wiring, leading to conditions sometimes classified by OSHA as imminent danger. Many junction boxes and outlet boxes were missing cover plates. No ground fault circuit interrupters were noted at any location on site although current code requires them in the vicinity of sinks and other wet areas.

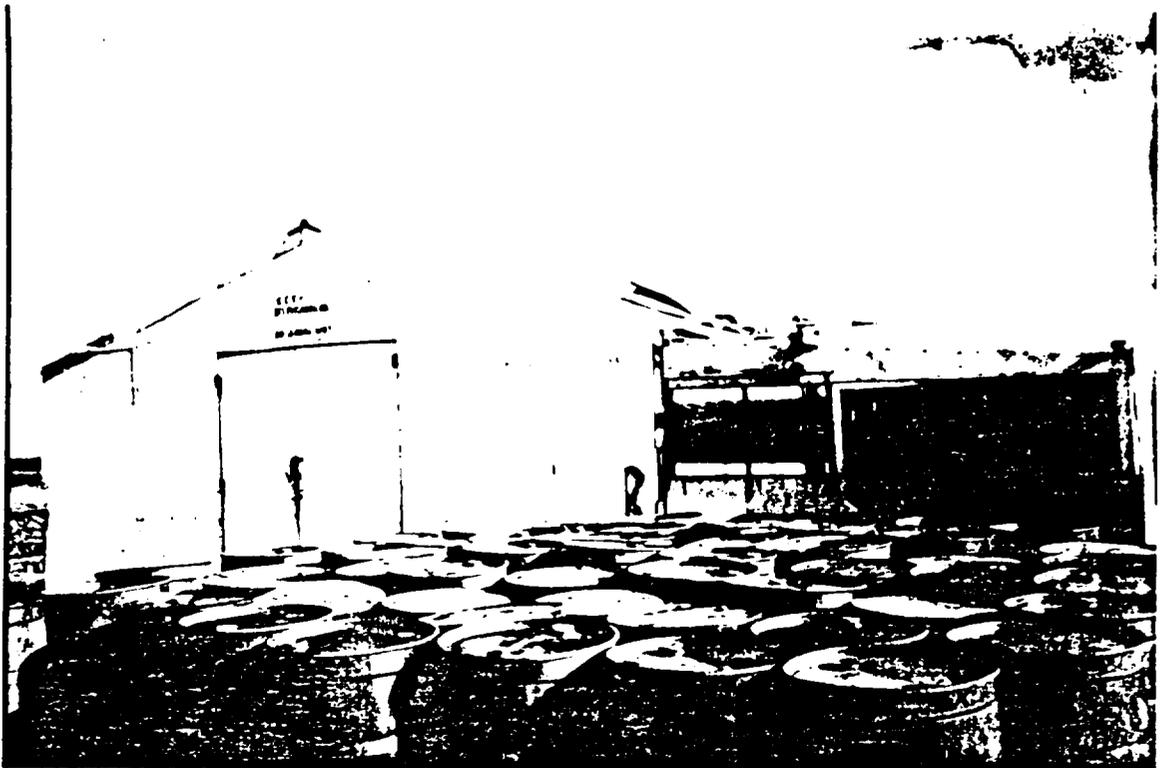
1. This building may not be structurally sound. The steel beams are badly corroded. The absence of a roof in several areas will accelerate further corrosion. The building should be demolished or rebuilt. Figures 1.8 and 1.9 show this building.
- 2.■ The evaporated milk in this building may not be palatable and should be disposed of. -- Completed.
- 3.\* There is a large number of drums of hydraulic fluid and oil stored. These should be properly labeled. -- These drums had been moved out of the shed and labeling was about to begin. Figure 1.9 shows these drums after they had been removed from the building.
- 4.■ The adjacent storage yard contains a degraded acetylene cylinder. It should be emptied and disposed of. -- It has been removed, emptied and is ready for land

**Figure 1.8**  
**Agricultural Storage Building showing Typhoon Damage to Roof**  
The rusted condition of the support beams is not readily apparent in this photo.

**Figure 1.9**  
**Agricultural Storage Building with**  
**Stored Drums Removed for Labeling**

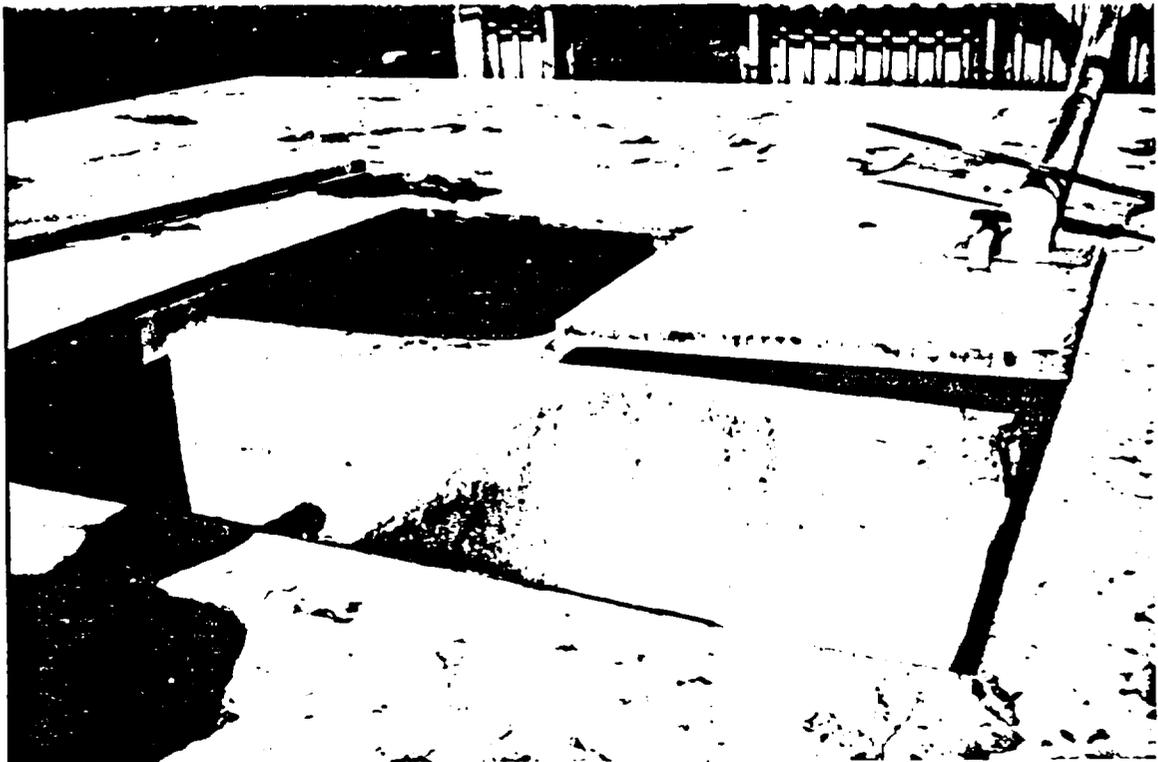
**Figure 1.12**  
**Cistern Top**

- 1.■ The lead bricks holding the cistern tops on should be replaced with a non-toxic material so there is no potential for harm if they fall into the cistern. -- Completed. The inspection team took the bricks from the island.
- 2.■ Retrieve the lead brick from the cistern east of the carpenter shop (Structure 16 on Figure 2). -- Completed. Figure 1.11 shows the brick before it was removed.
- 3.■ Obtain duplicate water samples from the cistern east of the carpenter shop for lead analysis. -- Completed. Samples were taken with the team.
4. The wooden structures supporting the cistern covers are generally rotted. An alternate cover system will soon be required in several locations. Figure 1.12 shows the top of one of the cisterns with all but one of the covers removed.

The wooden supports at the perimeter of the opening are rotted.

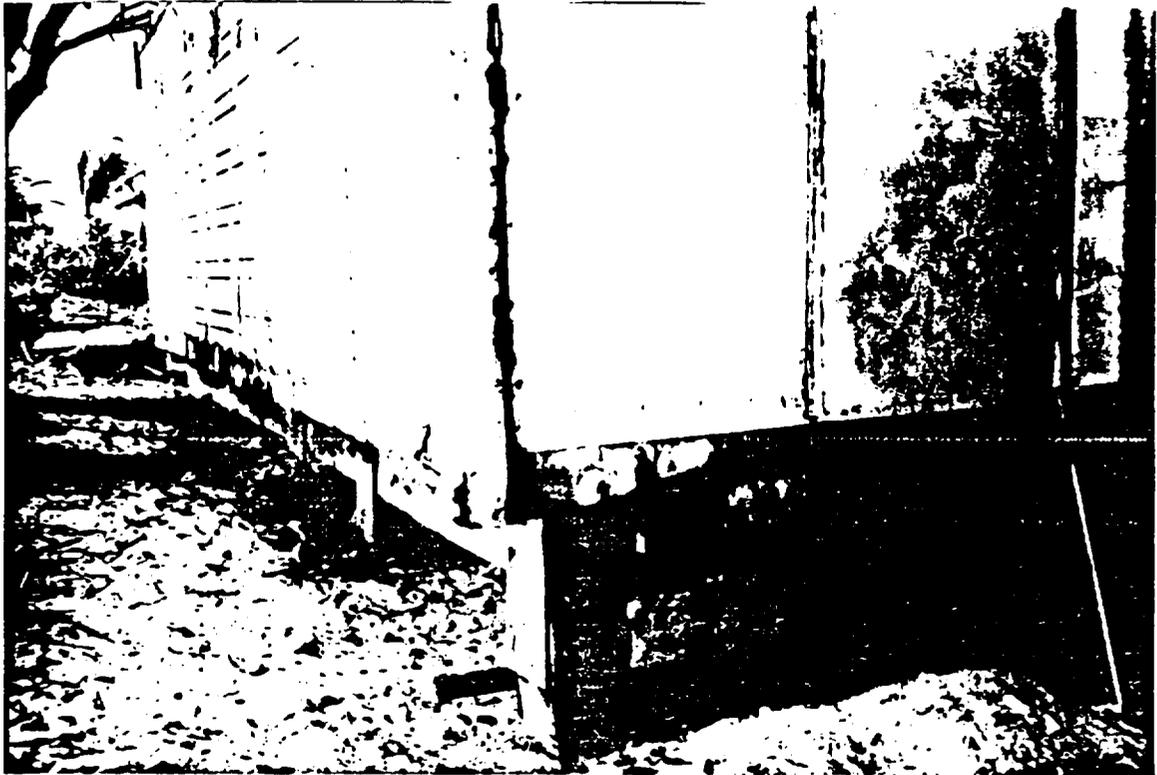
**Figure 1.13**  
**Rusted Siding on the Addition to the Kitchen Trailer**

1. The exterior siding on the addition to the kitchen trailer (Structure 4 in Figure 2) is badly rusted at the bottom. It could present a hazard to children in the vicinity and should be covered, preferable with plywood or some other material that will

not be adversely effected by the weather. Figure 1.13 shows the rusted siding.

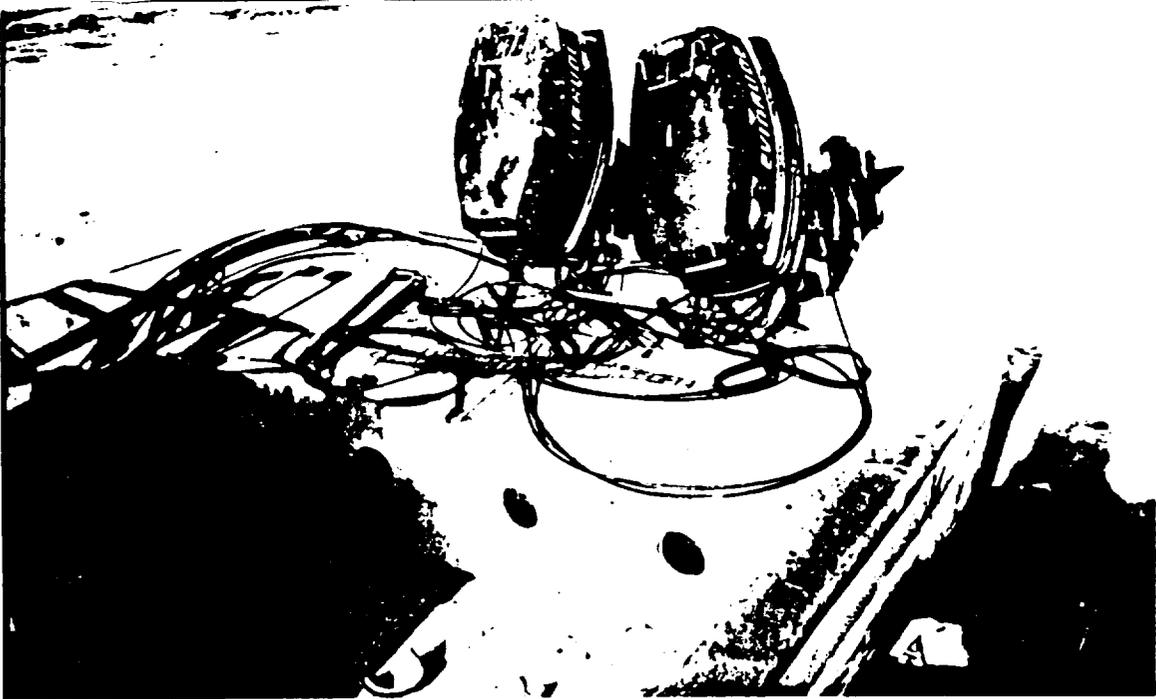
**Figure 1.16**

This shows the first attempt to ventilate the box where portable fuel tanks are stored. Additional vents, lower in the panel, were added later.

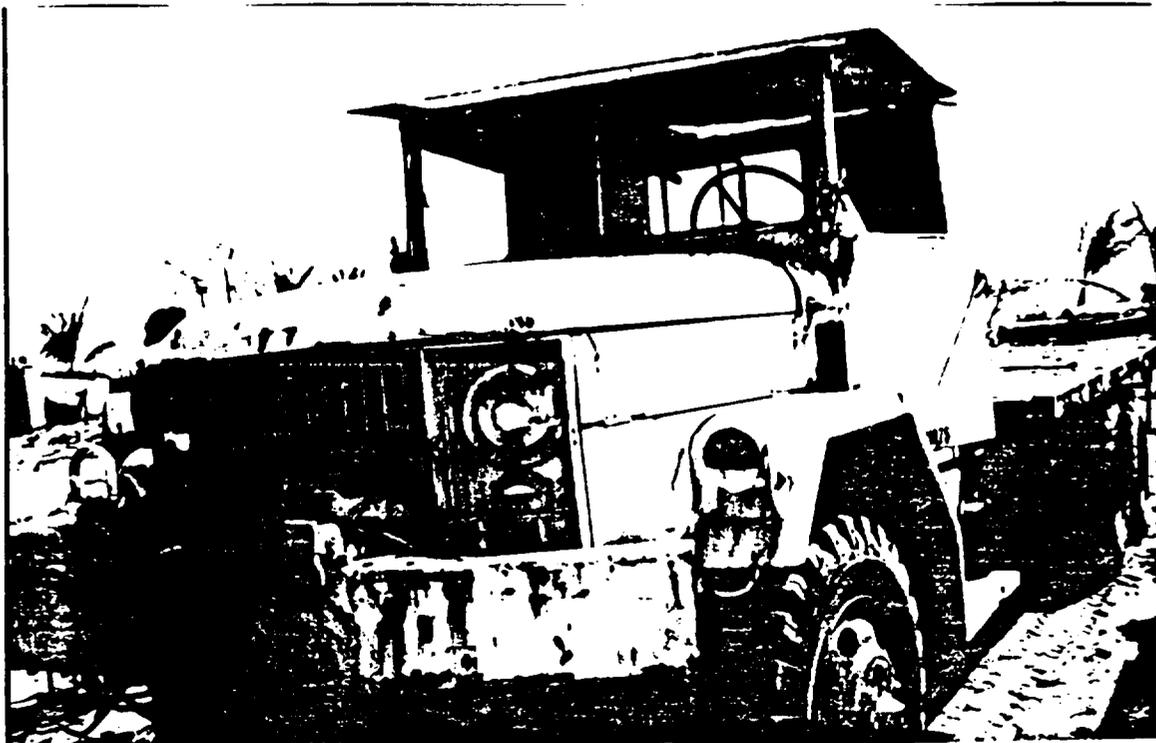
**Figure 1.17**

The front winch is inoperable. The only window glass was in the back and it was cracked. The top is plywood wired in place.

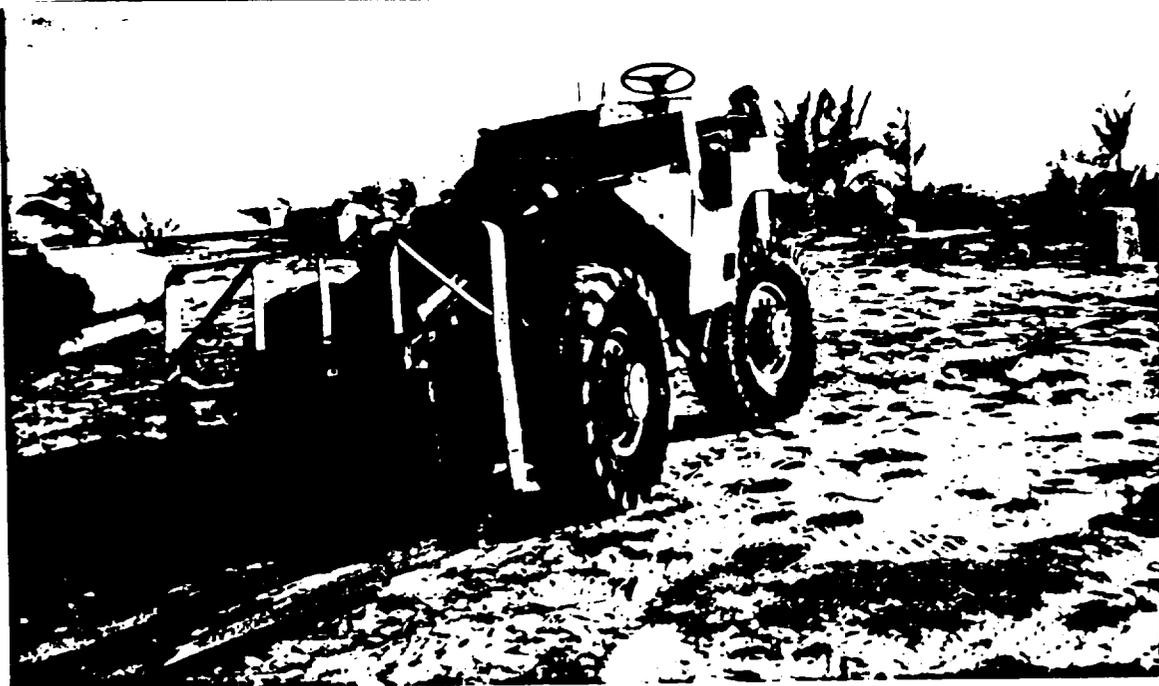
**Figure 1.18**

This vehicle had poor breaks and steering.

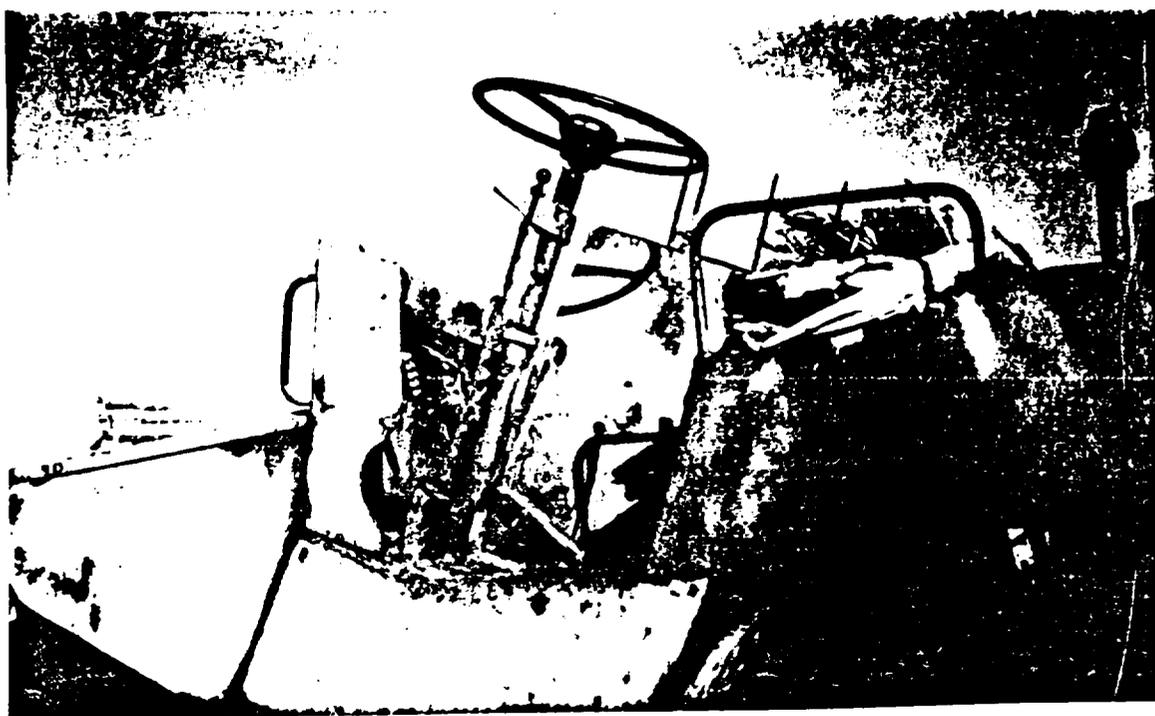
**Figure 1.19**

Detachment of the steering column from the dashboard contributed to the steering problems.
