OPERATING EXPERIENCE SUMMARY

Office of Environment, Safety and Health

Summary 2001-03

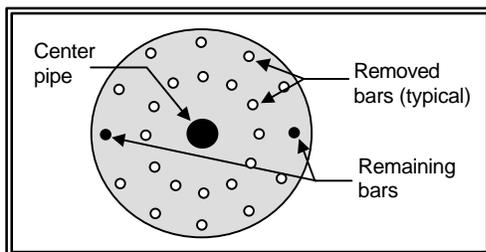
Tube bundle frames supported barrier tubes inside converters used for uranium enrichment at the K-25 Gaseous Diffusion Plant. During dismantlement, the tubes are removed before the frames are disassembled. A frame weighs over 11,000 pounds and consists of parallel support bars and several disk-shaped tube sheets (see Figure 1). The frames are lowered horizontally by crane onto a disassembly stand constructed of I-beams and then cut apart with cutting torches. In past practices, the frames rested on the stands during the cutting operation without another form of restraint, with a maximum of four inches between each tube sheet and the stand. In over 400 previous disassembly operations, the frame had never shifted during cutting. However, in this occurrence, the frame rolled as the worker cut partway through the center pipe in the frame. His left foot was positioned between an I-beam and a tube sheet (see Figure 2). The frame crushed his toes even though he was wearing boots with steel toecaps. The weight of the frame broke his first and second toes, rupturing blood vessels in the latter. The worker was hospitalized for four days, during which time a pin was surgically implanted in his big toe.

Figure 1. Tube Sheet in Tube Bundle Frame

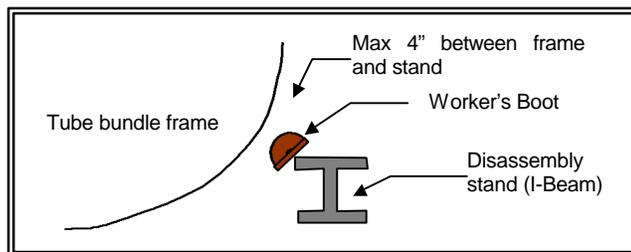
On July 3, 2001, at the East Tennessee Technology Park (ETTP) Building K-33, a heavy tube bundle frame rolled onto a worker's foot and crushed two of his toes. The worker was using a plasma torch to cut the frame, in compliance with a disassembly practice used many times before without incident. The possibility of unstable frame orientations and the hazards from pinch points had not been addressed in the design of the disassembly. (ORPS Report ORO--BNFL-K33-2001-0010)

Figure 2. Location of Worker's Foot in Pinch Point

A preliminary investigation team inspected the frame soon after the accident and found the tube sheets still in line and parallel, indicating the frame had rolled and not twisted or deformed. One of the key questions addressed in the contractor's accident investigation was why the frame rolled in this occurrence and not in previous instances. By observing frame movement evolutions, the investigation team found that in most cases, a stabilizer bar or jack plate prevented the frame from moving on the disassembly stand. But in one unique set-down position, the frame was unstable and could roll.

The accident investigation team found that the tube bundle frame disassembly design did not recognize the hazards from gaps and pinch points or the possibility of unstable frame orientations. Frame dimensions varied and there was no control on frame orientation, nor any requirement to secure the frame to the disassembly stand. Corrective actions taken by the contractor include revising the work procedure to require securing the frames during dismantling. The contractor will also revise its enhanced work planning process to better identify and address pinch point hazards.

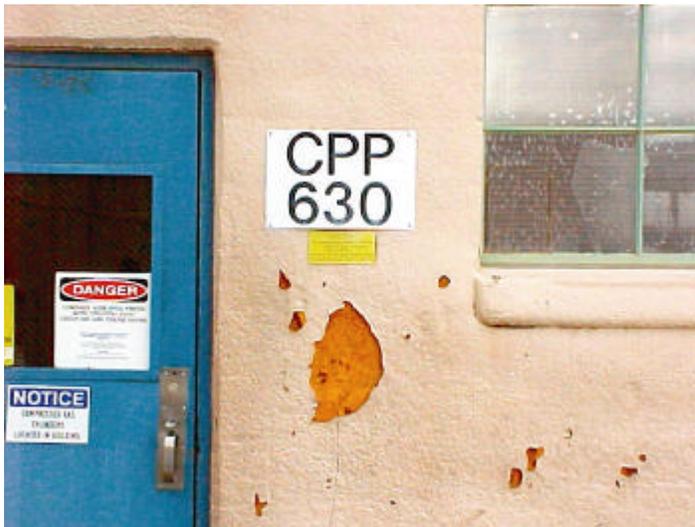
The exteriors of 11 INTEC buildings were insulated with polyurethane foam insulation and coated with an acrylic rubber elastomer in 1985. These facilities house nuclear material laboratories, deactivated processing equipment, tank farm instrumentation, and offices. The original facility safety documents did not address any fire hazard from the insulation. Fire hazard analyses developed as part of safety document upgrades in the mid-1990s recognized potential fire issues and recommended testing and evaluation of the insulation. The testing and evaluation were never performed; however, recent information on similar insulation used in Building 3019 at the Oak Ridge National Laboratory (ORNL) further emphasized the need to address the fire hazard from polyurethane foam insulation (see discussion below). Currently, the acrylic rubber elastomer (Diathon) coating is peeling off of the INTEC facilities' insulation in several places, further exposing the foam to possible ignition (see Figure 1).

Figure 1. *Diathon coating peeling off of the insulation of CPP-630.*

The USQ evaluation found that six of the eleven facilities (CPP-602, CPP-620, CPP-627, CPP-630, CPP-637, and CPP-640) have an increased risk of radioactive or chemical material release due to the large fire loading from the exterior wall insulation. The other five facilities are in separate buildings and house no hazardous materials, thus facility fires pose little risk from material release. For the facilities found to have increased risk, the contractor is implementing compensatory measures that include patching areas where the coating has peeled, removing combustible materials away from the walls, and prohibiting welding and grinding operations near the exterior of the facilities.
