OPERATING EXPERIENCE SUMMARY

Office of Environment, Safety and Health

Summary 2001-06

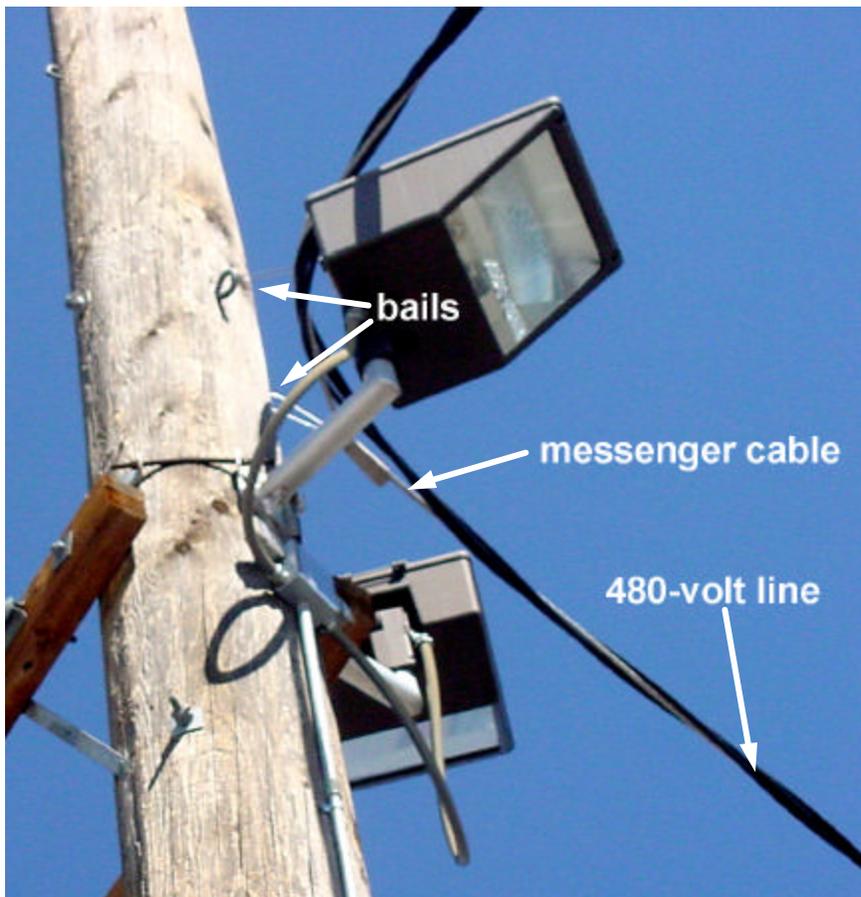
Figure 1. The upper messenger cable bail was reattached to the utility pole

In January 2001, workers reported that one of two messenger cable bails holding a 480-volt power line to a utility pole at the WROC was loose. Facility management decided that the job of reattaching the bail to the pole would involve little risk, and assigned this to the electricians in its maintenance organization rather than to utility workers in its power management organization. A craft foreman, electrician, and electrician's helper walked down and planned the task. They assumed that the power line's Tri-Plex wiring was sufficiently insulated to prevent an electric shock hazard, and thus saw no need for special electrical PPE. On August 8, 2001, the electrician's helper was raised in an aerial lift (Genie Lift), and used a rope to pull the line's messenger cable and reattach the bail to the utility pole (the upper bail shown in Figure 1).

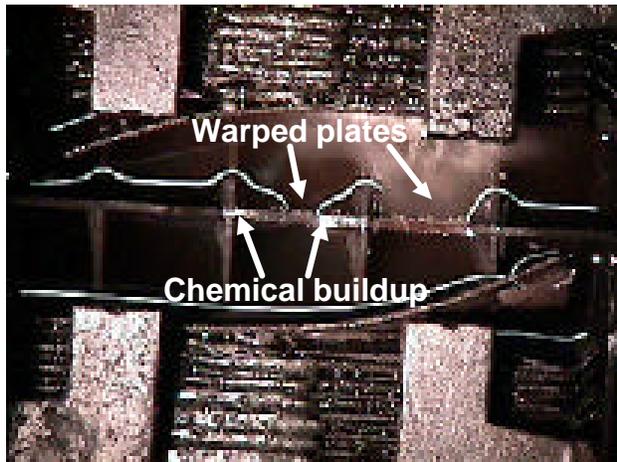
An investigation into the INEEL incident indicated that the cause was an end-of-life failure, and revealed that one cell in this battery was low on electrolyte, which was discovered during the quarterly Preventive Maintenance (PM) conducted six weeks before the explosion. The cell needed to be filled in order to allow a hydrometer reading to be taken, likely indicating a bad cell.

As a lead-acid battery ages, the corrosion layer on battery plates increases in thickness, causing the distance between the plates to narrow and the potential for cell degradation to increase. The battery voltage drop causes the charger to produce more current to normalize the voltage as a cell degrades. The increased current could boil off electrolyte in the cell, causing the top of the plates to be exposed, providing an air gap that can allow for arcing.

Figure 1 illustrates the inside of the battery that exploded at INEEL, revealing warped plates and chemical buildup across the plates.

Figure 1. The battery that exploded at Idaho

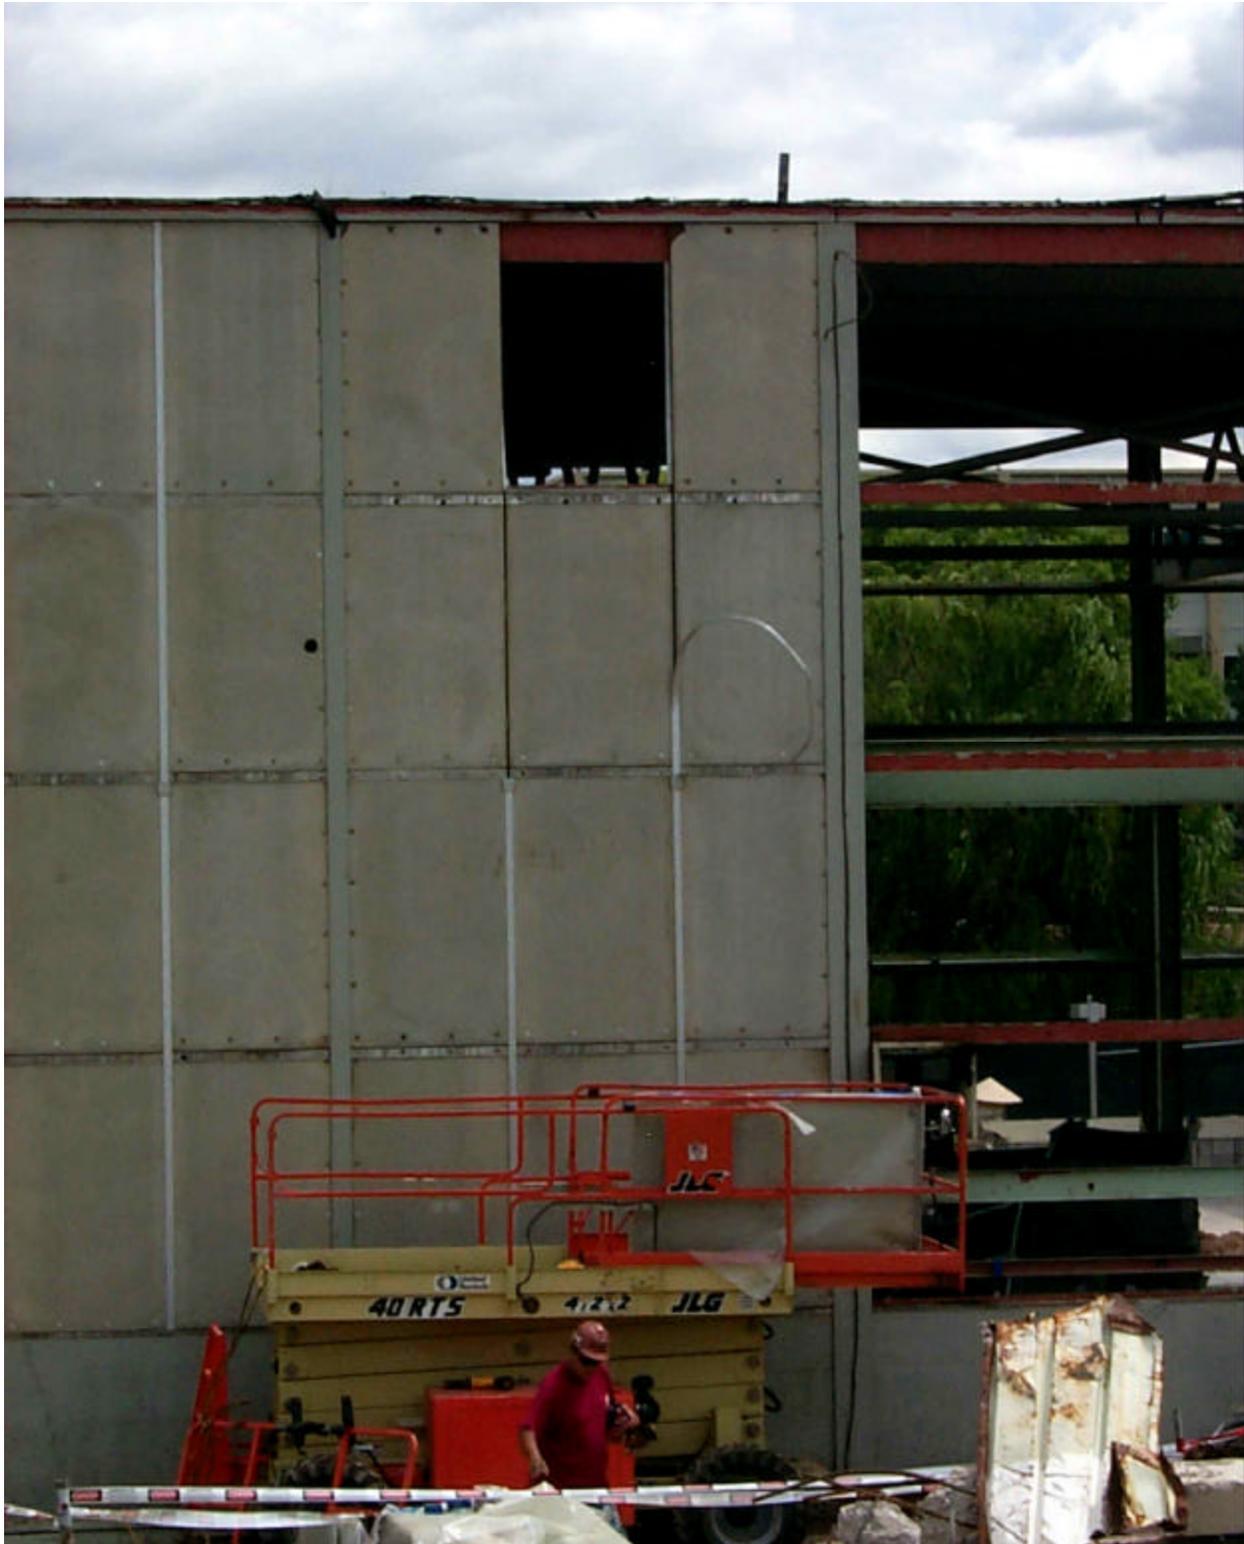
Two subcontractor workers were removing asbestos transite panels from a building exterior with the aid of a scissors lift. Figure 1 illustrates the building exterior from which the panels were being removed. The workers were wearing the required personal protective equipment for the job, which included steel-toed boots, hard hats, safety glasses, Tyvek coveralls, gloves, and respirators, but no fall protection gear. The scissors lift was located approximately 40 feet above the ground, two feet from the building, and within

Figure 1. Building showing the empty slot from which the panel fell and struck the worker

two feet below the bottom of the panel. The workers had momentarily lost communication with one another to ensure that one was bracing the panel while the other attempted to free it. Because of this lack of communication, both workers were pulling on the left and right sides of the bottom of the panel. The panel unexpectedly became loose and pivoted into the top of the scissors lift, where it struck the worker who was working to the left of the panel. The worker was knocked unconscious to the floor of the scissors lift platform for approximately one minute. He was taken to a medical center for treatment and later released.

Immediate actions taken included implementation of a subcontractor stop-work order and a review of the accident and safety ramifications of the accident. The procedure for removing the panels was also reviewed. Based on the results of a preliminary investigation, the site safety officer noted that no specific hazards and hazard controls were documented in the Site-Specific Health and Safety Plan (SSHASP). The direct cause of the accident is believed to be due to a lapse in communication, which was hampered by the respirators that the workers were wearing. This accident had the potential for a far more serious injury than what occurred; for example, the weight of the panel could have knocked the worker off of the raised scissors lift.

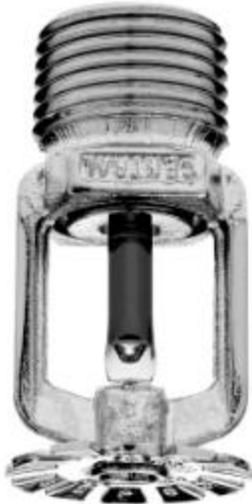
Central initiated this action because it discovered that these sprinklers with O-ring seals could degrade over time. The sprinkler heads can corrode, or minerals, salts, and other contaminants in water can affect the rubber O-ring seals. These factors could cause the sprinkler heads to fail to activate in response to a fire. Laboratory testing has indicated that the majority of the sprinklers would operate in a fire situation; however, some sprinklers required higher water pressure to activate than may be available in some buildings.

Figure 1. A Central Sprinkler “wet” model GB, subject to replacement under the program.

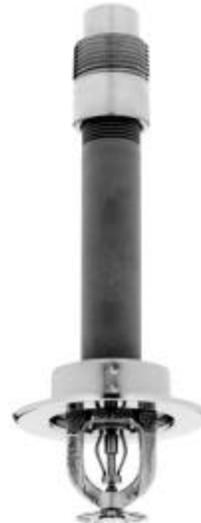
Figure 2. A Central Sprinkler “dry” model A-1

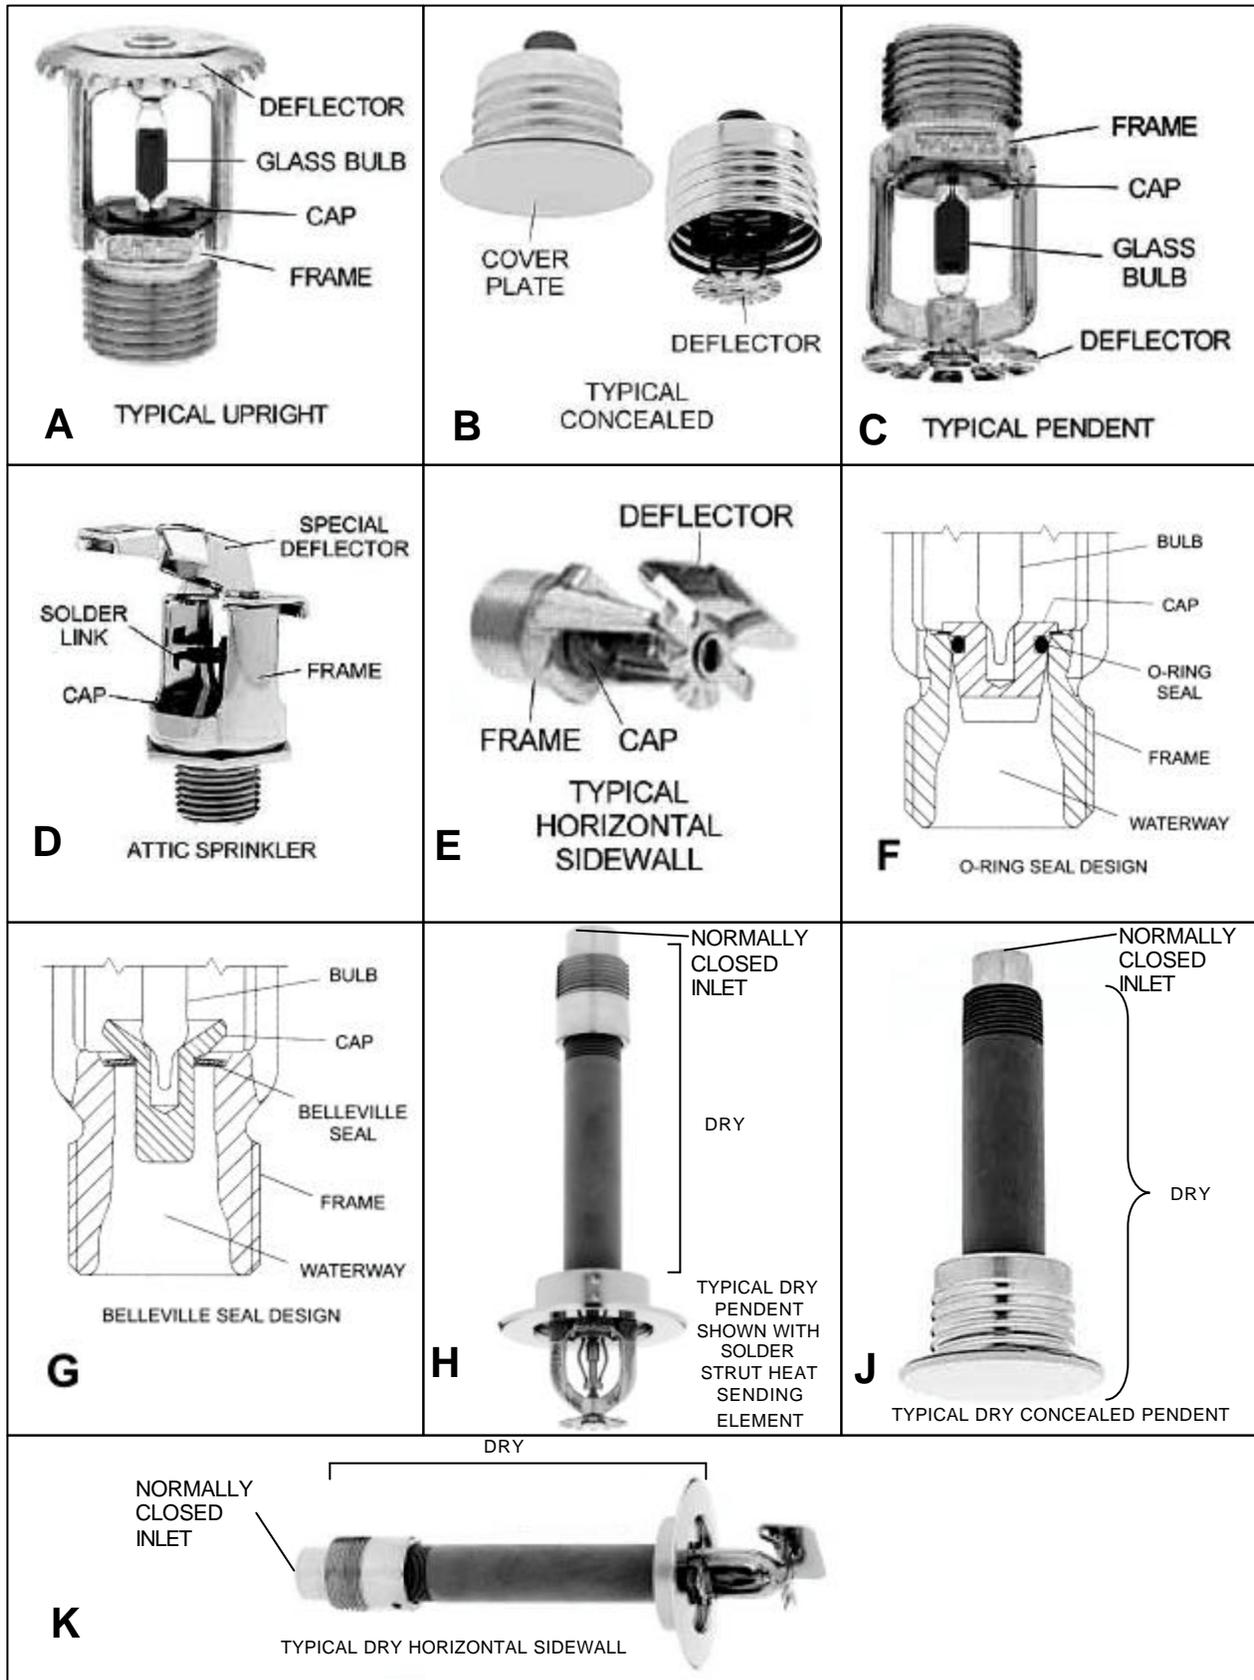
Figure 3. Sprinkler heads included in the recall
