OPERATING EXPERIENCE SUMMARY

Summary 2001-07

Operating Experience Summary 2001-07

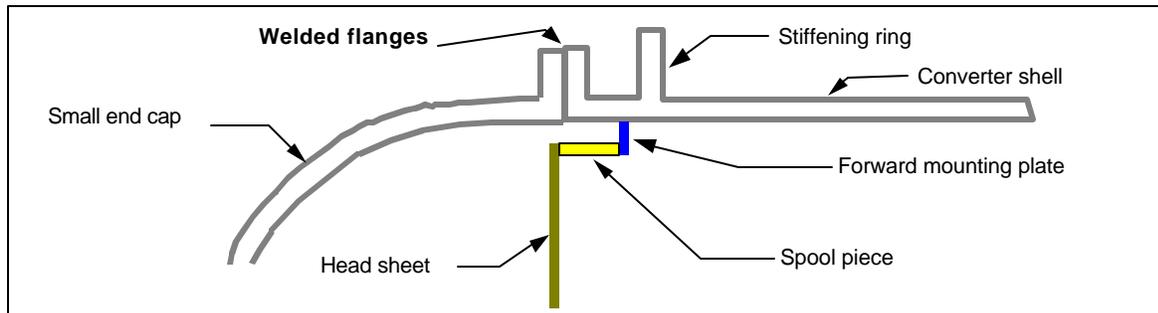
Figure 1. Cross section of converter and internal structures

A first step in disassembling converters is to cut off the small end caps of the converters shown in Figure 1 using plasma-arc torches. This allows access for removing the internal structures that support barrier tube bundles. The barrier tube bundles are located away from the small end caps, on the opposite side of the head sheet, spool piece, and forward mounting plate.

On July 25, 2001, another worker was cutting the small end cap from the 14th converter when the fire started. The subsequent investigation revealed that, like the first worker, he had used the stiffening ring to guide his torch in making a circumferential cut between the ring and the flanges connecting the converter shell to the small end cap. However, the second worker had held his torch vertically and not angled towards the end cap, as specified in the Enhanced Work Plan (EWP). This resulted in a cut close to the ring that caused hot metal to fall on the wrong side of the forward mounting plate and onto the tube bundle, igniting the tubes. A cut on the other side of the forward mounting plate would have led to hot metal falling onto the spool piece, without touching and igniting the barrier tubes. The investigators concluded that while the worker deviated from the EWP in not angling his cut, the EWP did not specify a precise cut location and did not require verification of the forward mounting plate location, although the equivalent Building K33 EWP did require such verification. The team that prepared the Building K-31 EWP had failed to recognize the significance of the gap between the external stiffening ring and the internal forward mounting plate. The investigators recommended that the EWP be modified to provide more specific instructions and to require measurement of internal structures and marking of cut locations prior to cutting.

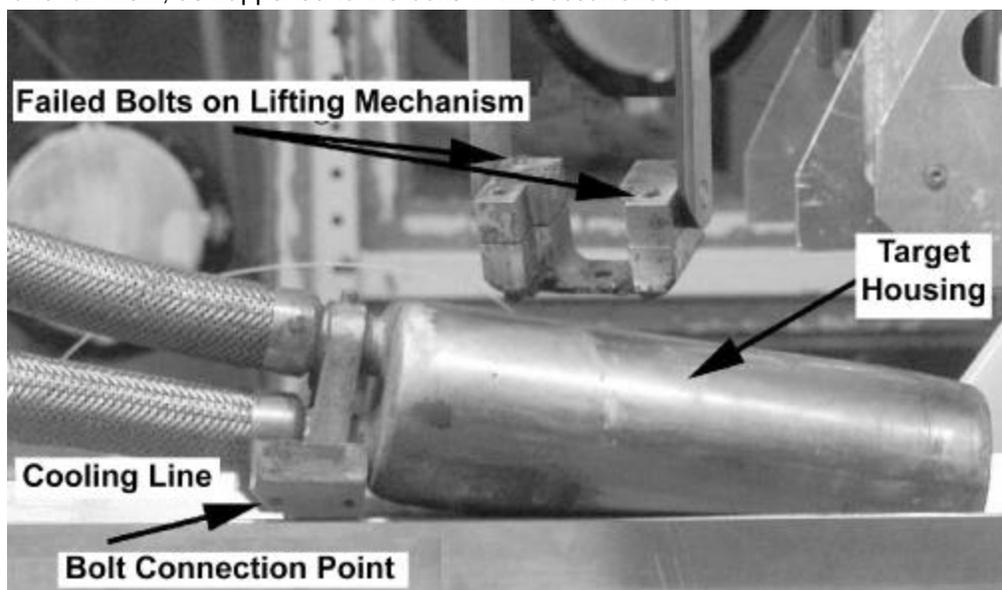
The target housing and part of the lifting mechanism are shown in Figure 1. The target consists of eight clad depleted uranium pucks, each weighing 3.6 kg (7.92 lbs.). The eight pucks are stacked inside of a nearly cylindrical housing that is welded closed on both ends. Cooling lines attach to one end of the

Figure 1. *Target housing and part of the lifting mechanism*

A visual inspection of the lifting mechanism, which was connected to the target by four 5/16" high-strength alloy steel bolts, revealed that all four bolts had failed. Furthermore, the failed surfaces of the bolts appeared oxidized, indicating that the failures were old.

This occurrence illustrates the importance of periodic inspection and load testing of the stressed components; particularly weight-bearing components made of dissimilar metals. When inspections are

not operationally feasible, the design should include defense-in-depth features, so that a common-mode-failure would not cause a significant problem to occur.

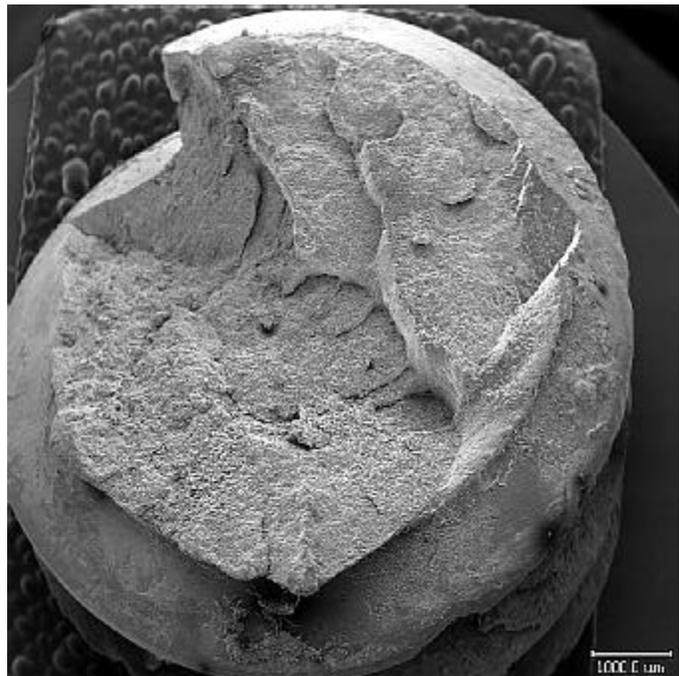
Galvanic corrosion occurs when two dissimilar metals (e.g., stainless and high-strength alloy steel) are placed in contact with an electrolyte (a conductive solution, such as in water produced by moisture). The damage from corrosion is more severe when metals are simultaneously stressed, such as from welding residual stresses, or, as in this case, from tensile stresses in bolt threads due to tightening. Over time, stress corrosion cracks can propagate through corroding and stressed metal components and fail them, as happened to the bolts in this occurrence.

A staff metallurgist examined the bolts on a scanning electron microscope to investigate the use of high-strength, low alloy steel bolts in a stainless steel assembly. The micrograph of the failed bolt pictured in Figure 2 shows evidence of an intergranular fracture, indicating the cracks proceeded along grain boundaries until the stress was sufficient to fracture the bolt.

Figure 2. Scanning electron micrograph of the fracture surface of one of the failed bolts
