OPERATING EXPERIENCE SUMMARY

Summary 2001-10

Operating Experience Summary 2001-10

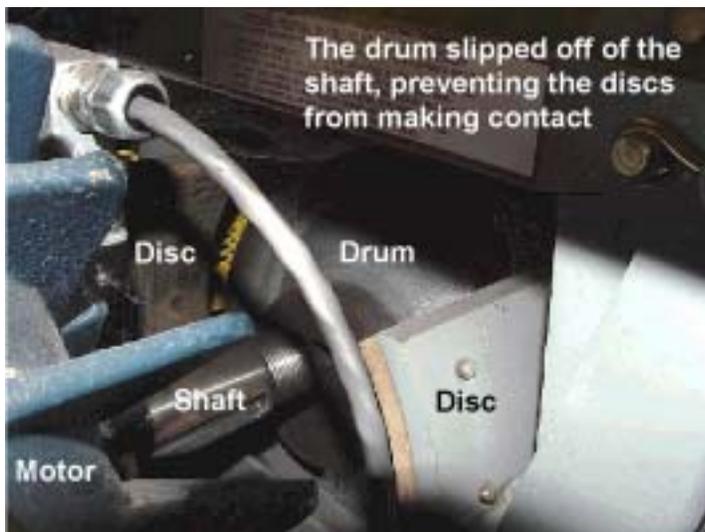
A preliminary inspection of the crane brake system revealed that the 30-ton crane brake drum had become unfastened and slid off its shaft. An investigation to determine the causal factors concluded that a retaining nut installed on the outboard side of the holding brake drum backed off, allowing the brake drum to slide completely off the motor shaft. When the operator released the wireless control hoist button, the holding brake should have engaged. However, because the drum had fallen off the motor shaft there was no drum surface area with which the brake discs could make contact (Figure 1).

Figure 1. Crane Holding Brake after the failure

The crane manufacturer informed SRS Nuclear Material Management Division engineering that a typical holding brake nut-retaining feature would include a standard nut and a split-ring locking washer. However, no locking washer was installed in this application. Preparations for repair based on engineering and manufacturer recommendations are in progress.

No corrective maintenance had been performed on the holding brake since it was installed in 1999. Preventive maintenance (in the form of periodic inspections) and manufacturer's recommended maintenance procedures were performed and no findings were identified. The type of inspections currently performed would not be expected to discover a missing lock washer. Inspectors typically

verify only that the nut is in place and appears secure. Recommendations have been made to evaluate and revise these inspection procedures.

applications for all overhead and gantry (bridge) cranes at SRS facilities will be conducted. The SRS Site Rigging Authority issued a Special Safety Alert on this crane incident. For additional information on this event or the safety alert, contact the Site Rigging Authority at (803) 557-4657.

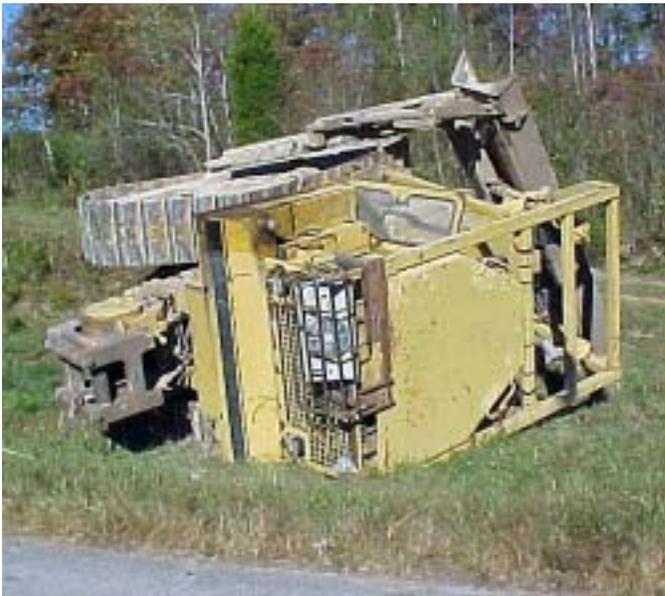
On October 18, 2001, at the Oak Ridge National Laboratory, a heavy equipment operator attempted to load a bulldozer onto a flatbed tractor-trailer when it skidded off the trailer and rolled onto its side (Figure 1). The metal bed of the trailer had become covered with heavy frost overnight, and the bulldozer's metal tracks slid off the slippery surface. The operator was uninjured, and the bulldozer sustained only minor damage. The contractor reported this as a near-miss occurrence. (ORPS Report ORO-ORNL-X10UTILITY-2001-0001)

Figure 1. *Bulldozer rolled onto its side*

The bulldozer and flatbed (lowboy) tractor-trailer had been parked overnight when the ground and equipment became covered with a heavy frost. At 8:25 AM, as the operator backed the bulldozer onto the trailer, the slippery contact of cold steel pressing on frost, coupled with a slight tilt of the trailer bed due to sloping ground, caused the bulldozer to slide off and roll. The closed cab of the bulldozer was equipped with a roll cage, and the operator was wearing safety glasses, hardhat, and his seat belt. He was unharmed. The bulldozer sustained only minor damage, and spilled a few gallons of crankcase oil.

This occurrence illustrates the hazards that weather changes can create. Heavy equipment operators should be cautious when loading steel-tracked machines onto steel beds covered with frost.
