OPERATING EXPERIENCE SUMMARY

Office of Environment, Safety and Health

Summary 2001-11

December 3, 2001

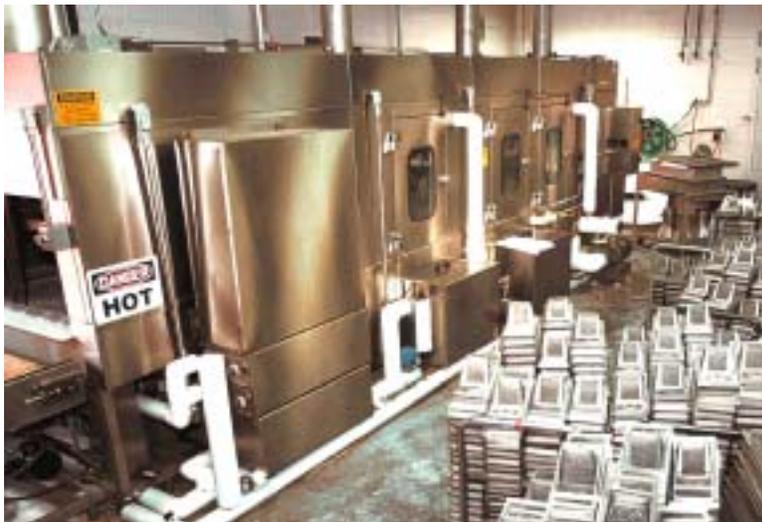
Figure 1. Tunnel washer and carts with cages and cage tops

The tunnel washer, shown in Figure 1, is used to clean animal cages and laboratory equipment that are passed through it on a conveyor belt while being sprayed with hot detergent or rinse water. Prior to the accident, the worker was working alone, cleaning pans, cage tops, and beakers. As she tried to move clean items through a narrow pathway between the washer and cages and cage tops stored next to the washer, either she or the cart she was using bumped into a filter assembly for the washer. This opened a latch holding the end cap for the filter assembly, and the worker was sprayed and scalded by water heated to 194° F and under 30 to 40 pounds per square inch (psi) of pressure.

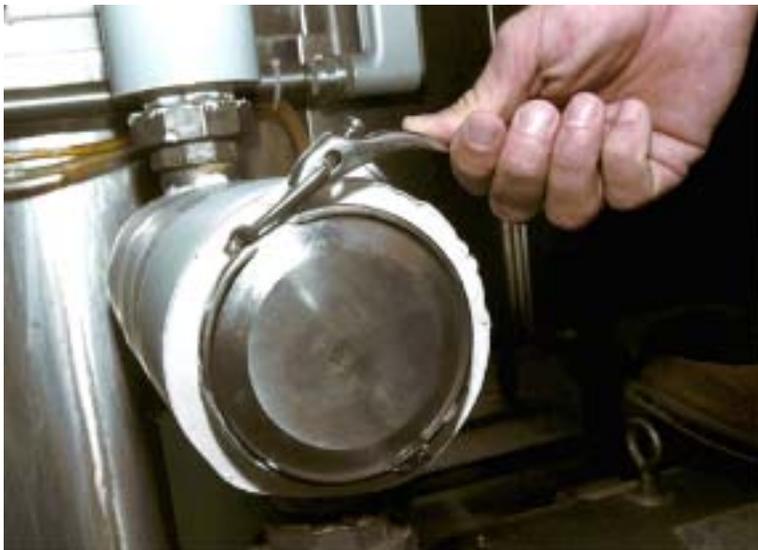
The investigation board concluded that the direct cause of the accident was the inadvertent opening of the filter access assembly. The end cap on the assembly was a last physical barrier containing the hot pressurized water, and the latch holding it in place could be opened by just 10 pounds of force (see Figure 2).

Investigators determined that the filter assembly and other hot water components could have been installed away from work areas. The current latch and cover configuration, installed in 1997, appears to have been selected for ease of access for maintenance rather than worker safety.

Figure 2. End cap and latch for filter assembly

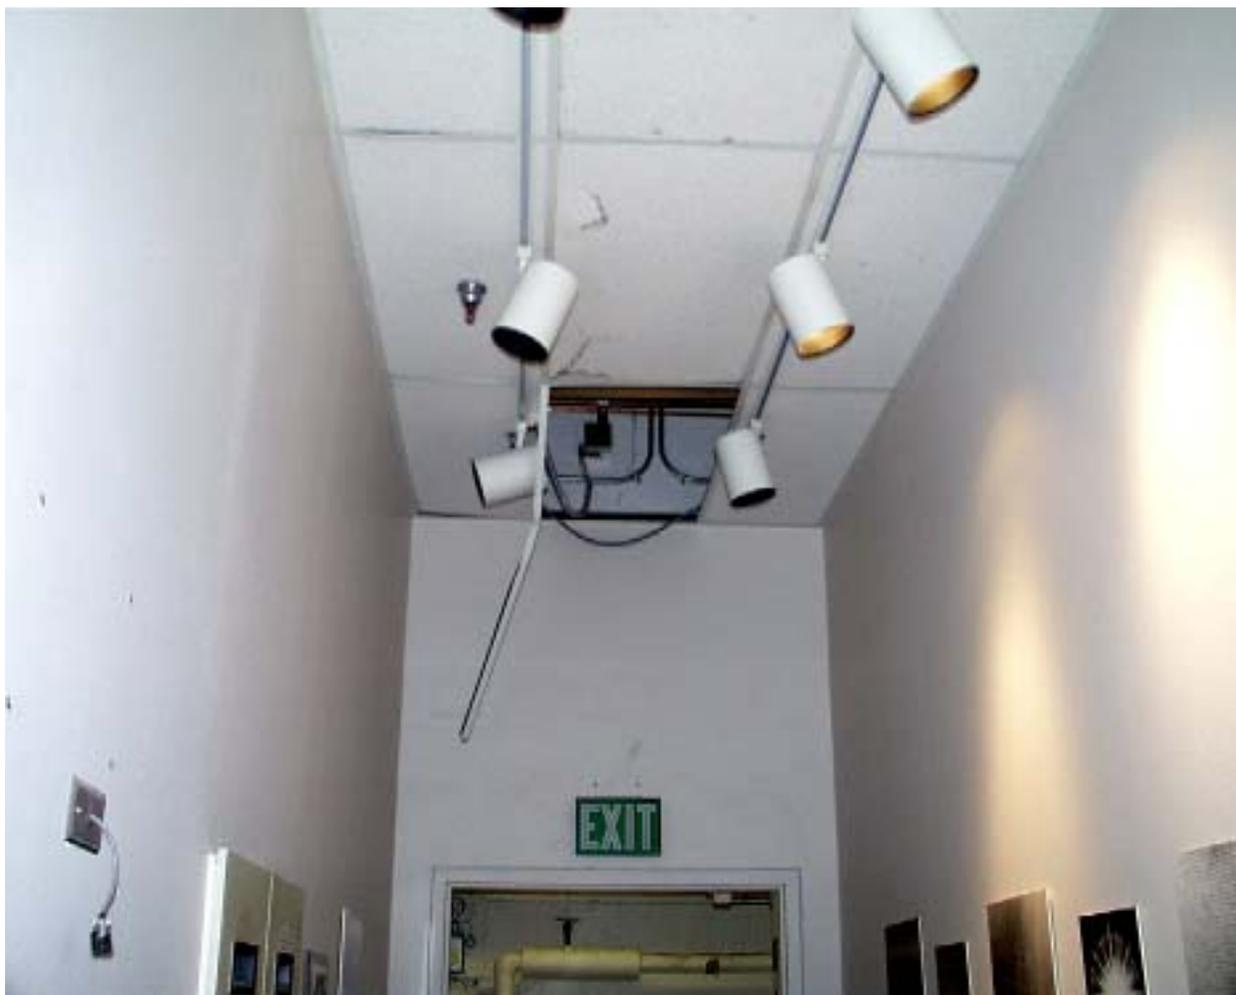
On October 15, 2001, at the Los Alamos National Laboratory (LANL), a facility engineer working in a laboratory space at the Materials Science Complex, fell through a false ceiling from a height of 12 feet and broke bones in both ankles (See Figure 1). The engineer was taken to the Los Alamos Medical Center, treated, and released the same day. (ORPS Report ALO-LA-LANL-MATSCCMPLX-2001-0004)

Figure 1. Photo showing missing ceiling tile through which worker fell

- securing the area until adequate planking is laid above the false ceiling that complies with OSHA requirements,
- surveying other areas for the existence of similar conditions , and
- disseminating lessons learned information on the event through meetings, news bulletins, and management councils

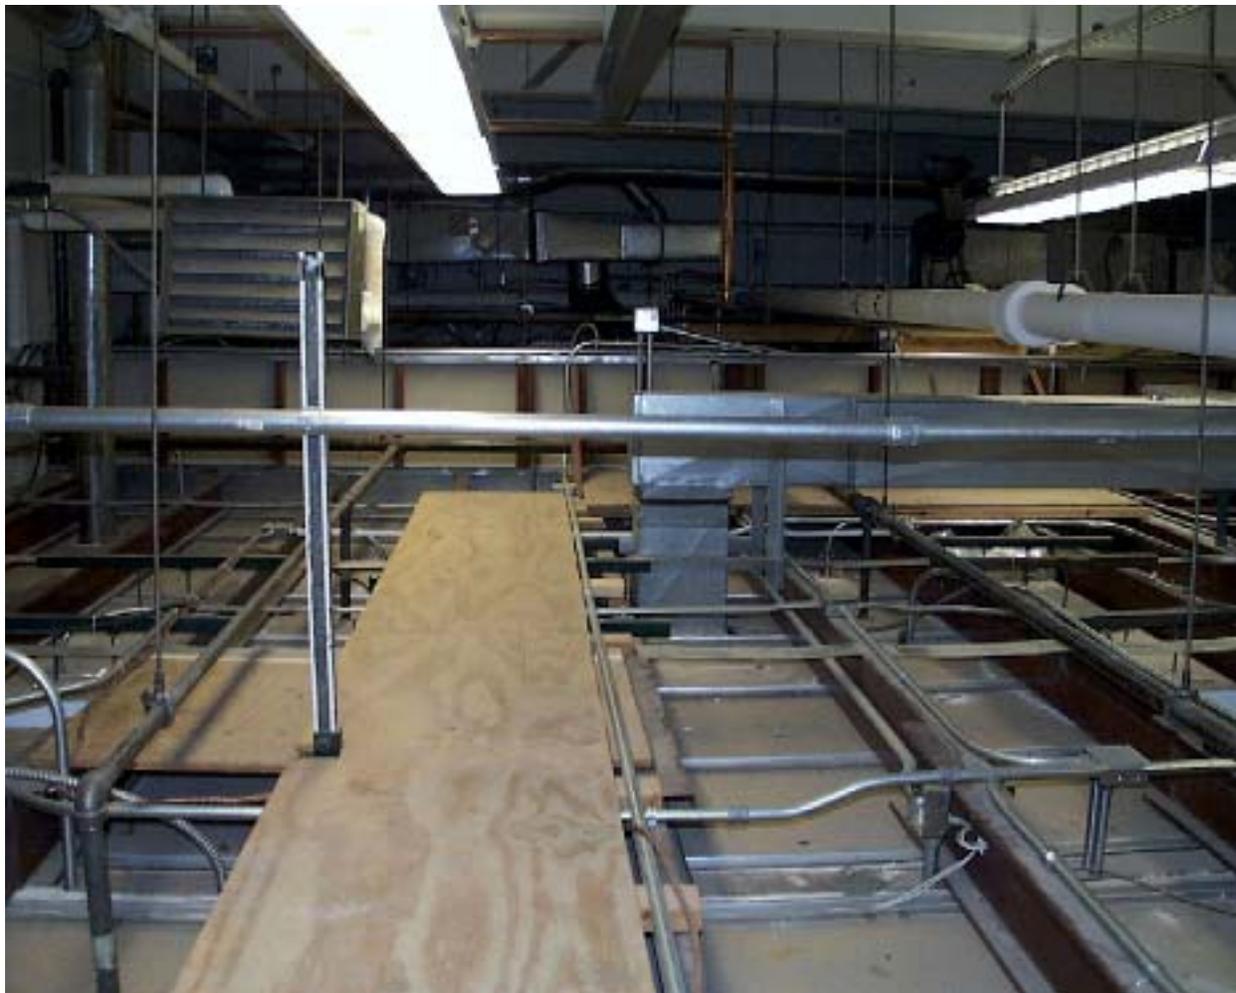
The ceiling area is locked and controlled to limit access. In order for personnel to reach equipment in this area, plywood walkways two feet wide and wood board walkways 10 inches wide were installed (See Figure 2). The employee has stated that, just before the fall, he was backing up onto a 10-inch wide walkway after checking a nameplate. He misstepped onto a ceiling tile and fell through it, landing on the floor in a hallway 12 feet below.

Figure 2: General view of walkways of area above false ceiling

The facility representative indicated that the engineer was alone at the time of the incident, without fall protection, and that the walkways did not comply with OSHA requirements such as installed toe boards and handrails. Management reportedly did not realize that this space did not meet the OSHA requirements, and the incident presented the potential for a more serious injury. The U.S. Department of Labor, Bureau of Labor Statistics data indicate that there were 640 fatalities from falls in the workplace during the year 2000. The facility representative also stated that there could be other spaces at LANL with similar conditions.

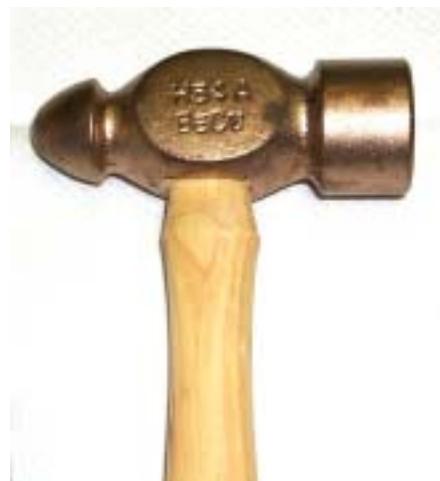
Figure 1. New hammer at Y-12 Plant with beryllium contamination at 1.5 micrograms/100 cm²

Beryllium-copper alloys have been widely used to make non-sparking tools such as wrenches, hammers, and axes. “BeCu” is often stamped on them (see Figure 1). A small percentage of beryllium in the alloy hardens the copper and adds corrosion resistance.

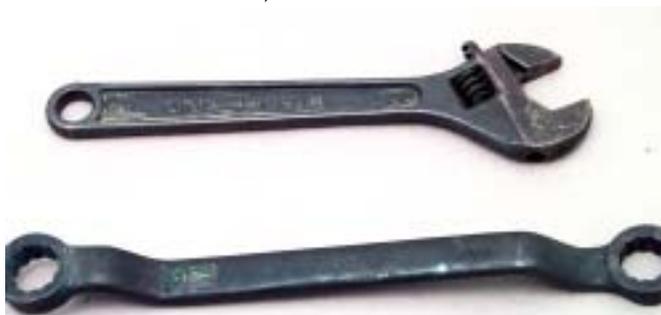
Figure 2. Oxidized wrenches found at the Y-12 Plant with beryllium contamination levels of 2.98 micrograms/100 cm² (above) and 21.0 micrograms/100 cm² (below).
