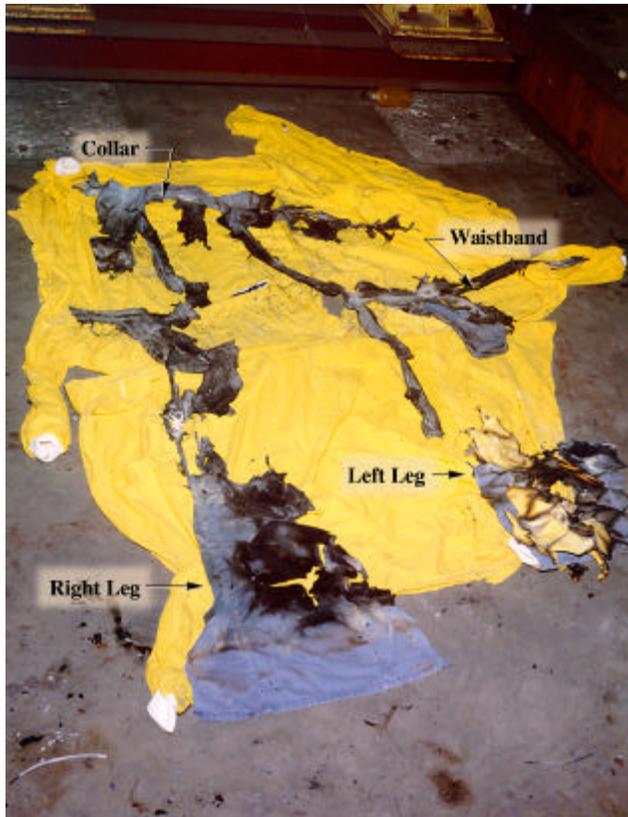
Exhibit 2-4. Remnants of the Welder's Burned Coveralls

Observing the extent of the fire at the elapsed time of 80 seconds on multiple mannequin test runs shows that containment or eradication by the Welder alone would be doubtful, if not impossible. In the Board's judgment, at 90 seconds from ignition, the extent and speed of the fire could only be controlled with fire-extinguishing equipment (e.g., fire blankets, fire extinguishers). Therefore, even if the worker felt the heat of the fire as early as 65 seconds into the event, he/she would have only 10 to 25 seconds to put it out before outside help would be necessary to extinguish the fire. At 120 seconds, the clothed mannequin was totally engulfed along the center axis, both front and rear, from the knee to the face. The fire continued to grow, and by 145 seconds, the shoulders and the clothing hood were in flames. A review of the test simulation videos shows approximately 90 to 95 percent of the clothing consumed in about 3½ to 4 minutes from ignition. This is consistent with the actual fire involved in the accident (see Exhibit 2-4, Remnants of the Welder's Burned Coveralls).

Results of the burn tests revealed that very high temperatures were attained quickly on the outer layers of the anti-contamination clothing, while the temperature at the skin level remained nearly the

The outer anti-contamination coveralls do not provide protection from fire.

same. The multiple layers of clothing effectively insulated the Welder from the heat and seriously impaired early detection of the fire. The burn tests also indicated that the anti-contamination and general-purpose coveralls worn by the Welder and other K-25 LMES welders did not, by themselves, provide any fire protection as personal protective equipment for the hazards of cutting, welding, and other hotwork. The flammability characteristics of the anti-contamination clothing made this clothing inappropriate for the cutting and welding operations being conducted at the time of the accident.
