**Type B
Accident Investigation**

**Injury Resulting From
Violent Exothermic Chemical Reaction
at X-701B Site
Portsmouth Gaseous Diffusion Plant**

Oak Ridge Operations

October 2000

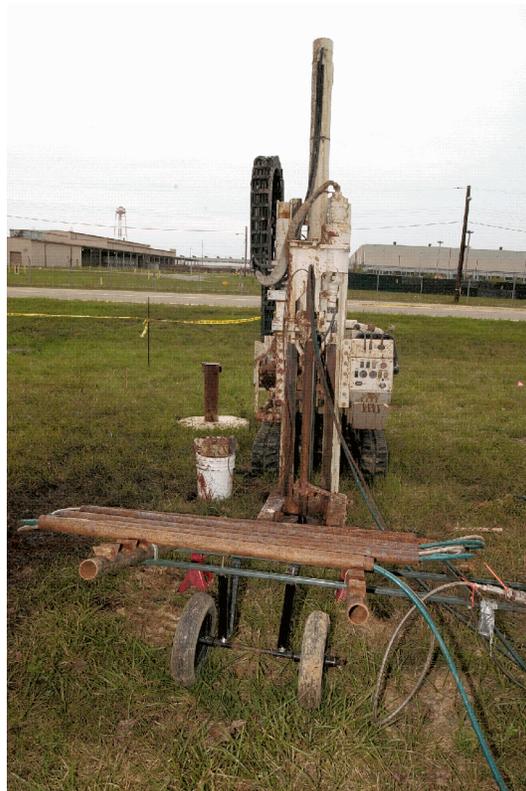
After returning from lunch, the Driller noted that the five-gallon bucket was at least two-thirds full of purple (permanganate) solution of unknown concentration. The five-gallon bucket containing the solution was moved from under the drill head by the Driller and handed to his assistant. The Driller's Assistant carried the bucket away from the drilling area, placed it on the ground, and returned to the drilling rig. The Driller drove the first rod down to the five-foot level and connected the second rod. After insertion of about one foot (a total of six feet) the Driller noted some bleed-up of permanganate solution through the rods. The insertion was stopped (see Exhibit 2-2). The second rod was pumped free of

Exhibit 2-2. Drilling Rig

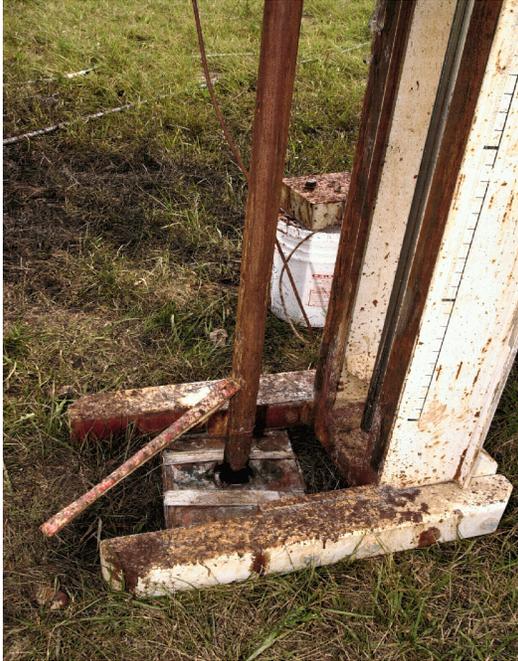
Exhibit 2-3. Location of Drilling Rig at Time of Accident

liquid and removed from the hole. The first rod was pumped free of liquid and raised to ground level for examination of the threads between the head and rod (see Exhibit 2-3). The Driller, the Driller's Assistant, and an FRx Field Technician were examining the threads when the accident happened. A loud explosion was heard, and solution from the five-gallon bucket became airborne, rising at least 15 feet in the air. The Driller's Assistant's back, as well as the drilling rig, were sprayed by the airborne solution. The other two individuals at the drilling rig were shielded from the airborne solution by the Driller's Assistant. The most seriously injured individual, the IT Laborer, was located immediately adjacent to the bucket. He was sprayed on his front by the airborne solution. No other workers were adversely impacted by the solution. The Driller's Assistant was treated on site and did not encounter any

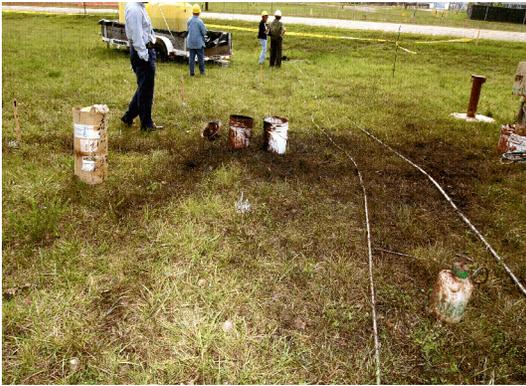
Exhibit 2-4. Thiosulfate Container and Two Five-gallon Buckets of Permanganate Solution.

The IT Laborer was standing over one of the five-gallon buckets when a violent exothermic chemical reaction occurred in the bucket. Permanganate solution was blown from the bucket up at least 15 feet in the air. The solution went all over the front of the IT Laborer. The front portion of the IT Laborer's 100% cotton blue jeans instantaneously ignited. No holes were noted in his 66% polyester/34% cotton shirt. The solution splashed onto the back of the Driller's Assistant. The Driller's Assistant was standing in front of the Driller and an FRx technician, thereby

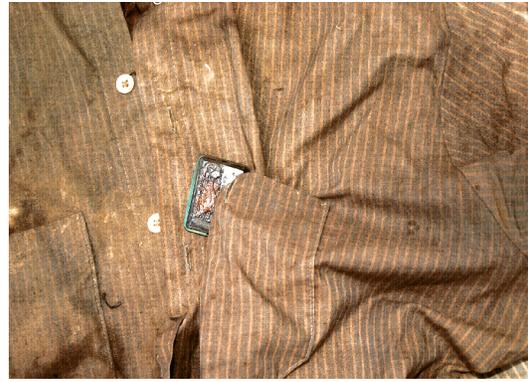
Exhibit 3-3. 66% Polyester/34% Cotton Shirt Worn by IT Laborer

The 100% cotton pants worn by the IT Laborer were practically disintegrated (see Exhibit 3-2), whereas, the 66% polyester/34% cotton shirt was not disturbed (see Exhibit 3-3). The Board concluded the reason was due to ignition of the cotton. The permanganate MSDS clearly states that permanganate can spontaneously ignite cloth or paper. The violent spraying of the heated solution onto the cotton pants caused the pants to ignite. The normal ignition temperature for cotton is around 255-400°C/490-750°F. The normal ignition temperature for polyester is 450-560°C/840-1040°F. The Board concludes the polyester/cotton shirt worn by the injured IT Laborer directly reduced his injuries and potentially saved his life. The use of proper PPE would have reduced the severity of injury resulting from the accident.
