3.0 Analysis

3.4 Chemical Analysis of the Accident

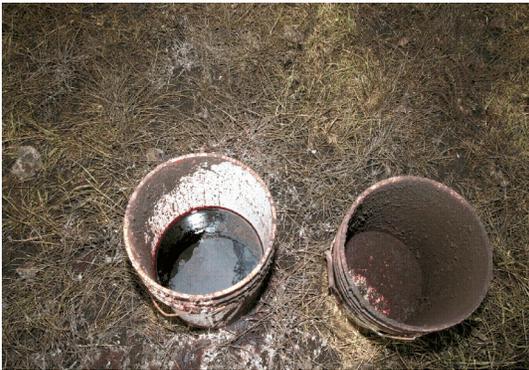
Exhibit 3-1. Five-gallon Bucket Where Reaction Took Place

The Board determined the chemical reaction that occurred on August 22, 2000, was initiated by the IT Laborer placing crystalline thiosulfate into a five-gallon bucket of concentrated permanganate (see Exhibit 3-1).

When the crystalline thiosulfate was added to the concentrated permanganate, initially nothing happened because the dissolution of thiosulfate into water is a mildly endothermic reaction. When the thiosulfate started reacting with the concentrated permanganate, a violent exothermic reaction was initiated. The water in the immediate vicinity of the crystalline thiosulfate was almost instantaneously heated to above the boiling point (100°C/212°F). The temperature rise in the localized area depends on the actual permanganate concentration at the time. The actual concentration is not known; however, the Board concludes the concentration was somewhere between 16 to 20% permanganate. Due to the high energy yield from the reaction, a super-heated steam bubble was created. The

reason for the super heating is the excess amount of permanganate available for reaction with the thiosulfate and the almost instantaneous release of energy. The violent release of the steam bubble caused the permanganate solution to be ejected from the five-gallon bucket over 15 feet into the air and onto the IT Laborer who was standing directly over the bucket.

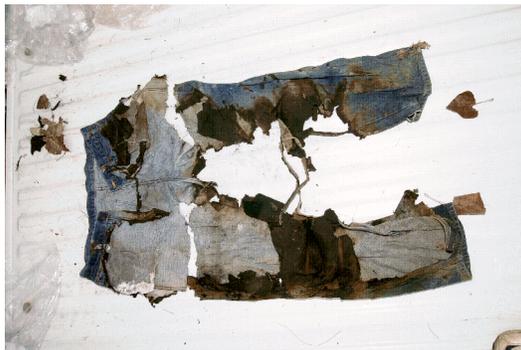
Exhibit 3-2. Cotton Pants Worn by IT Laborer

The 100% cotton pants worn by the IT Laborer were practically disintegrated (see Exhibit 3-2), whereas, the 66% polyester/34% cotton shirt was not disturbed (see Exhibit 3-3). The Board concluded the reason was due to ignition of the cotton. The permanganate MSDS clearly states that permanganate can spontaneously ignite cloth or paper. The violent spraying of the heated solution onto the cotton pants caused the pants to ignite. The normal ignition temperature for cotton is around 255-400°C/490-750°F. The normal ignition temperature for polyester is 450-560°C/840-1040°F. The Board concludes the polyester/cotton shirt worn by the injured IT Laborer directly reduced his injuries and potentially saved his life. The use of proper PPE would have reduced the severity of injury resulting from the accident.
