November 18, 2010

PANTEX DROPPED PIECE OF HIGH EXPLOSIVES

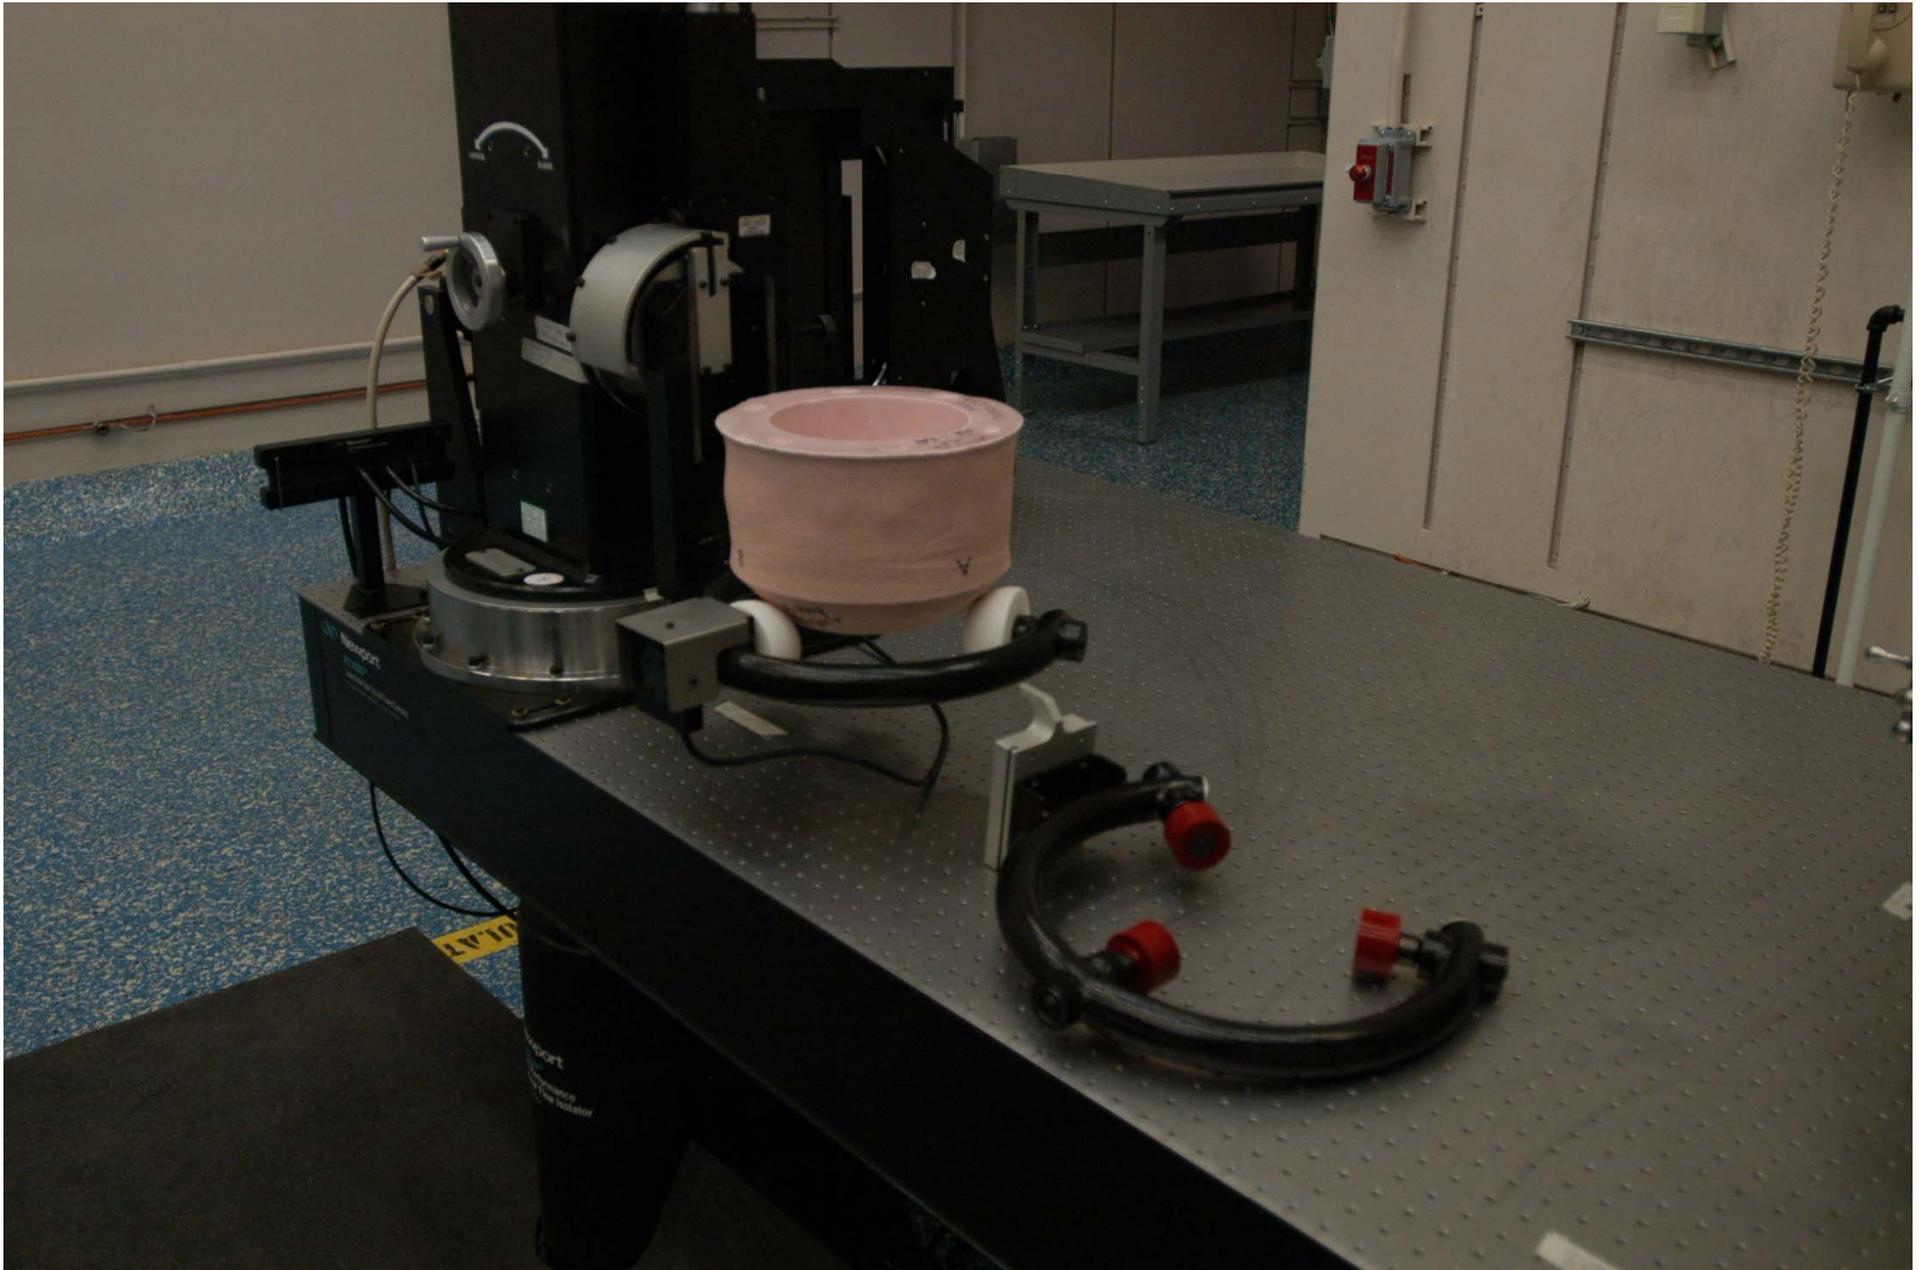
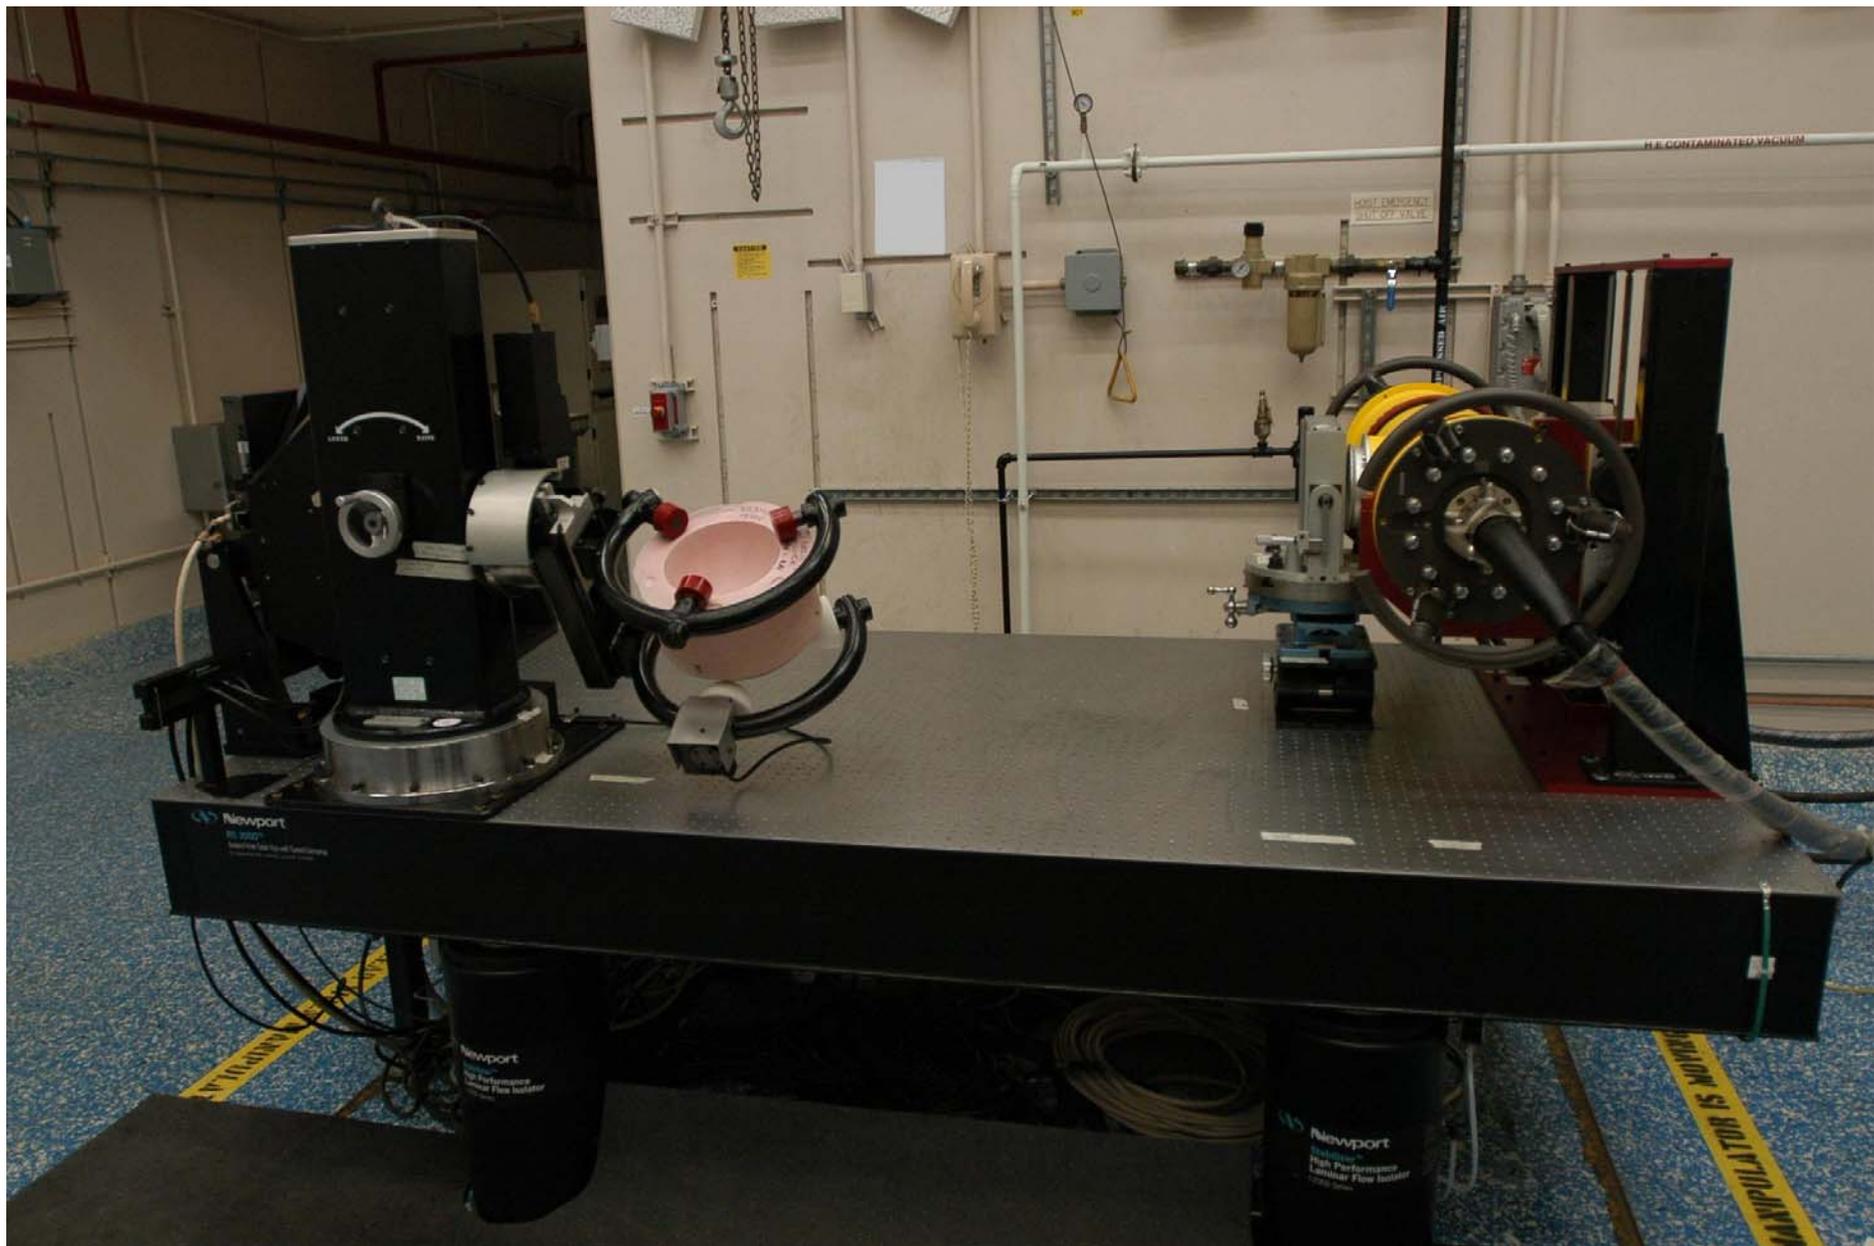
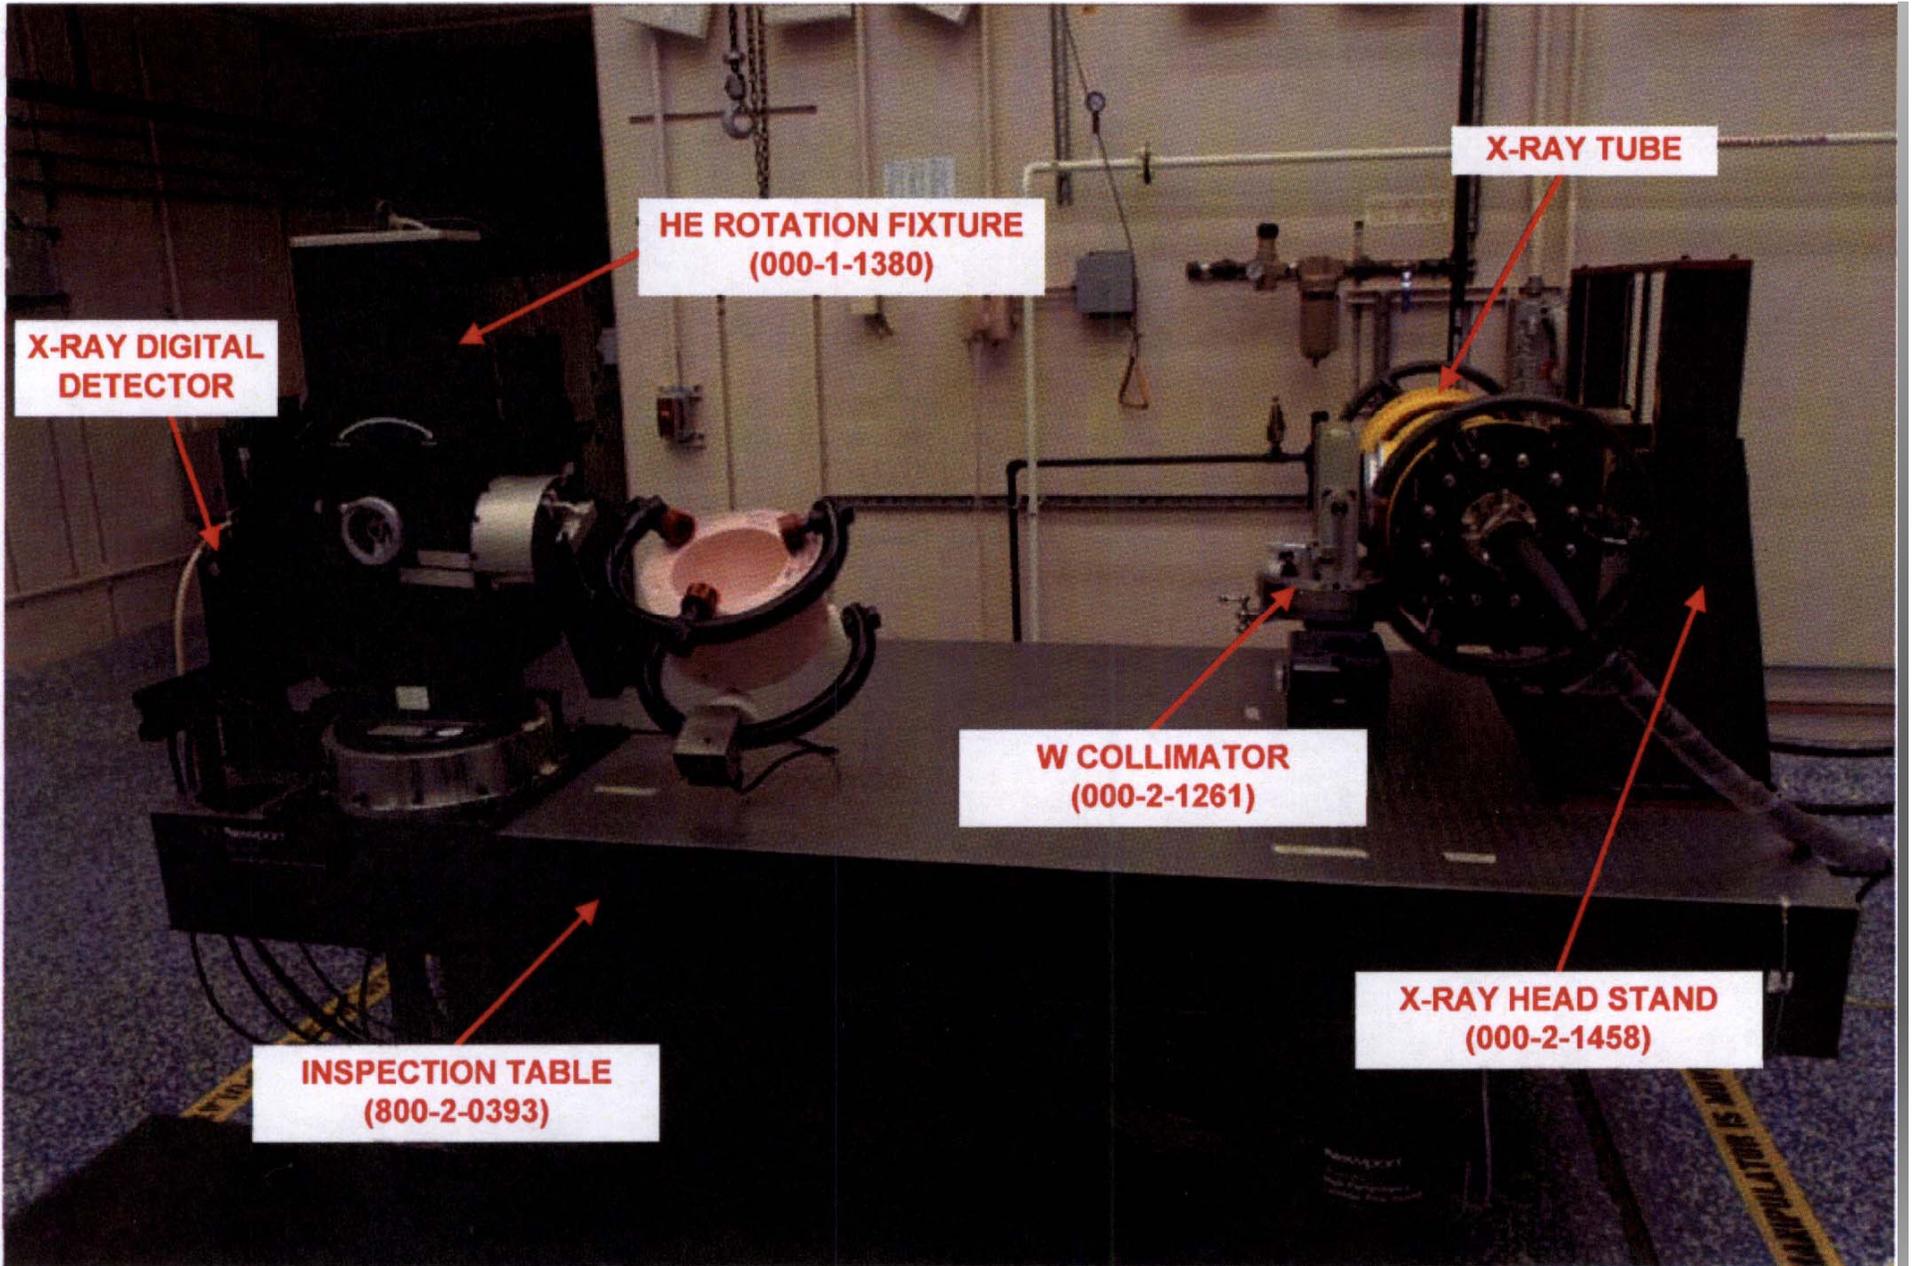
**INTERLOCK TO
PREVENT TILT**

**TOP RETAINING RING
OF THE ROTATION FIXTURE
(000-1-1380)**

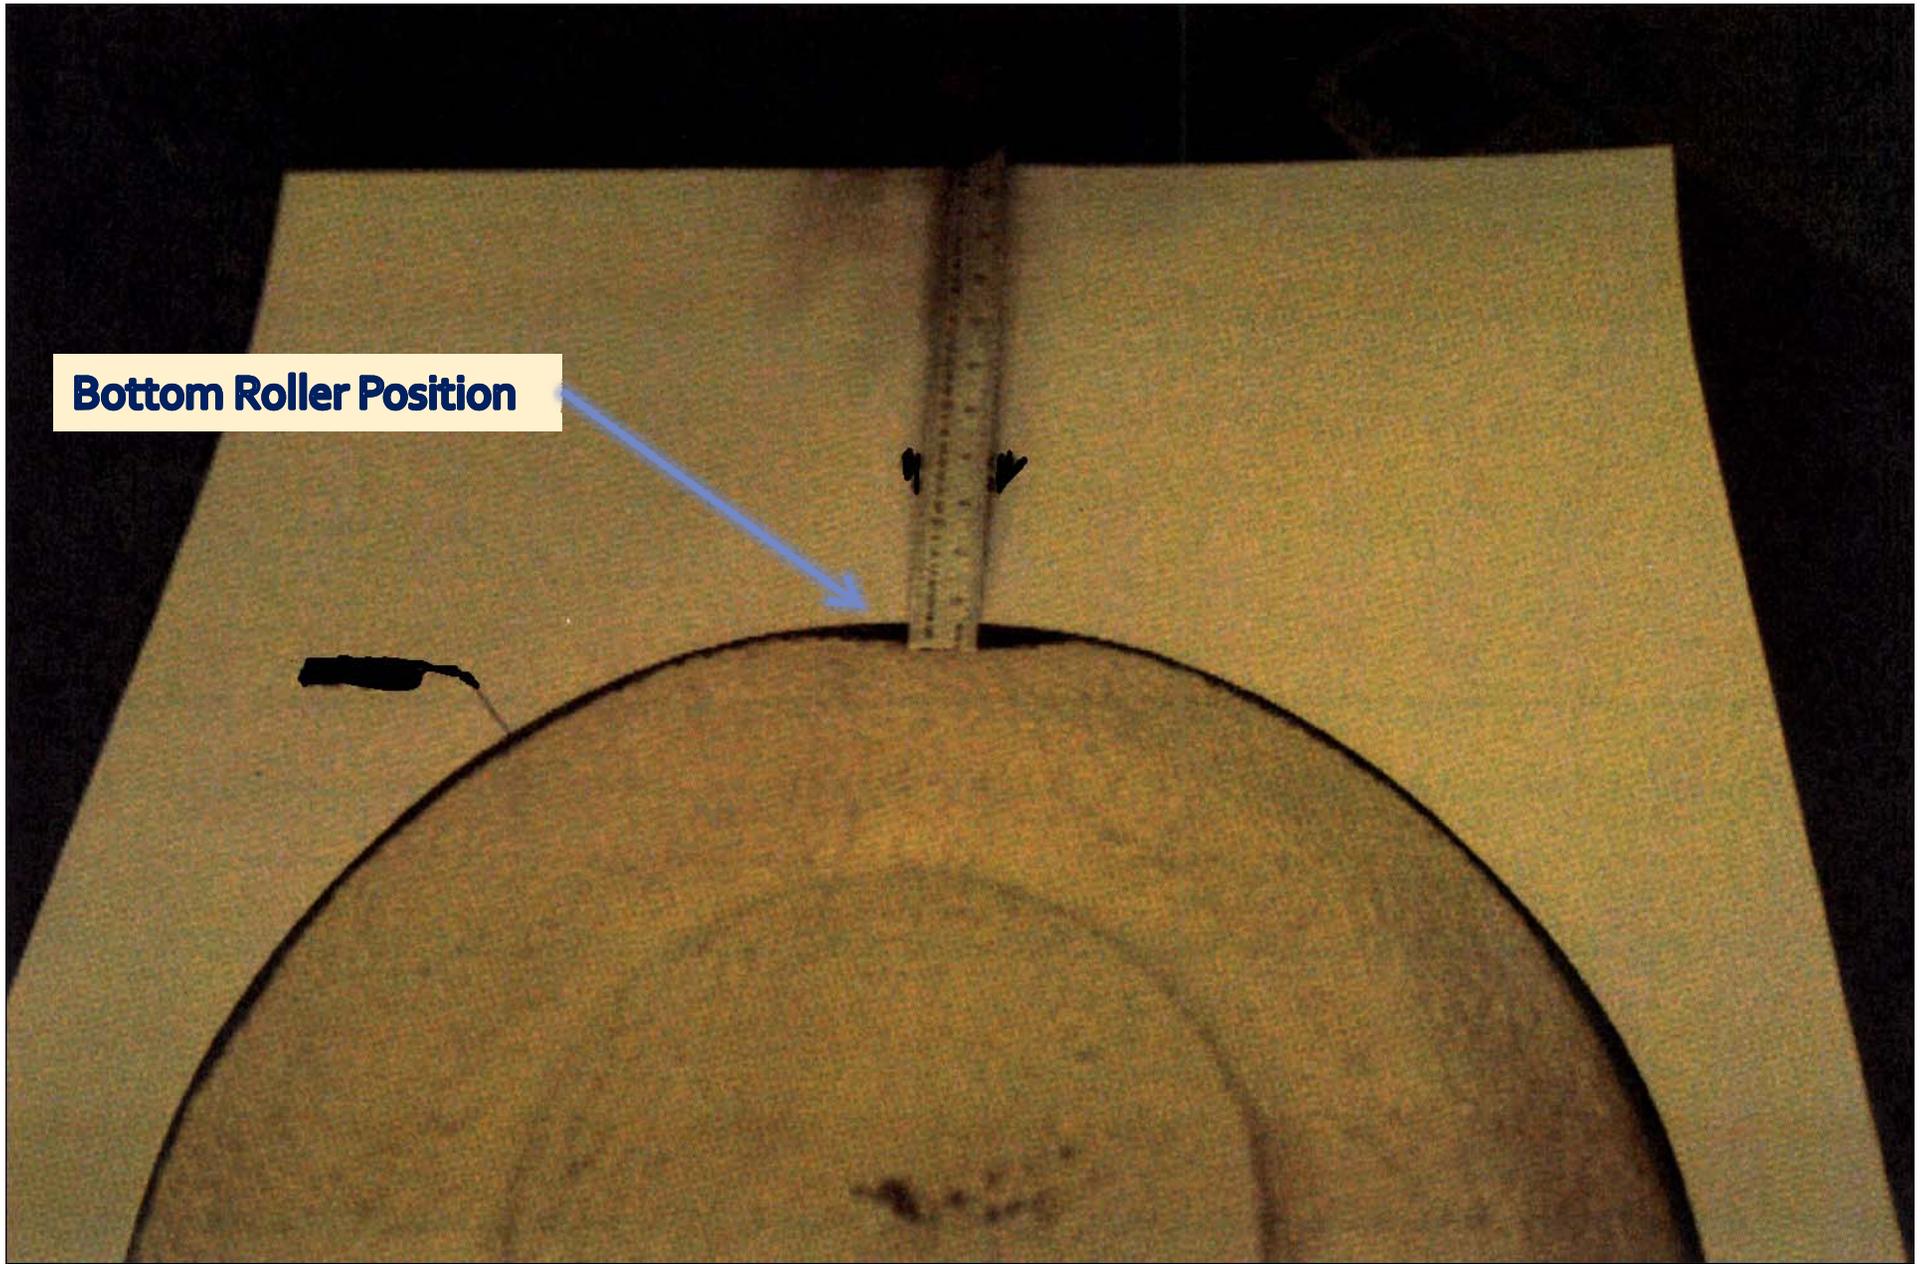
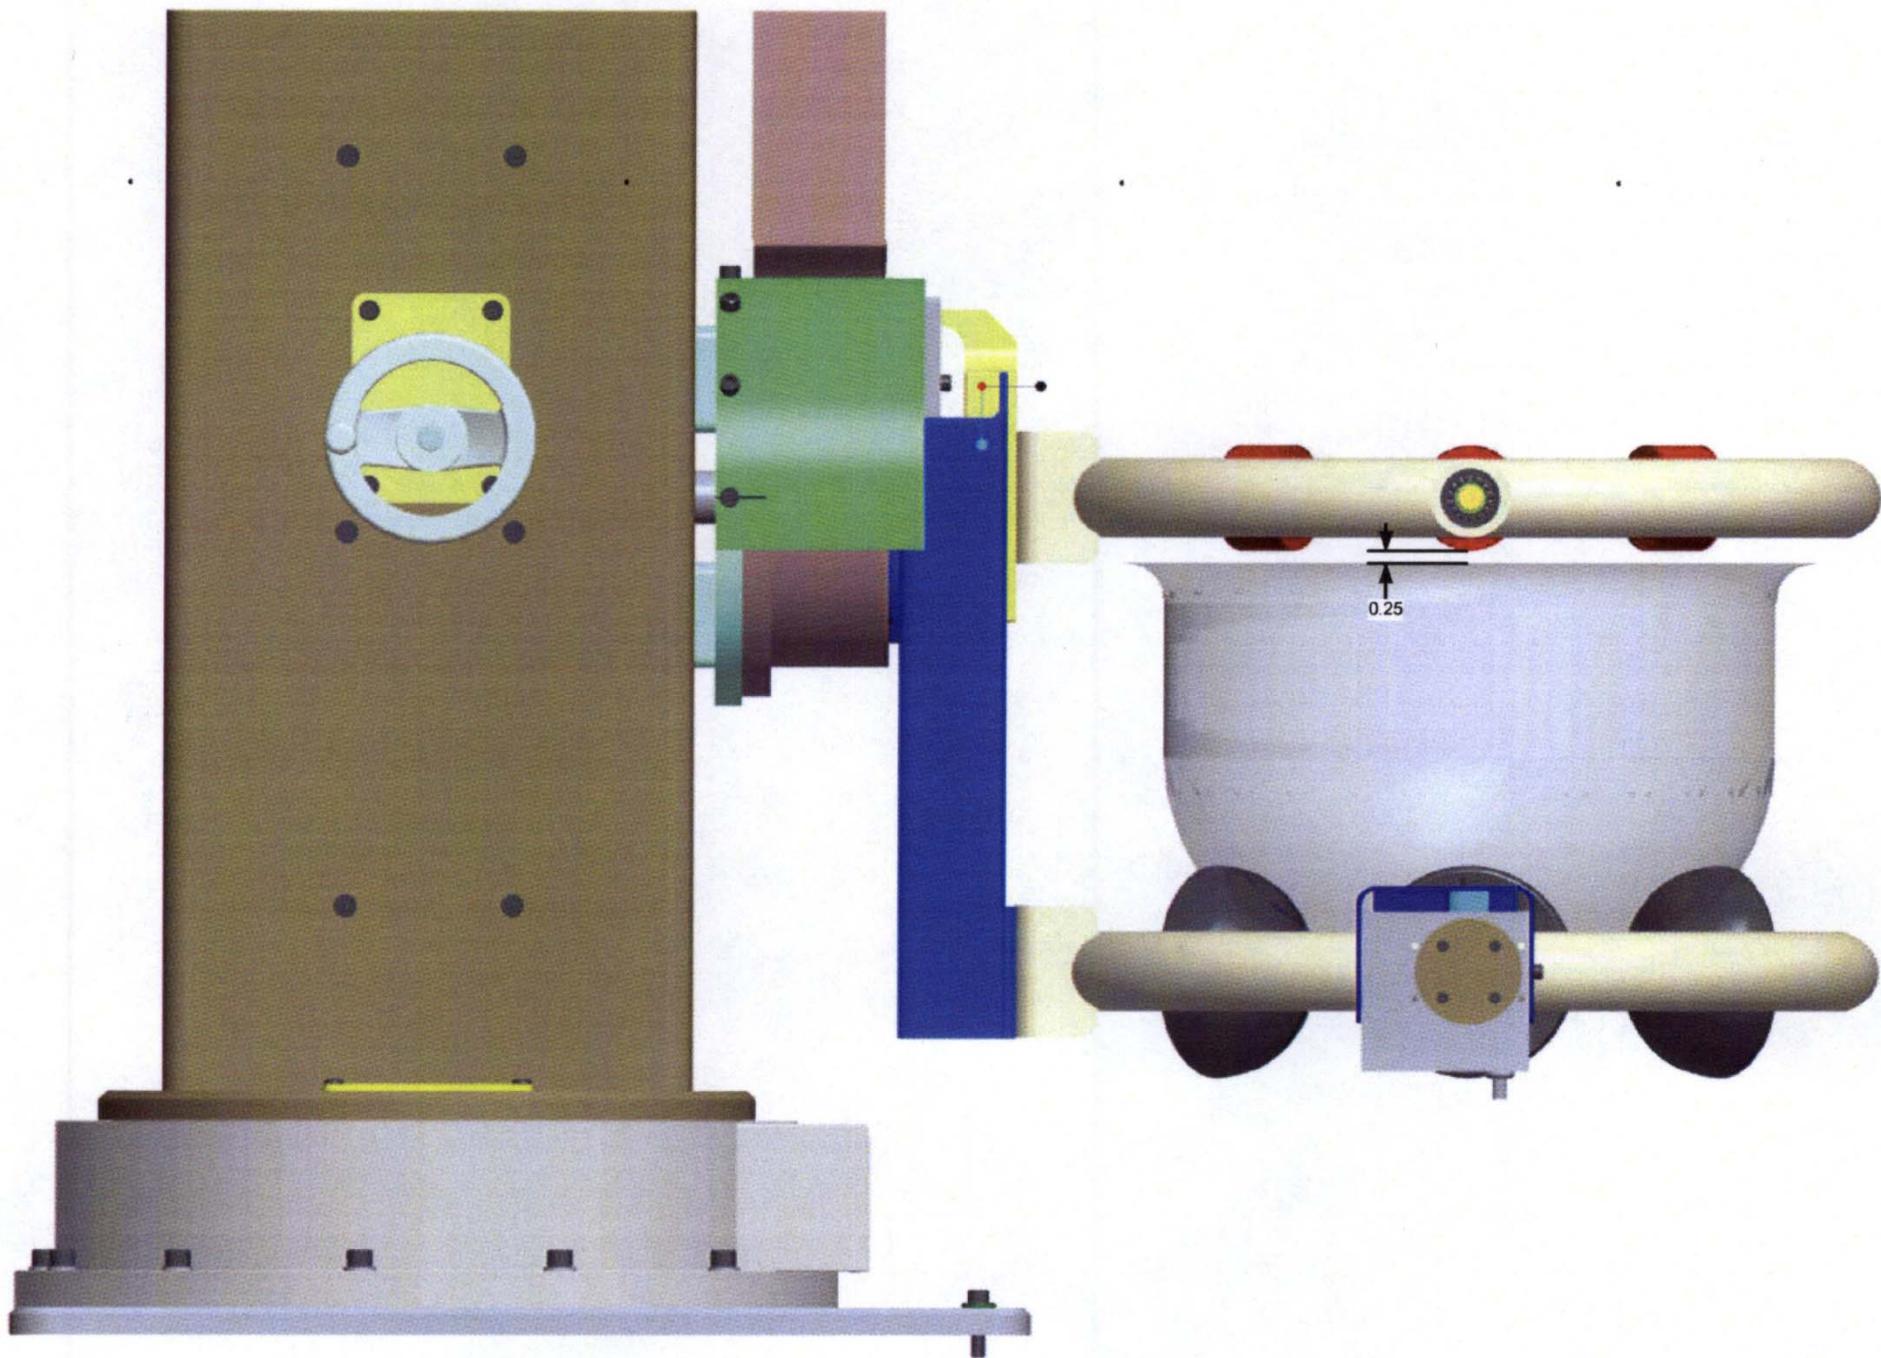
Bottom Roller Position

- The roller on the fixture rolled into an undulation in the HE surface and allowed the HE Part to drop enough to become dislodged.
- The Holding Fixture did not prevent the HE Part from falling to the table.

- Redesign HE Rotation Fixture.
- Evaluate other methods to identify undulations on HE Part.
- (Long-Term) Design and Construct New Facility.

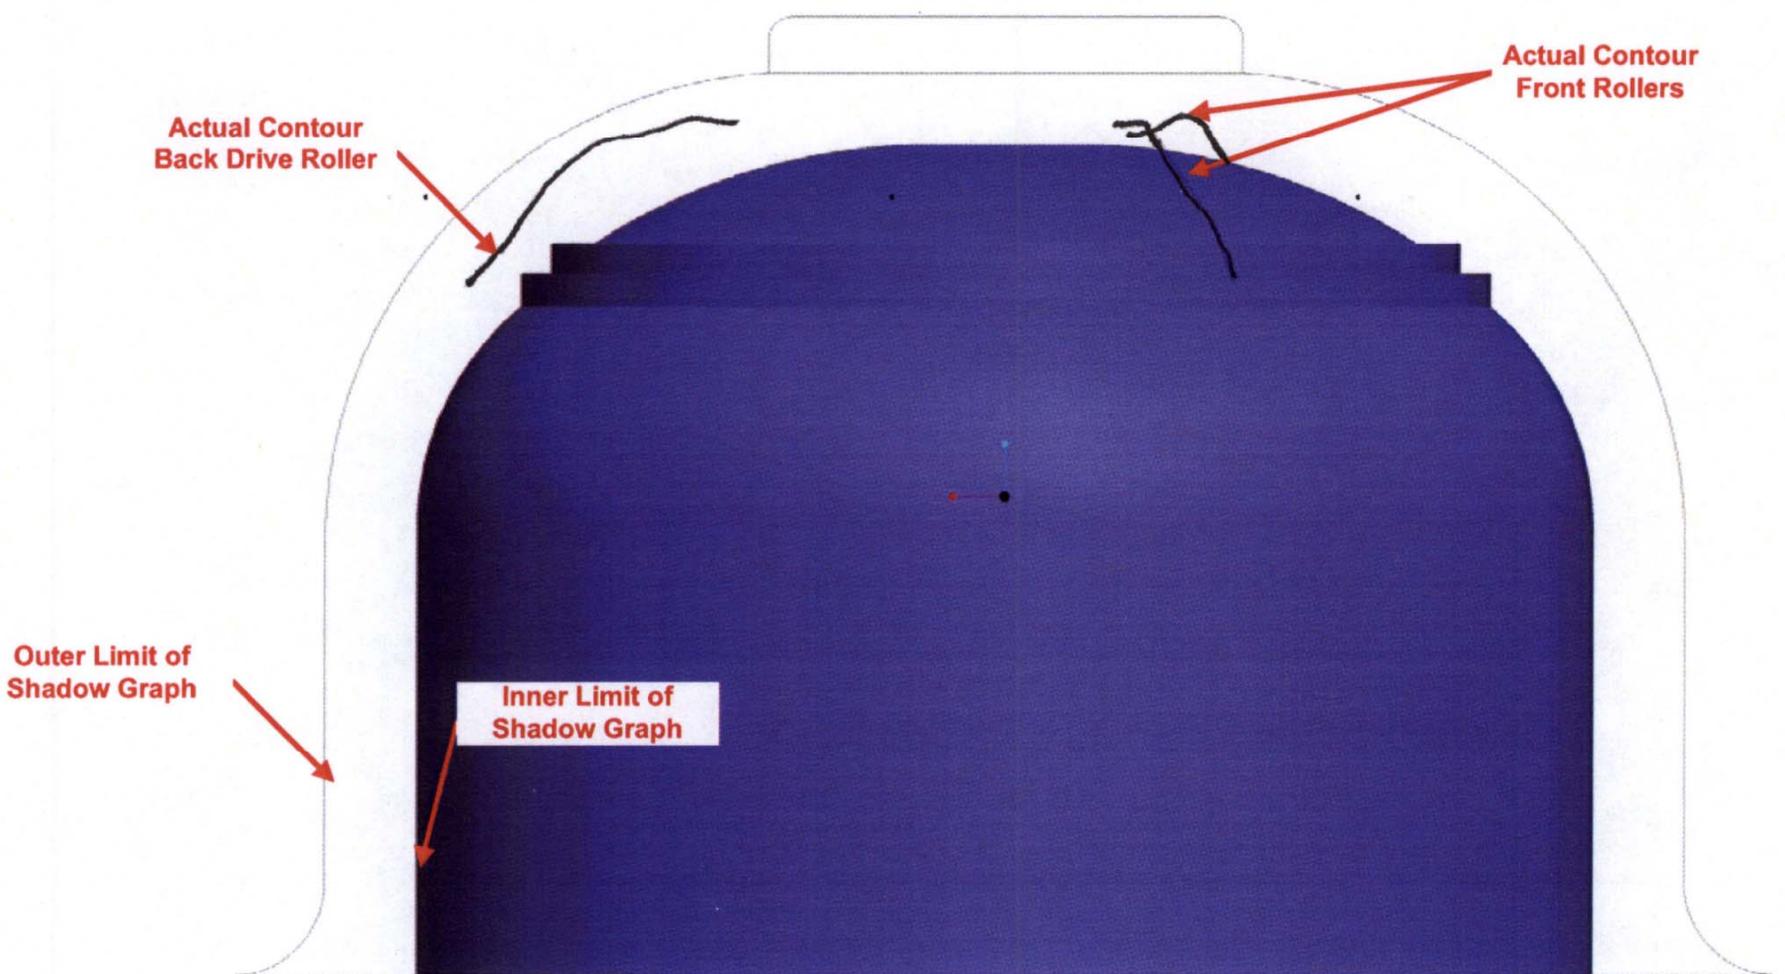
- The undulations in HE surface were not out of tolerance for the measurement method (Shadow Graph) in use.

**Actual Contour
Back Drive Roller**

**Actual Contour
Front Rollers**

**Outer Limit of
Shadow Graph**

**Inner Limit of
Shadow Graph**
