SAFETY & HEALTH HAZARDS ALERT

DOE/EH-0526

Issue No. 96-2

Respirator Protection System Coupling Nuts Fail

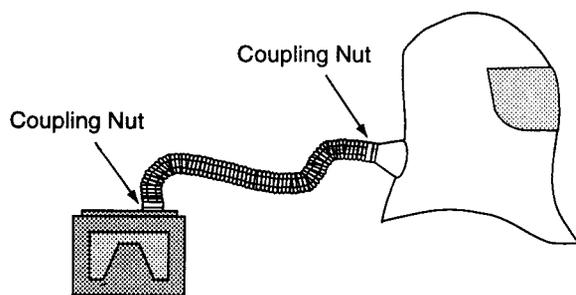
MSA OptimAir 6 PAPR

A T-Plant nuclear process operator reported three recent discoveries of fractured Mine Safety Appliance (MSA) coupling nuts on 19-inch hood breathing tubes on April 26, 1996, at Hanford. The tubes have plastic coupling nuts on both ends that connect powered air-purifying respirators (PAPRs) to MSA replaceable hood shells. The Westinghouse respiratory protection coordinator suspended use of the respirators until long-term corrective actions are taken to eliminate the coupling nut problem. Failure of the nuts could result in a radiological uptake. (ORPS Report RL--WHC-TPLANT-1996-0030)

The three nuts fractured at the horizontal shoulder of the nut. Two failed at the blower unit connection, and the other failed at the hood shell tube connection. The model number of the MSA coupling nut is 467175.
