SAFETY & HEALTH HAZARDS ALERT

DOE/EH-0518

Issue No. 98-1

Rotating Shaft Accident at Ames Laboratory

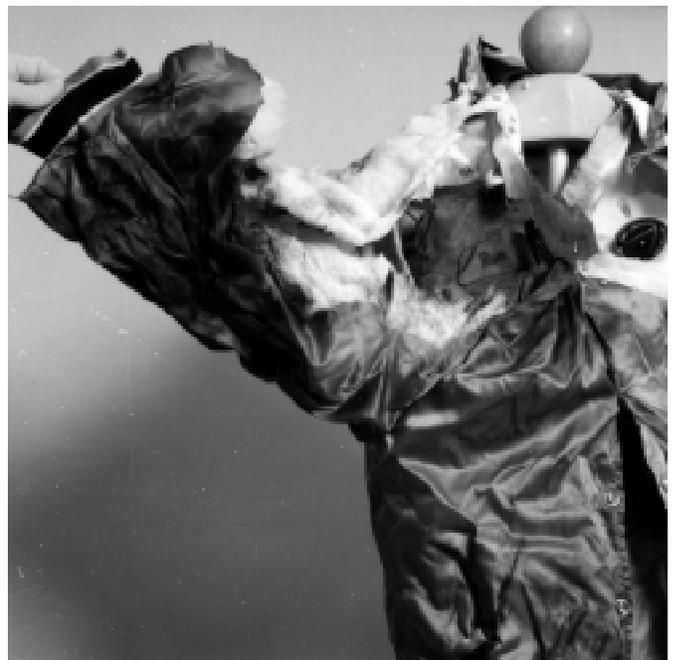
The direct cause of the accident was identified as the electrician's jacket having gotten pulled in to the end of the supply fan's exposed rotating shaft. Investigation findings determined that not only was the shaft end not safeguarded to prevent possible contact as prescribed in the general requirements in 29 CFR 1910.212(a)(1), but that it extended 7/16" beyond the dimensional limits dictated by 29 CFR 1910.219(c)(4)(i). Accident investigation results indicate, however, that even if the exposed shaft end had been in compliance with the OSHA standard, compliance would not have prevented the accident, and that overall, the referenced standard, which is based on the 1953 ANSI standard, is inadequate for protecting workers from hazards associated with rotating shaft ends.

Electrician's Jacket

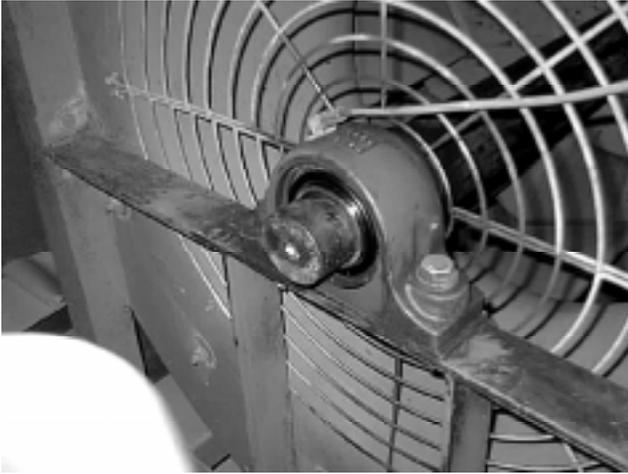
The most current standard ANSI/ASME B15.1-1996 does not allow shaft ends to protrude beyond the ends of pillow blocks. And although safeguarding features should always be part of equipment design and installation, they should also be part of a

Exposed Shaft

building and its structure according to ANSI/ASME B15.1-1996. The building in which the fan room was located was built in 1994. During a same-year building inspection, the protruding shaft end went unrecognized as not complying with the OSHA standard. In addition, fan room design with its cramped dimensions potentially limited the safe configuration of fan machinery and equipment, as well as access.

- the exposed shaft was not safeguarded in accordance with current OSHA standards or ANSI/ASME B15-1 and so it remained an unidentified and uncontrolled hazard;

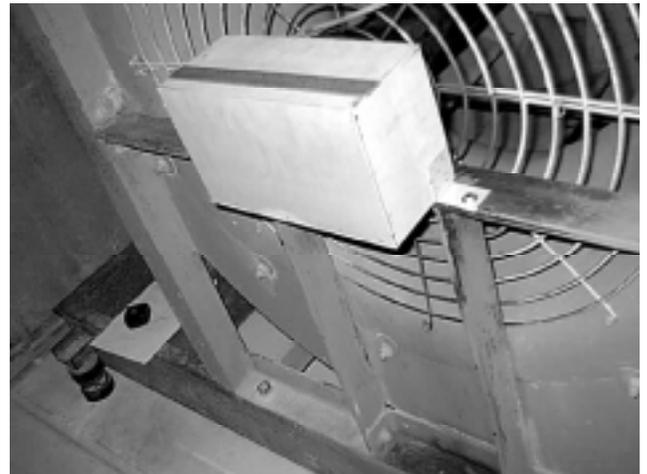
Guarded Shaft

are insufficient and inadequate as means by which to control hazards such as those associated with exposed rotating shaft ends. The Board has suggested that DOE HQ EH develop and issue appropriate guidance or requirements for guarding against such, and that it (EH) recommend to OSHA that 29 CFR 1910.219(c)(4)(i) be updated to reflect the requirements of the 1996 ANSI/ASME B15.1 standard (available for purchase on-line at <http://www.ansi.org>).
