**U.S. Department of Energy  
Office of Health, Safety and Security**

**Accident Investigation Report**

**Plutonium Contamination in the  
Zero Power Physics Reactor Facility  
at the Idaho National Laboratory,  
November 8, 2011**

**January 2012**

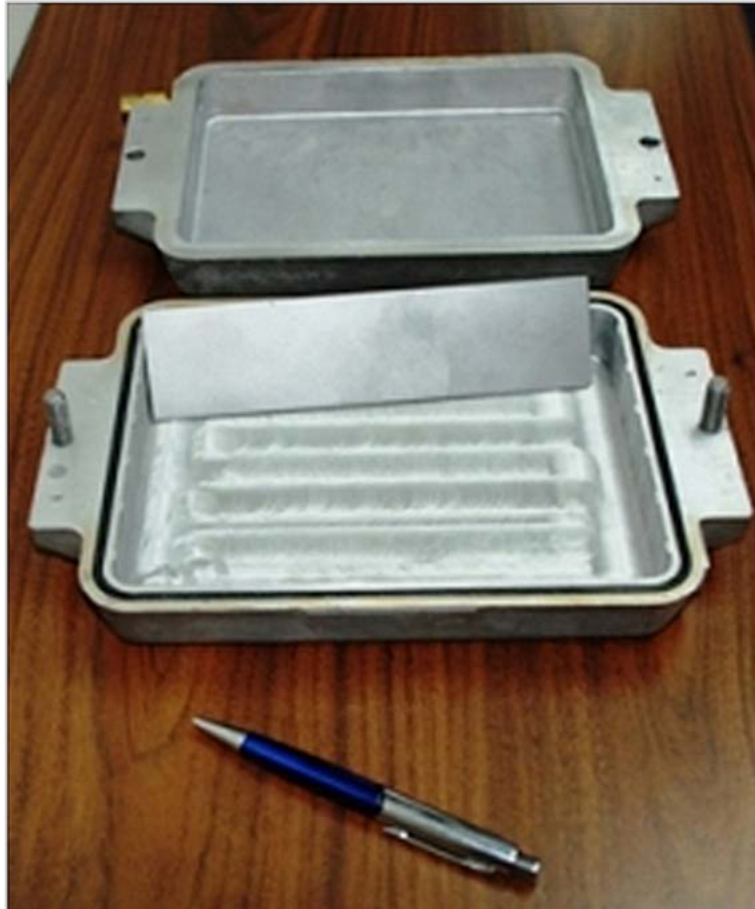
**Figure 2-4: Clamshell with Fuel Plate**

By examining witness testimony and historic documentation, including the ZPPR Suspect Fuel Log, the Board determined that the fuel plate was damaged prior to being stored over 30 years ago. This damage resulted in a breach of the stainless steel jacket, which in turn allowed air (oxygen) and moisture (water) to infiltrate the fuel plate and react with the transuranic alloy. This assumption is supported the ZPPR Suspect Fuel Plate Log and by labeling seen on the clamshell that contained this fuel element prior to the accident, as well as witness testimony

concerning the material condition observed during the accident. Over time, well-understood reactions between the air and moisture, which was present in the clamshell, and the metallic fuel alloy formed transuranic oxides and hydrides – likely including (but not limited to)  $\text{UO}_2$ ,  $\text{PuO}_2$ ,  $\text{AmO}_2$ ,  $\text{PuH}_3$ , and  $\text{AmH}_3$ . For example, assuming Pu is the radionuclide, the formation of such compounds can generally be characterized by the following equations:

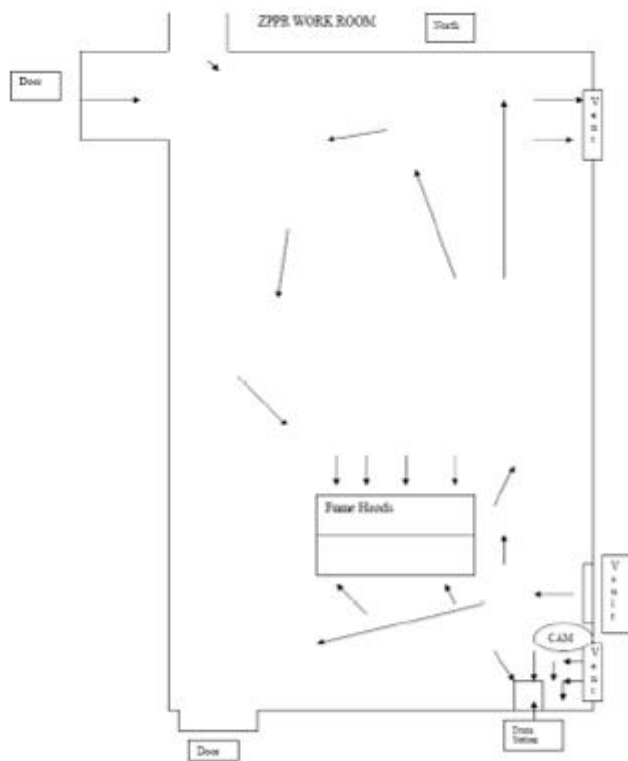
**Figure 2-5. ZPPR Workroom Ventilation Air Flow from ECAR-127**

The Board reviewed the ECARs that determine the air monitoring requirements and placement of air monitoring equipment at ZPPR. During April 2010, ECAR-105, which contained original analysis for determining air sampling requirements for all MFC facilities, was cancelled and replaced by ECARs 894 through 897. ECAR-897 includes the information for the ZPPR Facility. Specific air flow studies to support the air sampling requirements are documented in ECAR-127. Review of the most recent air flow study (see Figure 2-5) revealed that the evaluation included neither the descriptions of the room/facility conditions during testing (e.g., ventilation status, doors open/closed, personnel positioned in front of the hood) nor a legend defining the symbols used to indicate flow descriptions. In reference to the ZPPR Vault and Workroom, the most current revision of ECAR-127 states:

*The general air flow goes out of the vault and is directed onto the alpha CAM mounted on the wall and then to the hood in the work room. A portable CAM is positioned in the immediate work area when needed. The vault and work room are well characterized by CAMs.*

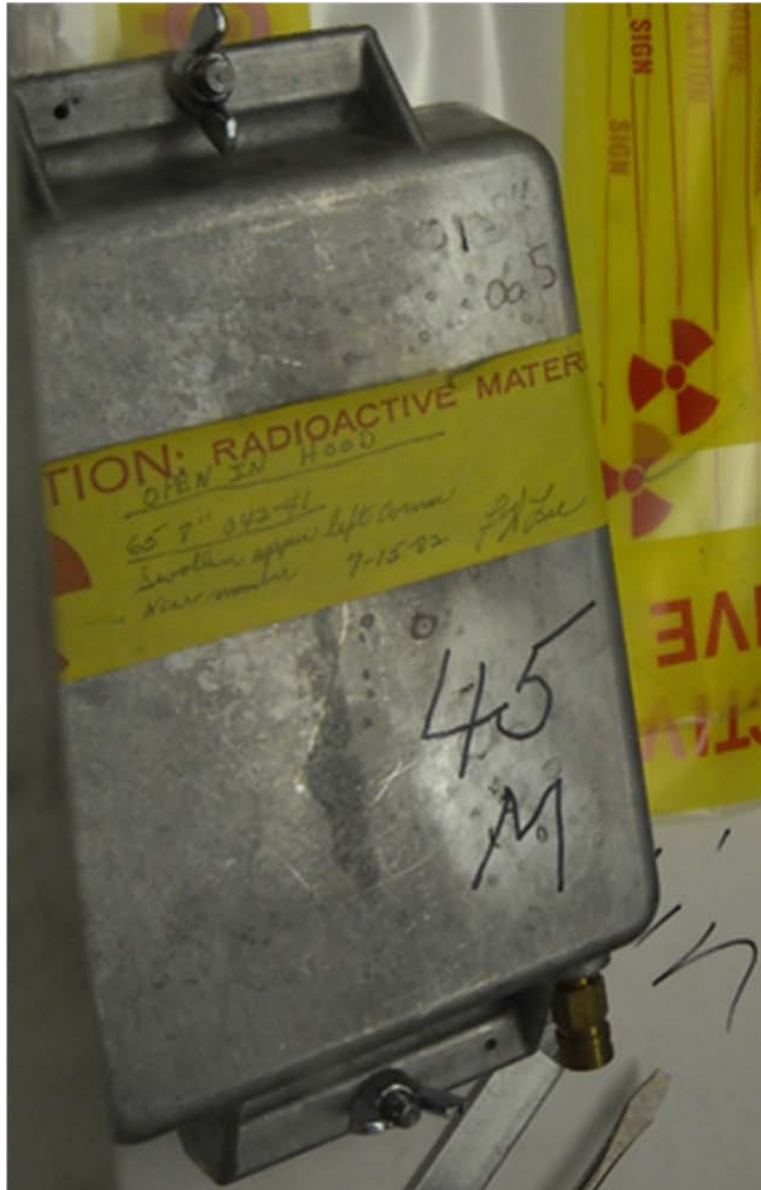
Figure 2-6. Clamshell Number 45 M

During transfer of the four clamshells from the Vault to the Workroom South Hood, workers observed radioactive material labels on two of the clamshells. The label on the 45M clamshell stated, “Open in hood . . . swollen upper left corner near number.” It was dated 7-15-1982 and initialed. (See Figure 2-6.) The label on the 47 S clamshell stated, “1-Plate dented, 1-plate contaminated, < 10 d/m/plate  $\alpha$  & is wrapped in plastic” and was dated April 1, 1986. (See Figure 2-7.) In addition, the writing on the 47 S clamshell itself included a statement to “check monthly.” After observing the labels, workers initiated a work “time out,” prompting a phone call from the SS to the NFM. The result of the discussion was a decision to proceed with the activity.

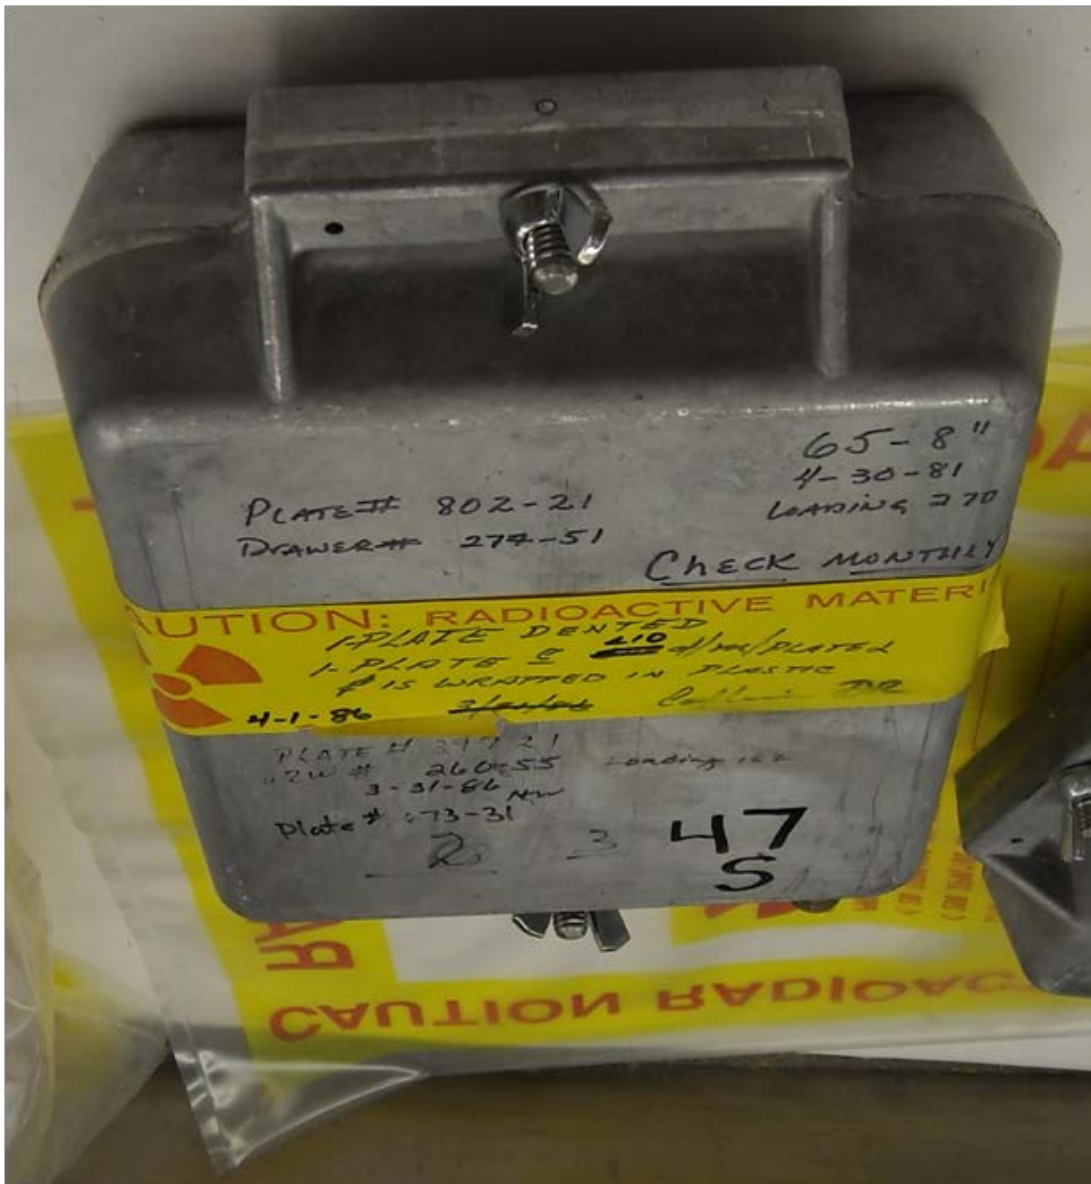
**Figure 2-7. Clamshell Number 47 S**

Date/Time	Event	Conditions
04/01/1986	Clamshell numbered 47 S is labeled with a "CAUTION: RADIOACTIVE MATERIAL" label. Clamshell was placed in the ZPPR Vault.	<p>The label stated the following:</p> <p><b>1-Plate Dented</b>  <b>1-Plate <u>C</u> &lt;10 d/m/plate <math>\alpha</math></b>  <b>&amp; is wrapped in plastic</b></p> <p>Date of 03/31/86 on label was crossed out and it was re-dated with the 04/01/86 date.</p> <p>Writing on clamshell indicates that there were a total of three plates inside.</p>
03/26/1991	Excessive Contamination Level was found on a PuAl fuel plate. (NE-CH-AA-ANLW-ZPPR-1991-0002)	Different fuel matrix than the 11/08/11 accident.
1992	The ZPPR Reactor was placed in non-operational standby.	
05/30/2003	ANL-W Deputy Associate Laboratory Director (ALD) issued a report on <i>Fissile Material Control Noncompliances of ZPPR</i> .	<p>An independent investigation team determined the overall root cause of the noncompliances as "management deficiency."</p> <p>Of specific note, the report expressed concerns with the lack of Pu-specific training and surveillance.</p>

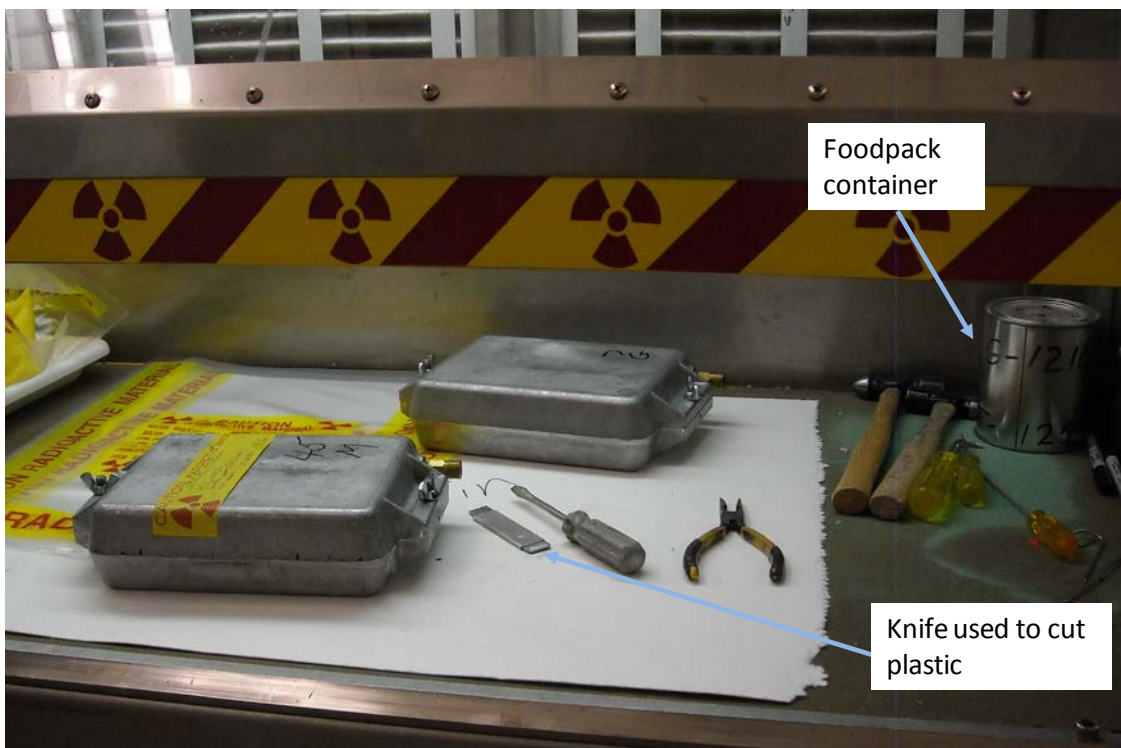
**Figure 2-8. Re-entry Photo of Work Area in South Hood**

At this point in the evolution, the first clamshell (45 M) was opened, revealing a single fuel plate wrapped in plastic material and bound by tape. The RWP provided no limiting conditions for

contamination levels inside the hood; the limiting conditions for loose surface contamination applied exclusively to external surfaces of the clamshell and transfer cart. After verification that there was no removable contamination in the clamshell, OP-1 cut the plastic and tape on the fuel plate, as directed by the SS. When the plate was turned over to cut the other side, powder was observed on the inside of the clamshell. A smear sample was taken near the powder, and the clamshell was closed. The smear “pegged” the frisker on the lowest scale (later counted on December 8, 2001 and found to contain 5.5 million dpm alpha). Approximately three minutes after the plastic was cut, the Vault CAM alarmed which then initiated an evacuation of the Workroom. Figure 2-8 shows the work area in the South Hood with Clamshell 45 M, the foodpack, and the knife used to cut the plastic wrapping.
