DOE ACCIDENT PREVENTION AND INVESTIGATION

Bi-Annual Summary Report

U.S. Department of Energy ▪ Office of Health, Safety and Security ▪ AI-2010-02 ▪ November 1, 2010

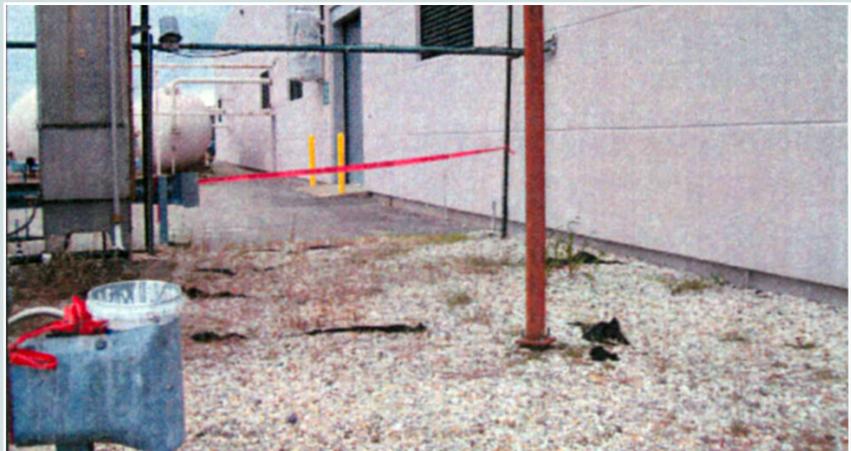
Type B Accident Investigation

Employee Injury at Building 1005H
Upton, New York

October 9, 2009

The Board determined the Direct Cause of the accident was the unanalyzed loud sound produced by the Cryogenic venting process.

The Board determined the Root Cause of the accident to be BNL's failure to implement an effective ISMS program to ensure all hazards associated with the operations of its facilities are identified, analyzed, and controlled.

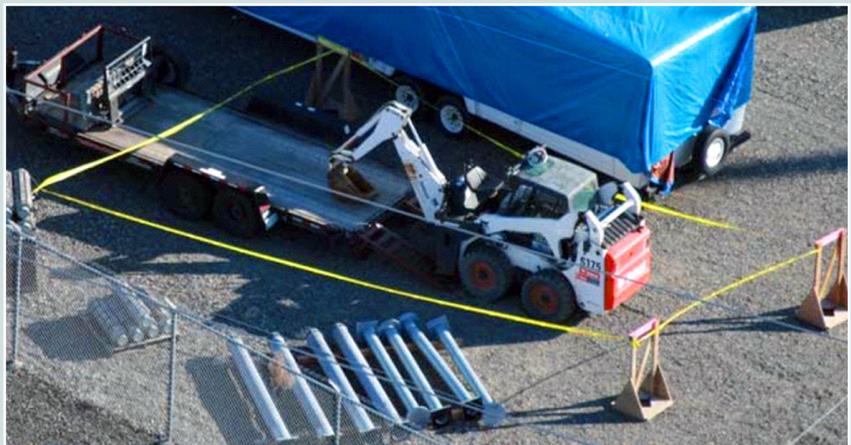
Level 1 Accident Investigation

Fatal Bobcat/Backhoe Accident
at the White Bluffs Substation

March 1, 2010

The Board concluded that the Direct Cause of this accident was that the CHEO activated the hydraulic controls while standing in the pinch point.

The Board determined the Root Cause of the accident was that the CHEO bypassed the Bobcat safety features.

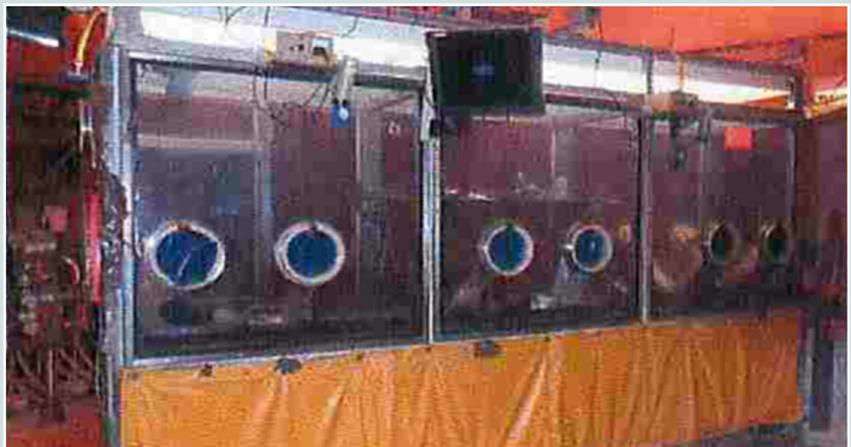
Type B Accident Investigation

Employee Puncture Wound at the
F-TRU Waste Remediation Facility

June 14, 2010

The Board determined the Direct Cause of this accident to be that a contaminated survey flag punctured the worker's PPE and hand, resulting in a radiological intake.

The Board determined the Root Cause of the accident was a less than adequate graded approach used for high hazard TRU waste remediation work; this did not coincide with the discipline warranted for high hazard work.
