# OPERATING EXPERIENCE SUMMARY

Summary 2001-05

# Operating Experience Summary 2001-05

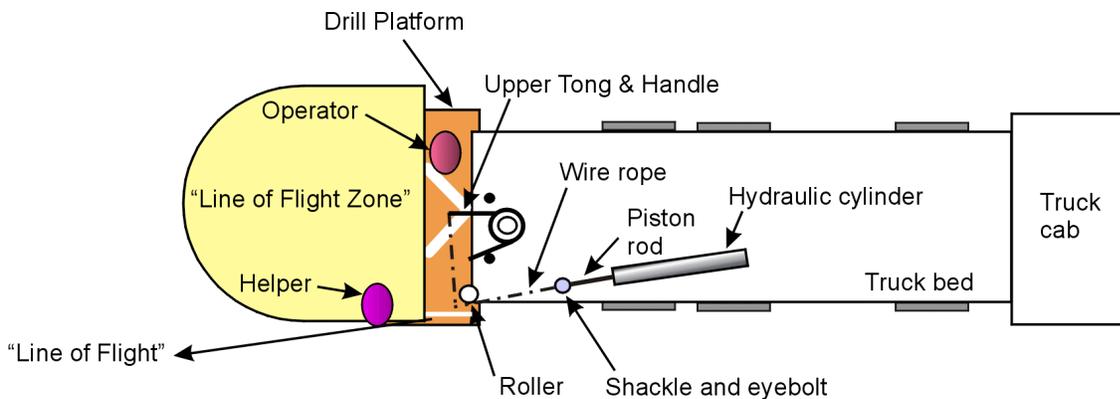
**Figure 1. Overhead Schematic of Drilling Rig**

On June 21, 2001, a construction sub-tier contractor employee at the Fermi National Accelerator Laboratory received serious head injuries requiring hospitalization when he was struck by part of the drilling rig (a "tong") that he was operating. The tong, a 32-inch steel bar with a handle, was used as a pipe wrench to connect and disconnect drill piping. Figure 1 provides an overhead view of the drilling rig. The accident occurred when a welded connection in the hydraulic system used to apply force to the tong failed as the two-man crew was removing lower sections of the drill assembly. The drill rig helper indicated that at the time of weld failure, the operator was standing with his head near the tong and operating the hydraulic cylinder to disconnect a drill section joint. The operator remained hospitalized until July 9, 2001.

A detailed description of the causal factors is available in the Type A investigation report. The direct cause of the accident was the weld failure on the eyebolt and piston rod connection released tension on a wire rope sling attached to the tong; the tong recoiled toward the Operator and struck him in the head. The original threaded connection had failed on the aging equipment and had been field repaired with a welded connection.

The Root cause was determined to be Fermilab's failure to implement a hazard analysis process that was effectively applied to task-specific hazards for construction subcontractors and sub-tier contractors.

- Fermilab needs to improve the existing hazard analysis process as specified in the Fermilab Environment, Safety, and Health Manual (FESHM) 7010 by developing instructions and guidance to ensure that the process applies to sub-tier construction contractors at the work activity level.

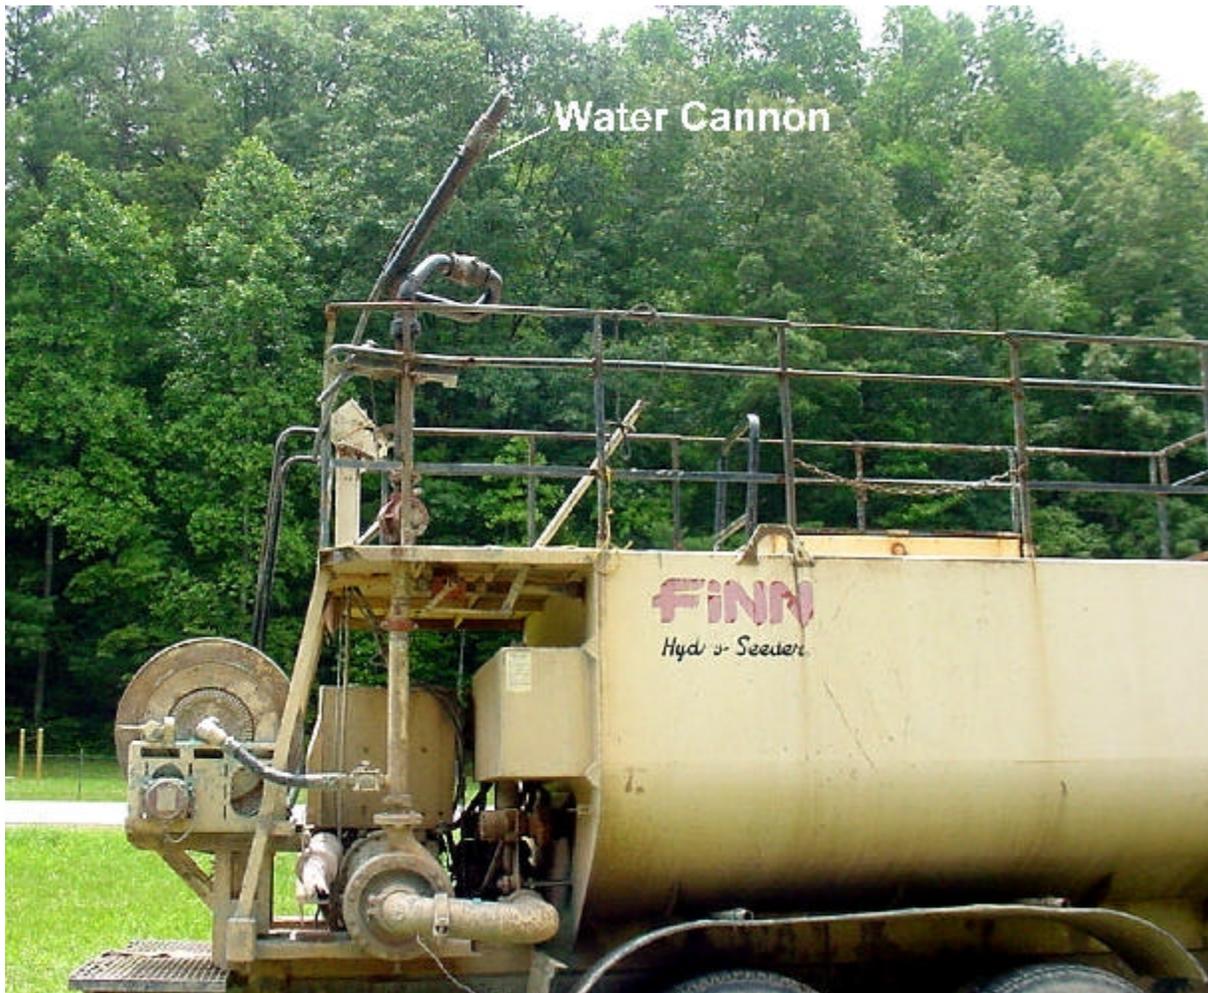
**Figure 1. Hydroseeder with Unsecured Water Cannon on Top**

A work crew was seeding grass on an area of the EMWMF construction site on June 12, 2001, using a truck-mounted hydroseeder. Figure 1 shows the type of hydroseeder that was used. A span of communication lines and 13.8 kV electrical transmission lines cross over an entrance road to this area. A construction crew had previously raised the road several feet, but neglected to maintain a minimum height between the road and overhead wires. The site environment, safety and health (ES&H) plan requires a minimum clearance of 15 feet, and the National Electrical Safety Code requires a minimum clearance of 15½ feet.

During the afternoon, the work crew drove through the entrance with the water cannon atop the hydroseeder in an unsecured, upright position. The maximum height that the water cannon and its arm can extend is 15 feet 3 inches above the ground. The water cannon caught the communication line and pulled the line and nearby utility poles. As the water cannon broke from its holder, tension was suddenly released in the line and the poles sprung back, causing the 13.8 kV phase line to be pulled from its insulators on three adjacent poles. This caused several fuses to trip, causing a power outage to the EMWMF and LSF sites. Immediate actions taken included ensuring that the area was safe and no workers were injured, closing the entrance, and initiating an investigation. The investigation revealed that:

- Project management identified concerns about changing site conditions and potential overhead line problems, but did not communicate these to all affected parties.
- Although the site ES&H plan addressed the overhead lines, the activity hazard analysis and pre-task safety plan for hydroseeding did not.
- No one evaluated the height of the hydroseeder, its water cannon, and the overhead lines prior to the start of the task.
- The water cannon was not secured in a lowered position.
- No observer (spotter) was used while the hydroseeder was moving under the lines, as required by the site ES&H plan.
- The construction crew that raised the entrance road did not maintain the minimum clearance between the road and overhead lines, as required by the National Electrical Safety Code.

The contractor has yet to formalize corrective actions and lessons learned. One action under consideration would be to modify the site ES&H plan so that its minimum clearance requirement for overhead lines is consistent with that specified in the National Electrical Safety Code.

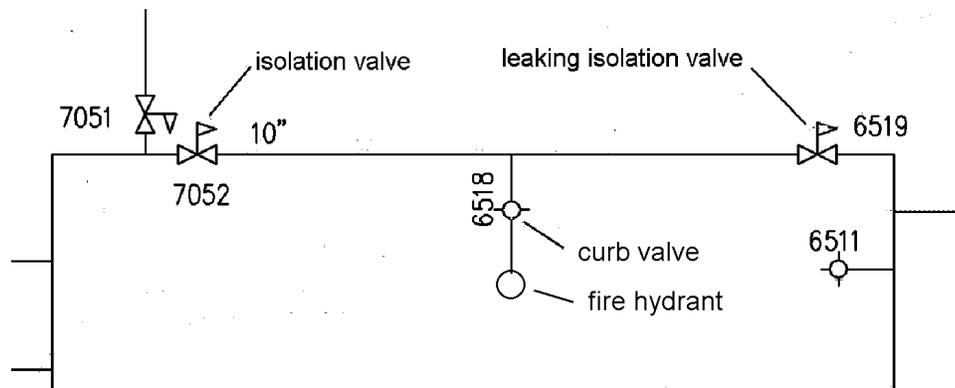
**Figure 1. Fire hydrant piping and valve diagram**

Figure 1 is a schematic of the hydrant and its valves. Before excavation to remove the hydrant began, the utility maintenance crew closed, locked, and tagged two isolation valves (Valves numbered 6519 and 7052 in Figure 1) in the hydrant's water supply loop. When the crew opened the line to verify zero pressure, the hydrant leaked only a small amount of water, indicating successful isolation. However, no one had opened the curb valve near the base of the hydrant's riser pipe. Thus, the pressure check reflected line isolation only at the closed curb valve and failed to disclose that one of the isolation valves was faulty and leaked, and that the line upstream of the curb valve was still pressurized.

The maintenance crew excavated soil around the hydrant's riser pipe and curb valve. As the crew removed one of the concrete thrust blocks supporting the riser pipe, a mechanical slip joint upstream of the curb valve separated due to water pressure, gravity load, and movement of the riser pipe. Water escaped through the joint at approximately 120 pounds per square inch (psi). The resulting pressure fluctuation in the fire main caused a diesel firewater pump to start and to feed high-pressure water to the main, as designed. High-pressure water continued to flow past the malfunctioning isolation valve, out the separated joint, and into the excavation, which overflowed. There were no workers in the excavation when it flooded, and no one was injured. However, had workers been in the excavation, the flooding could have posed a risk of workers drowning or the excavation walls caving in. The contractor identified this occurrence as a near miss.

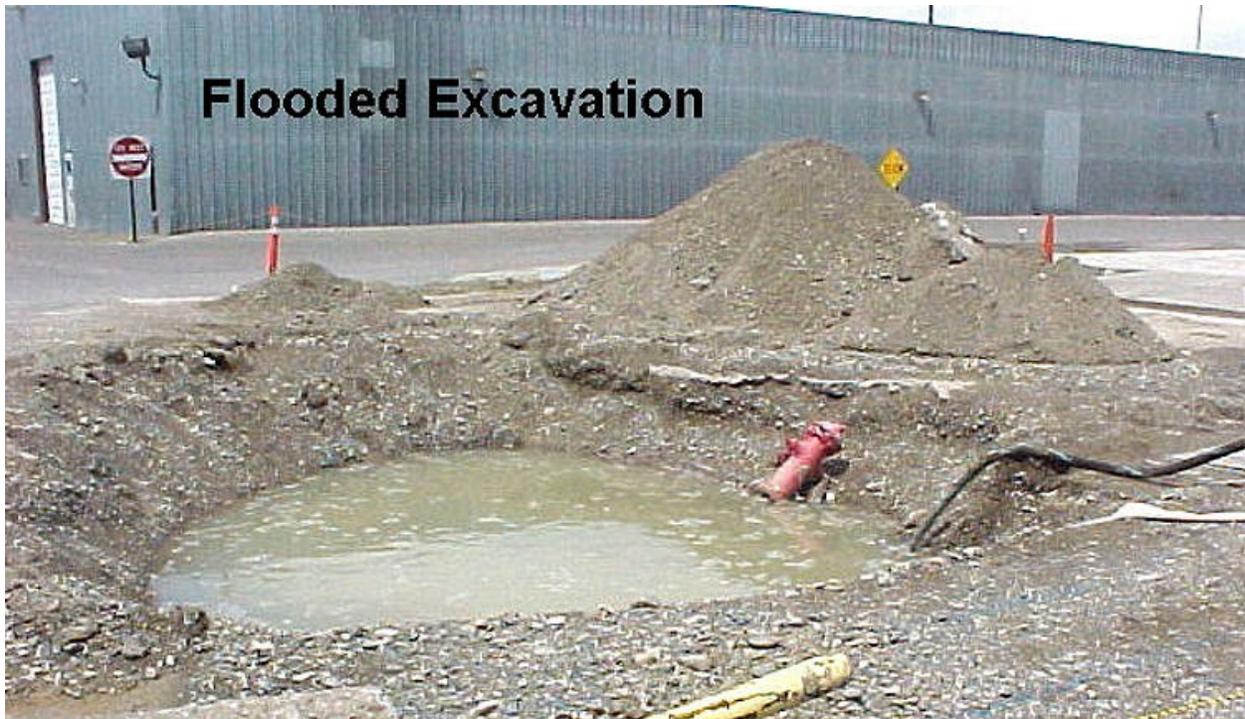
**Figure 2. The flooded excavation after the event**

Figure 2 shows the flooded excavation after the event. A critique performed soon after the occurrence found that the work order and training for this maintenance operation clearly required that the curb valve be opened during the pressure check. Several factors appear to have resulted in the failure to do so. A Comprehensive Environmental Response, Compensation, and Liability Act (CERCLA) work area boundary around the hydrant during the isolation process prevented the utility maintenance crew from performing the pressure test. The maintenance foreman assigned responsibility for the pressure check to the CERCLA lead man, who was not trained to perform the check and did not open the curb valve during the check. The critique found several authorization approvals had been omitted, including utility operations' approval to start work.
