OPERATING EXPERIENCE SUMMARY

Summary 2001-08

Operating Experience Summary 2001-08

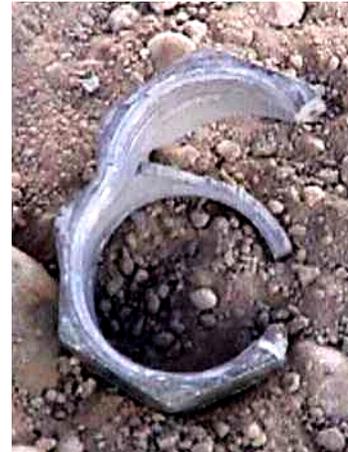
On October 15, 2001, a subcontractor employee was struck in the head by failed grouting equipment parts at the Radioactive Waste Management Complex at the Idaho National Engineering and Environmental Laboratory. A metal fitting broke on a high-pressure grout pump, propelling grout and parts of the coupling through the air with great force. One of the coupling parts struck the worker above his eye, gashing his forehead and knocking him unconscious. He was hospitalized. The worker was wearing the required hardhat and safety goggles, and the goggles absorbed much of the impact. The Idaho Operations Office has begun a Type B investigation of the accident. When the investigation is completed, the OE Summary will discuss its major findings and conclusions. (ORPS Report ID--BBWI-RWMC-2001-0028)

Figure 1. The broken fitting

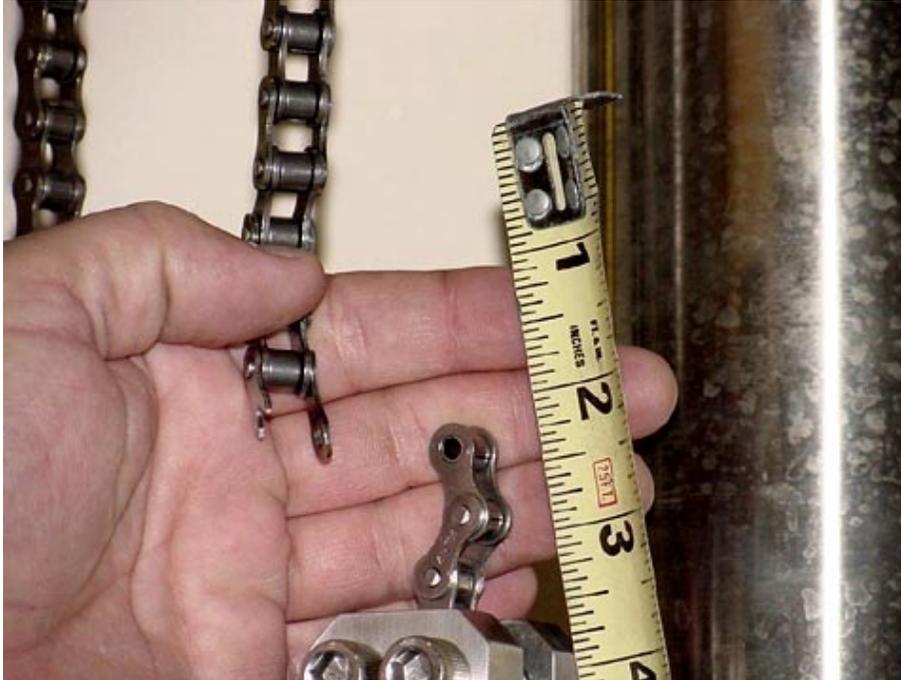
On August 14, 2001 at the Thomas Jefferson National Accelerator Facility (TJNAF), a 40-pound electric hoist failed when its support chain broke. The hoist arm fell about four feet and landed on the lid of an ultrasonic tank, which was not damaged. A technician was working about six feet away from the hoist, but was not injured. TJNAF had designed and fabricated the hoist for special operations, but had not reviewed the hoist's design or fabrication. The hoist was installed for handling larger accelerator components weighing up to 200 pounds. All lifting equipment was reviewed following this incident. (ORPS Report ORO--SURA-TJNAF-2001-0004)

A preliminary review noted that the hoist's support chain and chain sprocket did not align properly. The hoist was not operating at the time of the incident. The misalignment is believed to have stressed the

Figure 1. The broken sprocket chain

chain by placing a bending action on the chain, and may have been the direct cause of the chain failure. Figure 1 shows the broken chain. The accelerator's material handling coordinator failed to review the fabrication process. In addition, the modifications were not made to any specific safety criteria or regulations.

Workers failed to follow a process for modifications to equipment in which changes are reviewed and approved by a cognizant authority before they are implemented.

This occurrence underscores the need for special attention to the design, modification, and inspection of equipment before installation or operation.
