2.0 Facts

On August 22, 2000, IT and its subcontractors were engaged in deployment of in-situ remediation of ground formations (low permeability Minford and Gallia) in the X-701B Area of PORTS (see Exhibit 2-1 a & b). While pulling the rods from the third injection hole that morning, solution was pumped out of the first two rods into a five-gallon bucket. The rods were placed onto the storage rack, and the soil was washed off prior to proceeding to the next location. The drilling rig and rod storage rack were relocated to the fourth injection location of the day. The Driller noted solution coming out of one of the drill head ports. He

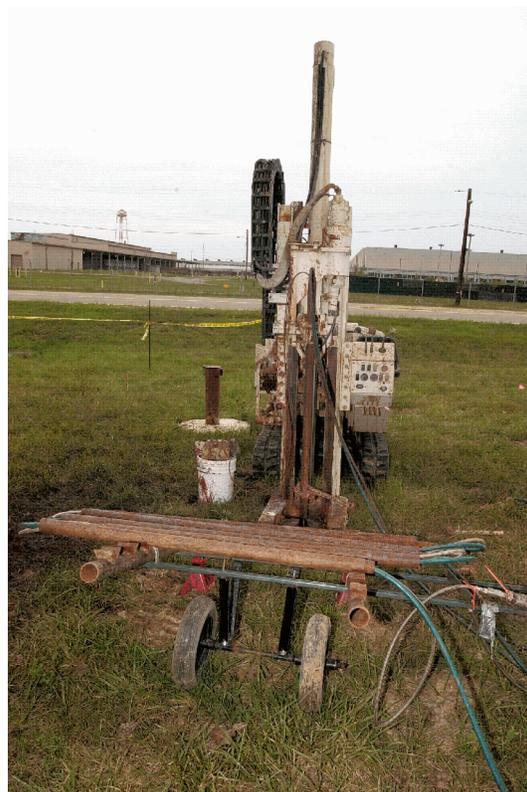
Exhibit 2-2. Drilling Rig

After returning from lunch, the Driller noted that the five-gallon bucket was at least two-thirds full of purple (permanganate) solution of unknown concentration. The five-gallon bucket containing the solution was moved from under the drill head by the Driller and handed to his assistant. The Driller's Assistant carried the bucket away from the drilling area, placed it on the ground, and returned to the drilling rig. The Driller drove the first rod down to the five-foot level and connected the second rod. After insertion of about one foot (a total of six feet) the Driller noted some bleed-up of permanganate solution through the rods. The insertion was stopped (see Exhibit 2-2). The second rod was pumped free of

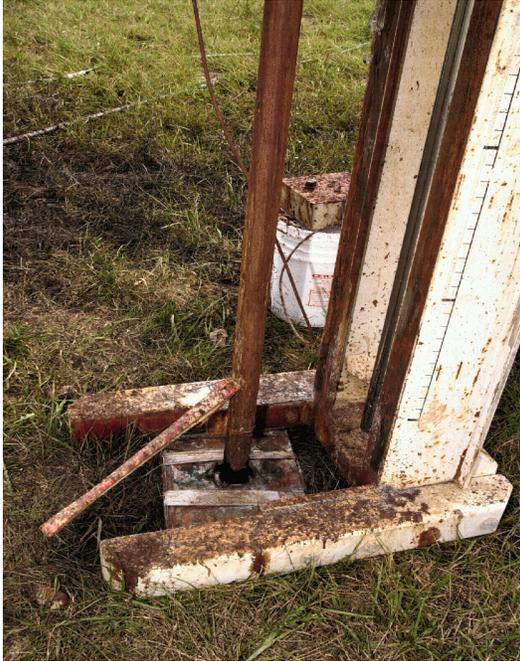
Exhibit 2-3. Location of Drilling Rig at Time of Accident

liquid and removed from the hole. The first rod was pumped free of liquid and raised to ground level for examination of the threads between the head and rod (see Exhibit 2-3). The Driller, the Driller's Assistant, and an FRx Field Technician were examining the threads when the accident happened. A loud explosion was heard, and solution from the five-gallon bucket became airborne, rising at least 15 feet in the air. The Driller's Assistant's back, as well as the drilling rig, were sprayed by the airborne solution. The other two individuals at the drilling rig were shielded from the airborne solution by the Driller's Assistant. The most seriously injured individual, the IT Laborer, was located immediately adjacent to the bucket. He was sprayed on his front by the airborne solution. No other workers were adversely impacted by the solution. The Driller's Assistant was treated on site and did not encounter any

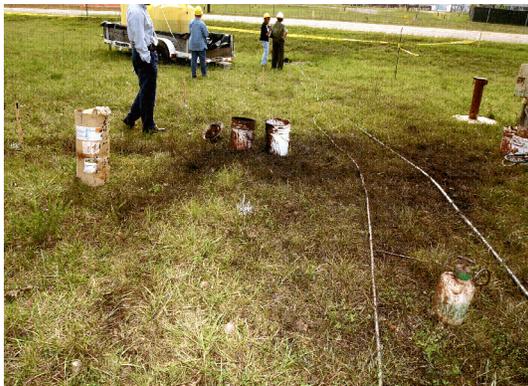
Assistant moved the bucket out of the drilling area. The IT Laborer yelled at him to set the bucket down and he would take care of it. When the Driller's Assistant sat the bucket down, it was the only item in that area (i.e., no other bucket or cardboard container was present). At some point, a second five-gallon bucket containing purple permanganate solution and a cardboard container of thiosulfate were placed near the first five-gallon bucket, which contained permanganate solution with a deep purple color (see Exhibit 2-4). Interviews of on-site personnel did not clarify where the second bucket and cardboard container came from or who placed them at the scene.

Exhibit 2-4. Thiosulfate Container and Two Five-gallon Buckets of Permanganate Solution.

The IT Laborer was standing over one of the five-gallon buckets when a violent exothermic chemical reaction occurred in the bucket. Permanganate solution was blown from the bucket up at least 15 feet in the air. The solution went all over the front of the IT Laborer. The front portion of the IT Laborer's 100% cotton blue jeans instantaneously ignited. No holes were noted in his 66% polyester/34% cotton shirt. The solution splashed onto the back of the Driller's Assistant. The Driller's Assistant was standing in front of the Driller and an FRx technician, thereby
