Mitigation of the Effects of the U1 Steam Leak  
on U2 Outage & Turbine Building Operations  
Peter G. Dorosko, PE  
Carolina Power & Light  
Brunswick Nuclear Plant  
Southport, North Carolina, 28461-0429

Abstract

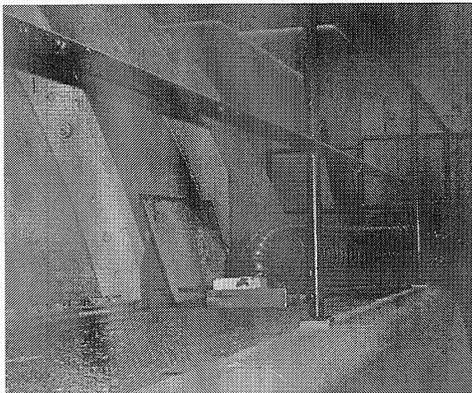
Figure 1

Outlet point from under U1 Turbine

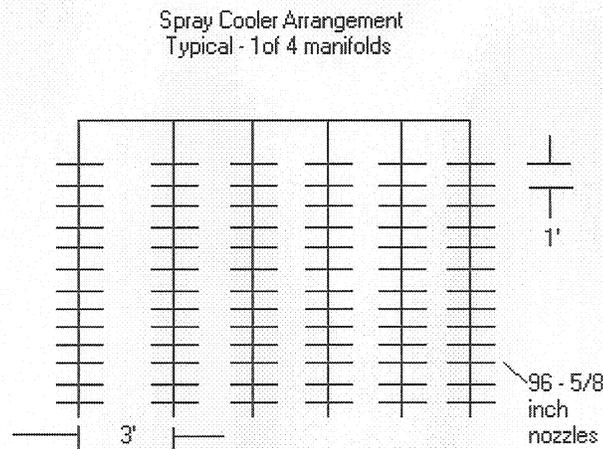
Figure 5

Once the effluent was routed into the ventilation system it passed through the spray cooler arrangement illustrated below. The spray manifold consists of a four sections containing 6 two inch diameter pipes with 96 nozzles. The flow rate through this spray system is approximately 2000 gpm.

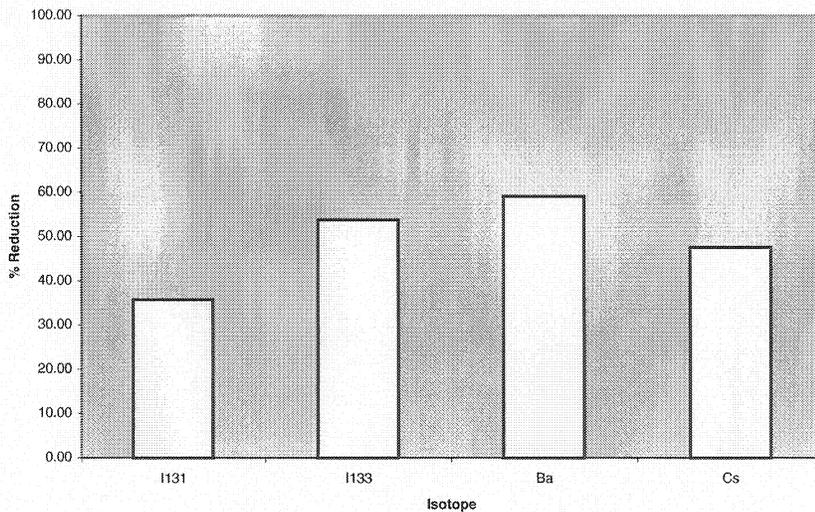
Graph 1, Reduction in Airborne Activity

As can be seen in the following graph, there was a significant reduction in airborne activity. Depending on the isotope, the reduction was between 35% and 60%.

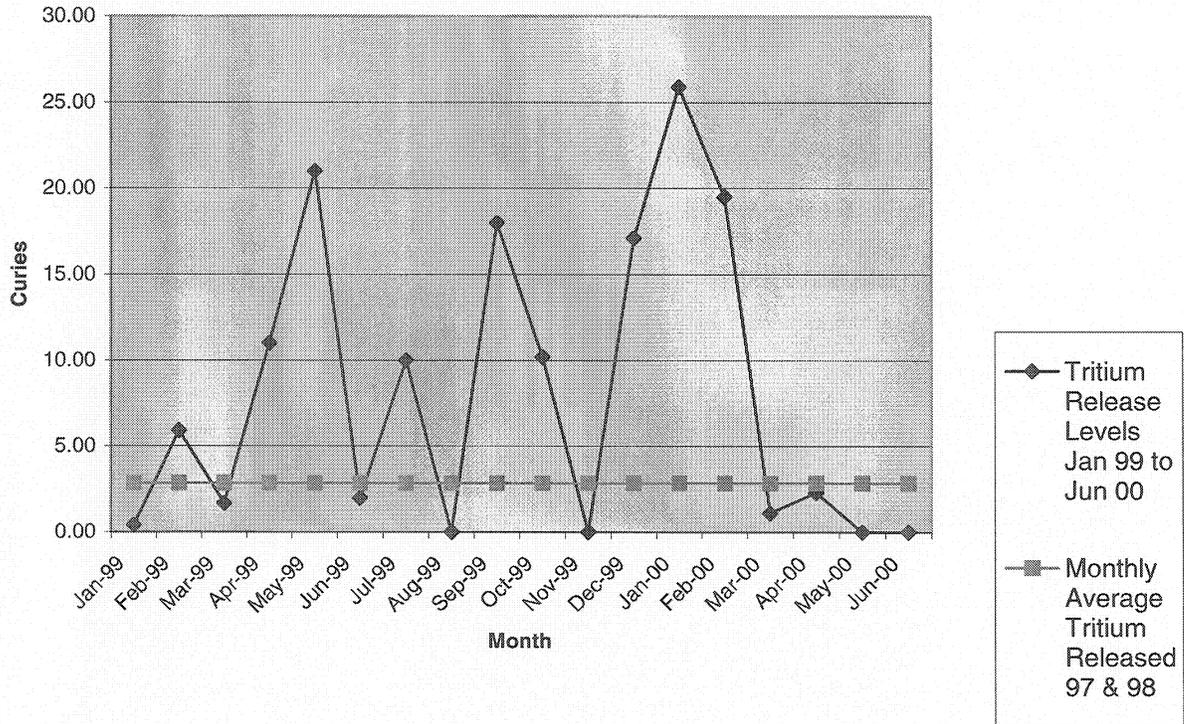
Graph 2, Radiological Liquid Tritium Released

Another indication of the affect of the scrubbing by the spray wash sub-system of the Turbine Building ventilation system was the increase in the level of tritium being released from the plant. As part of the ventilation system, water that overflows from the chill water basin is routed to a holding pond. It is sampled and then released in the discharge canal for the condenser cooling water. The average liquid tritium released for 1997 and 1998 was 2.3 curies per month. The level increased to approximately an average of 10 curies per month. There are large swings in the amount of radiological tritium released in a given month because it is controlled based upon the activity level in the holding pond and the level of the pond.
