# **TSA-RE Dry Pendant Sprinklers Replacement at the AMWTP ...a Success Story**

**David K. Young, P.E.**

**DOE Fire Safety Workshop**

**April 2008**

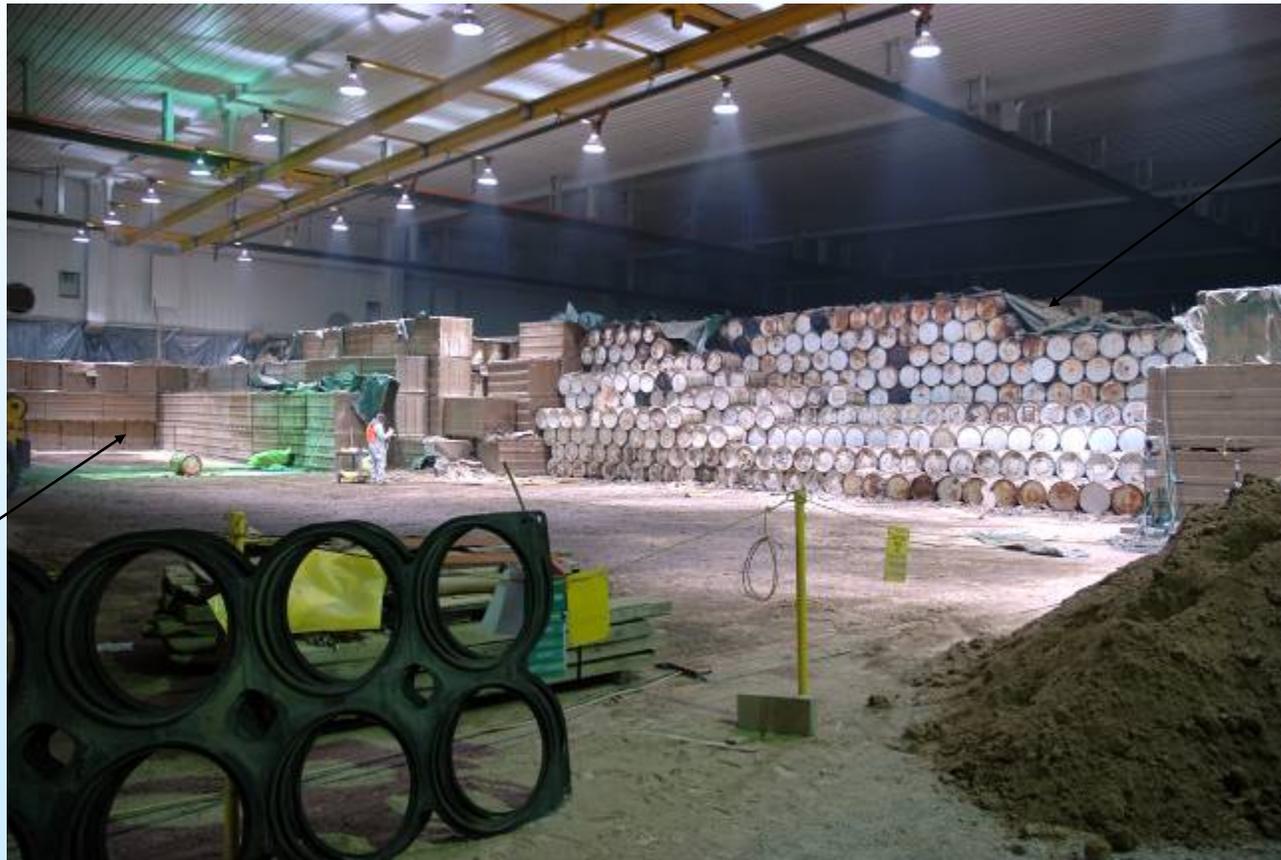
Fiberglass reinforced plywood boxes

Tarp and plywood sheet material

How about now?

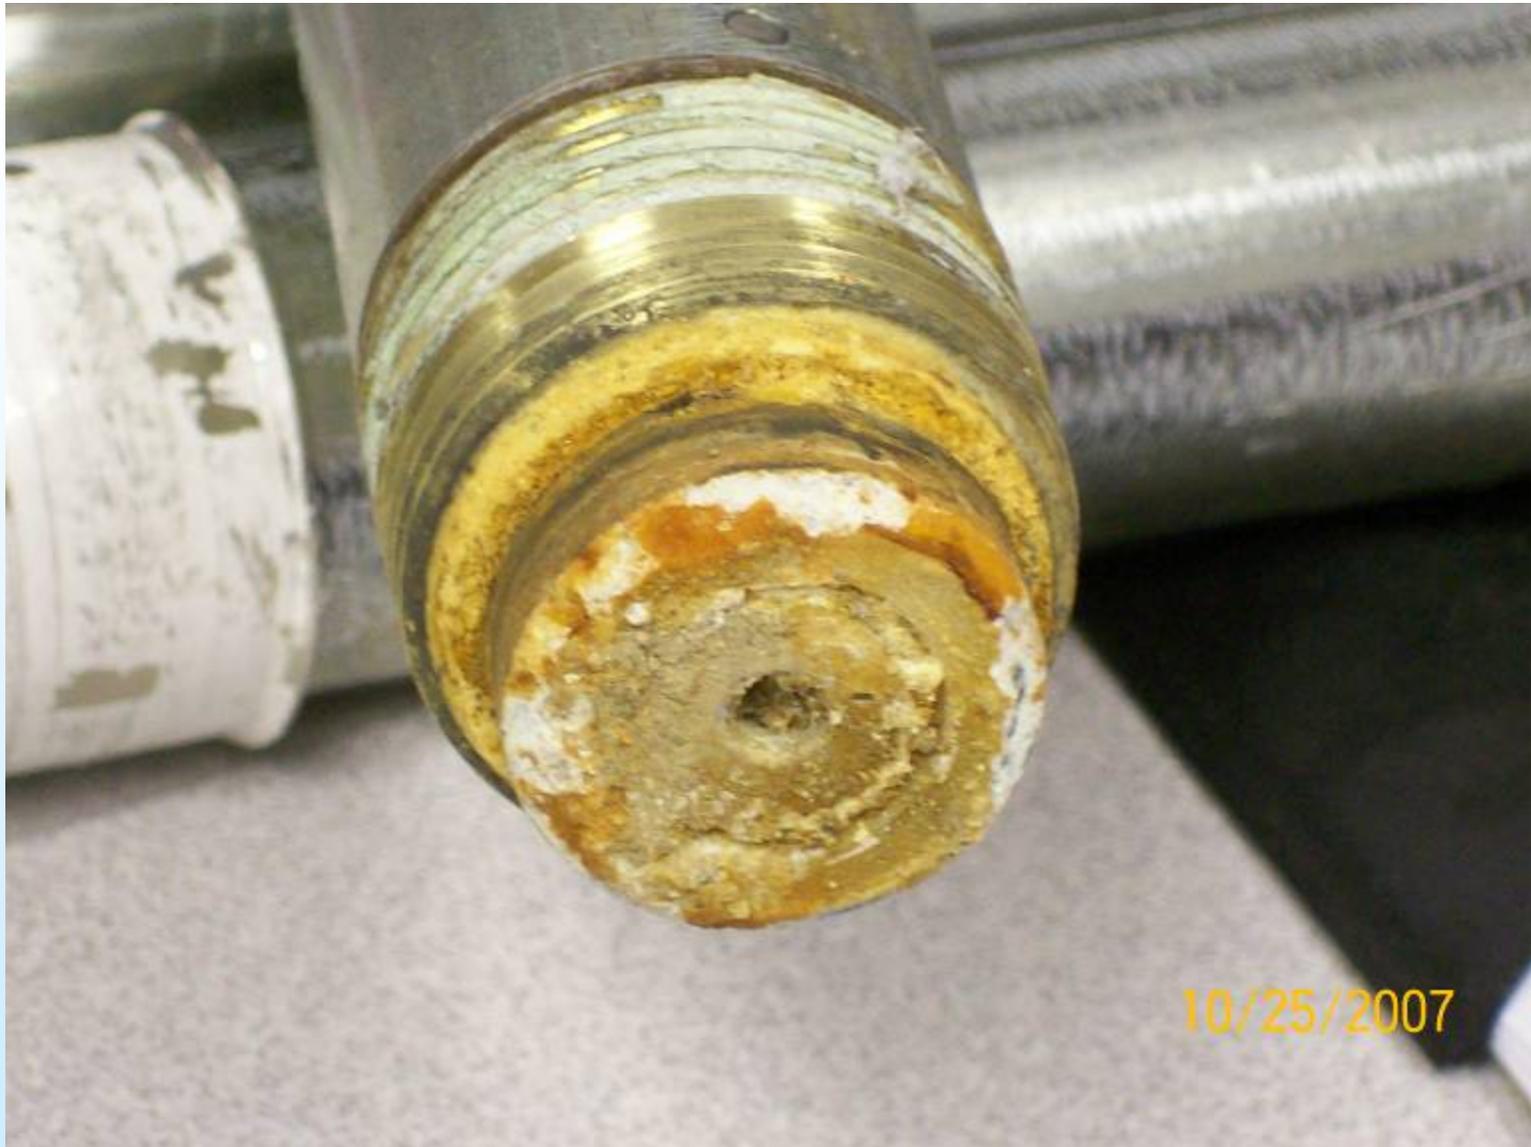
10/25/2007

- FPEs and management agreed it was prudent to test additional sprinklers
  - ◆ Was an equivalency possible based on
    - 25-psi operating pressure?
    - Robust water supply?
    - Equivalency on top of an equivalency?
  - ◆ 10 sprinklers from 8 systems removed and tested
- 80 sprinklers sent to UL for testing (plunge test)
  - ◆ 75 actually tested (remainder damaged during removal)
  - ◆ 5 failures (of total population 6 of 96 failed: 6%)
  - ◆ Failures ranged from activation at 36 psi up to did not operate at 100 psi
- Based on a 6% failure rate and the condition of some of the removed sprinklers, absolutely no technical basis to pursue equivalency
