Management of Time Sensitive Chemicals (I): Misconceptions Leading to Incidents

Jim Bailey (Bechtel Jacobs, Oak Ridge), David Blair (Heritage-ETS), Lydia Boada-Clista (DOE Ohio Field Office), Dan Marsick (DOE-EH), David Quigley (Y-12), Fred Simmons (SRS), Helena Whyte (LANL-HSR-5)

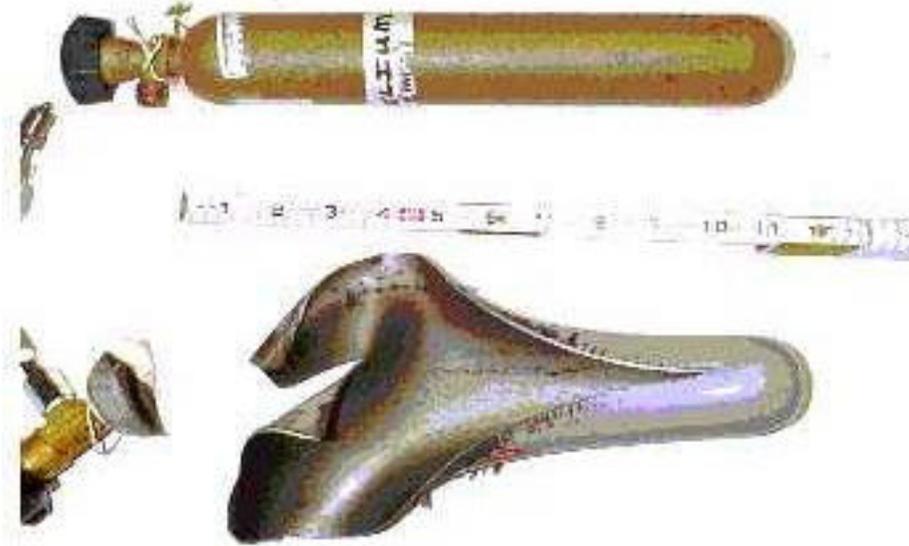
Another example of a chemical that is incompatible with its container over prolonged storage is anhydrous hydrogen fluoride (AHF). Anhydrous hydrogen fluoride is a colorless, corrosive and toxic liquid normally packaged in mild steel cylinders under its own vapor pressure of 2.1 kPa (0.3 psig.) at 20 °C. AHF over time will react with the mild steel of the cylinder to produce hydrogen which is a nonliquefiable gas. The build up of hydrogen gas will cause the pressure inside the cylinder to increase. Numerous incidents have been reported of sudden failure of AHF gas cylinders due to over pressurization (17). This usually occurs with AHF that has been in storage over a long period of time, typically for 15-25 years. If this over pressurization occurs in a cylinder with a pressure relief device, then the pressure relief device will actuate and allow the contents of the cylinder to be released. If no pressure relief device is present, such as on lecture bottles, then the over pressurization can result in the catastrophic failure of the cylinder (Figure 2). One lecture bottle of AHF stored for 14 years developed an estimated pressure of 2,400 psig. that was in excess of the nominal 1800 psig. cylinder pressure rating. A similar situation was recently reported in which anhydrous hydrogen bromide (AHBR) was stored for long periods of time in lecture bottle cylinders (18). Some of these lecture bottles of AHBR were found with pressures that, again, exceeded the 1800 psig. pressure rating of the cylinder. No instances could be found involving anhydrous hydrogen chloride cylinder over pressurizations.

Figure 2 – Anhydrous Hydrous Fluoride Cylinder, Before and After Catastrophic Failure. Note How The Failure Has Resulted in Fragmentation of The Cylinder.
