**Type B
Accident Investigation**

**Injury Resulting From
Violent Exothermic Chemical Reaction
at X-701B Site
Portsmouth Gaseous Diffusion Plant**

Oak Ridge Operations

October 2000

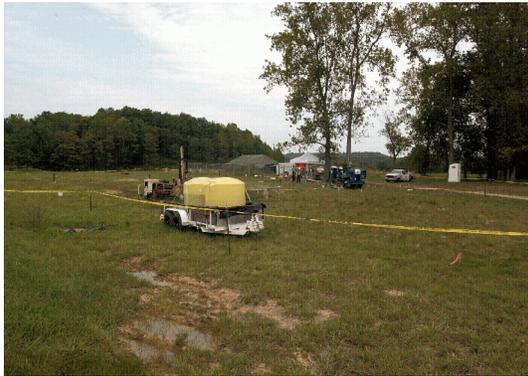
Exhibit 2-1a. Lance Permeation Site Overview

On August 22, 2000, IT and its subcontractors were engaged in deployment of in-situ remediation of ground formations (low permeability Minford and Gallia) in the X-701B Area of PORTS (see Exhibit 2-1 a & b). While pulling the rods from the third injection hole that morning, solution was pumped out of the first two rods into a five-gallon bucket. The rods were placed onto the storage rack, and the soil was washed off prior to proceeding to the next location. The drilling rig and rod storage rack were relocated to the fourth injection location of the day. The Driller noted solution coming out of one of the drill head ports. He
