November 18, 2010

PANTEX DROPPED PIECE OF HIGH EXPLOSIVES

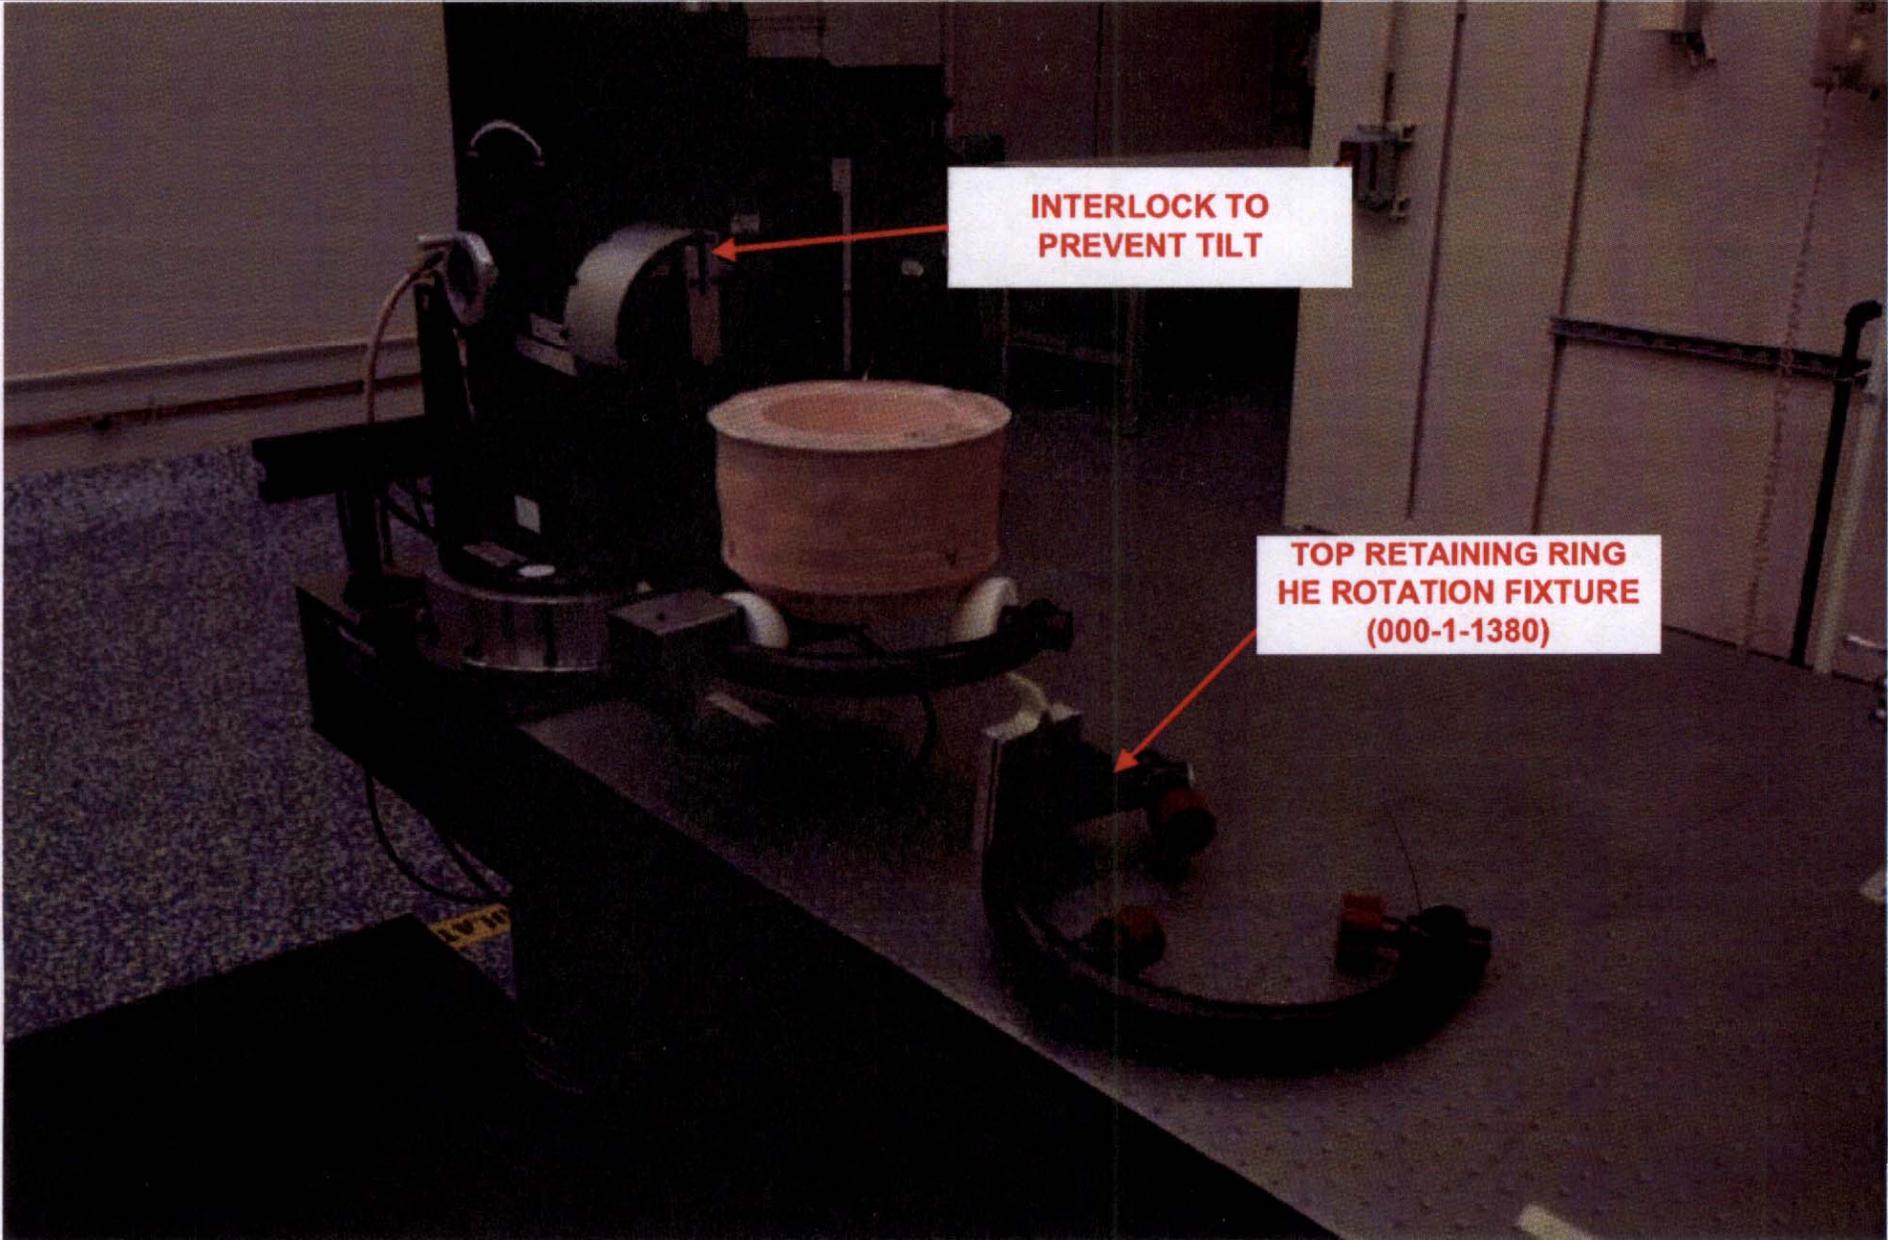
- Quality Assurance Technicians (QATs) Performing Radiography of a High Explosives (HE) Part.
- HE manipulated through automated sequence to preset positions.
- Holding fixture designed to allow positioning of the HE for x-ray shots.
- Remote Operation, observed by closed circuit camera.
- QATs Noted HE Movement Within the Holding Fixture, Stopped Operation, But HE Part Slipped Out of Holding Fixture Onto a Padded Work Surface.

**INTERLOCK TO
PREVENT TILT**

**TOP RETAINING RING
OF THE ROTATION FIXTURE
(000-1-1380)**

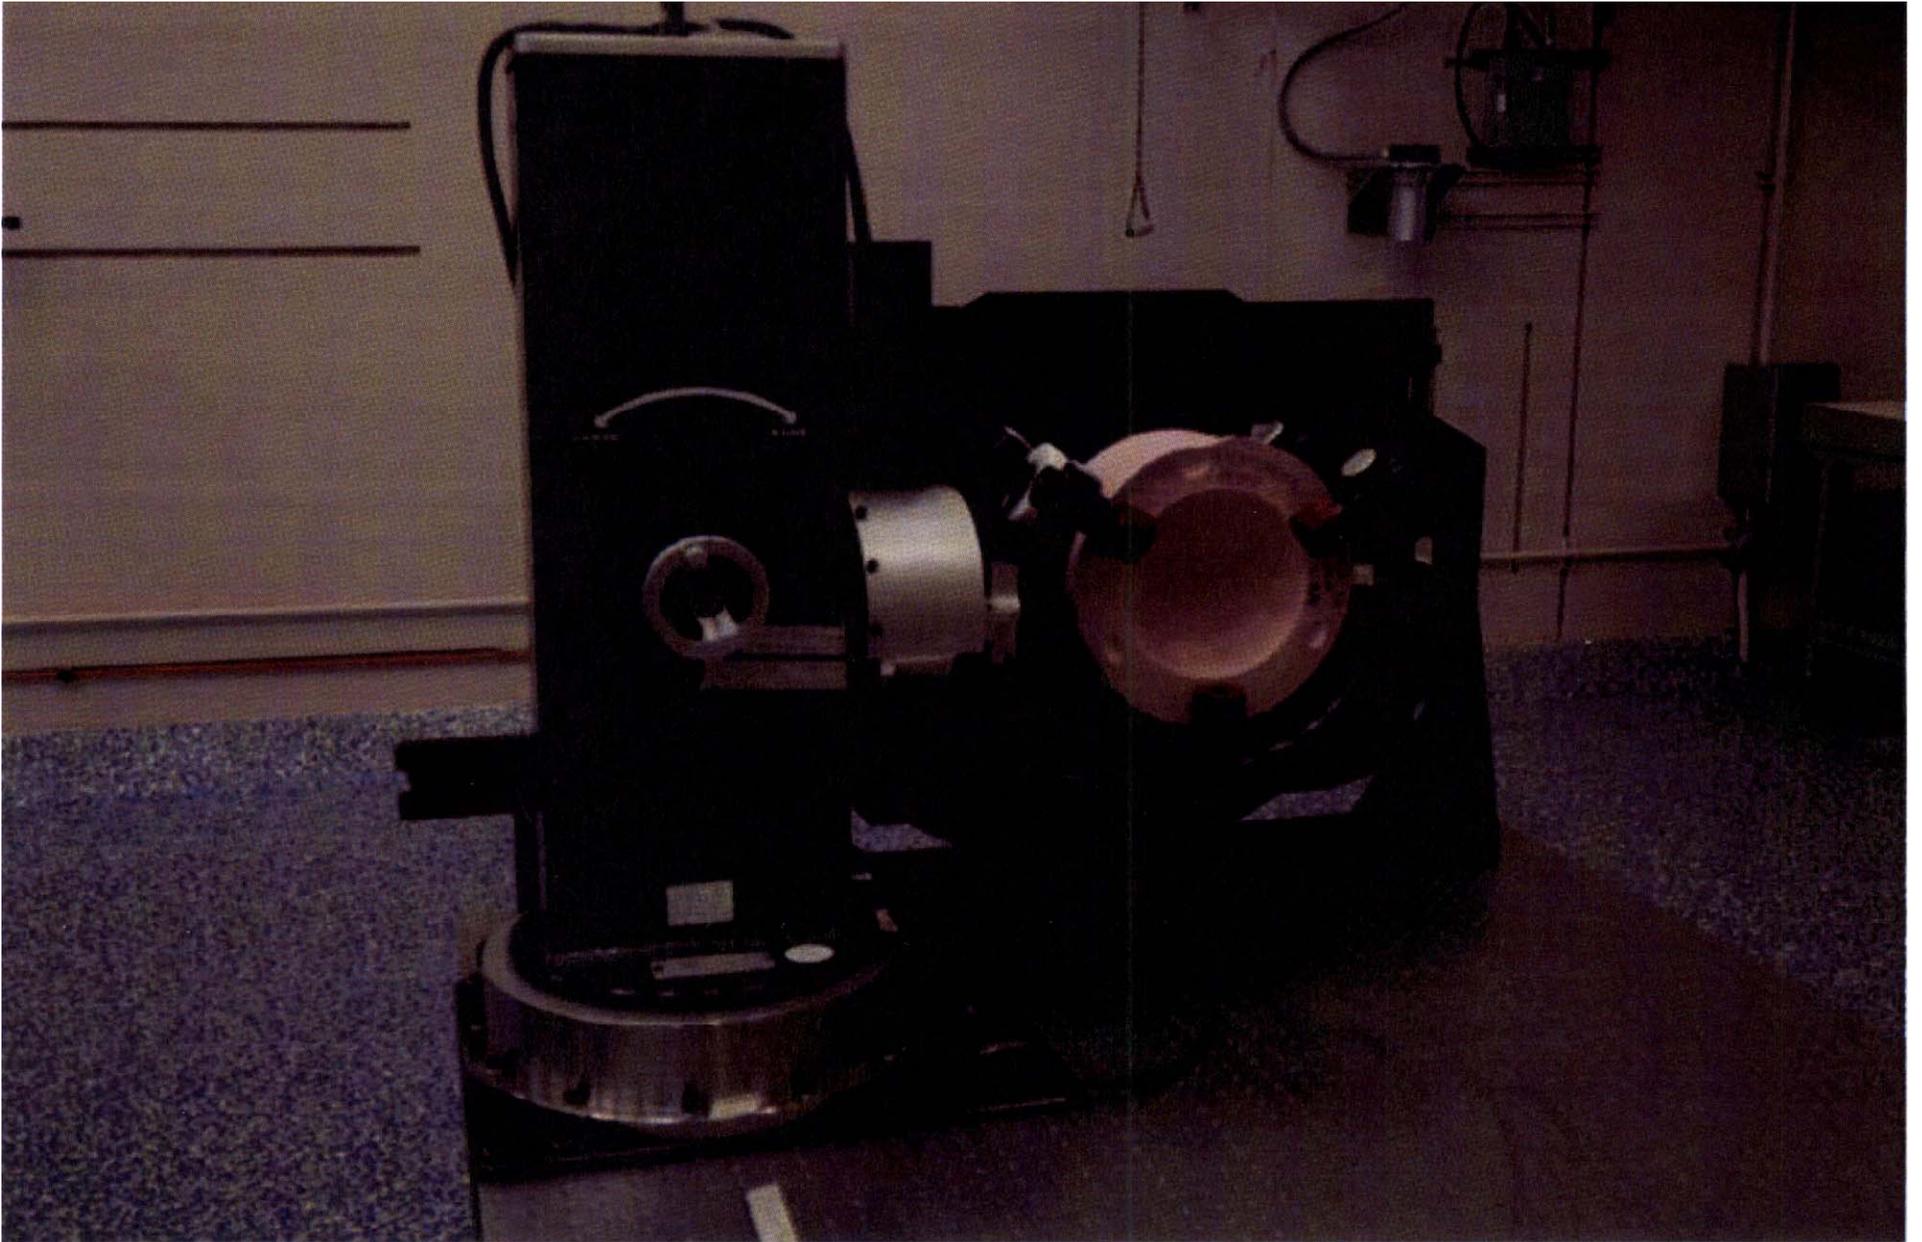
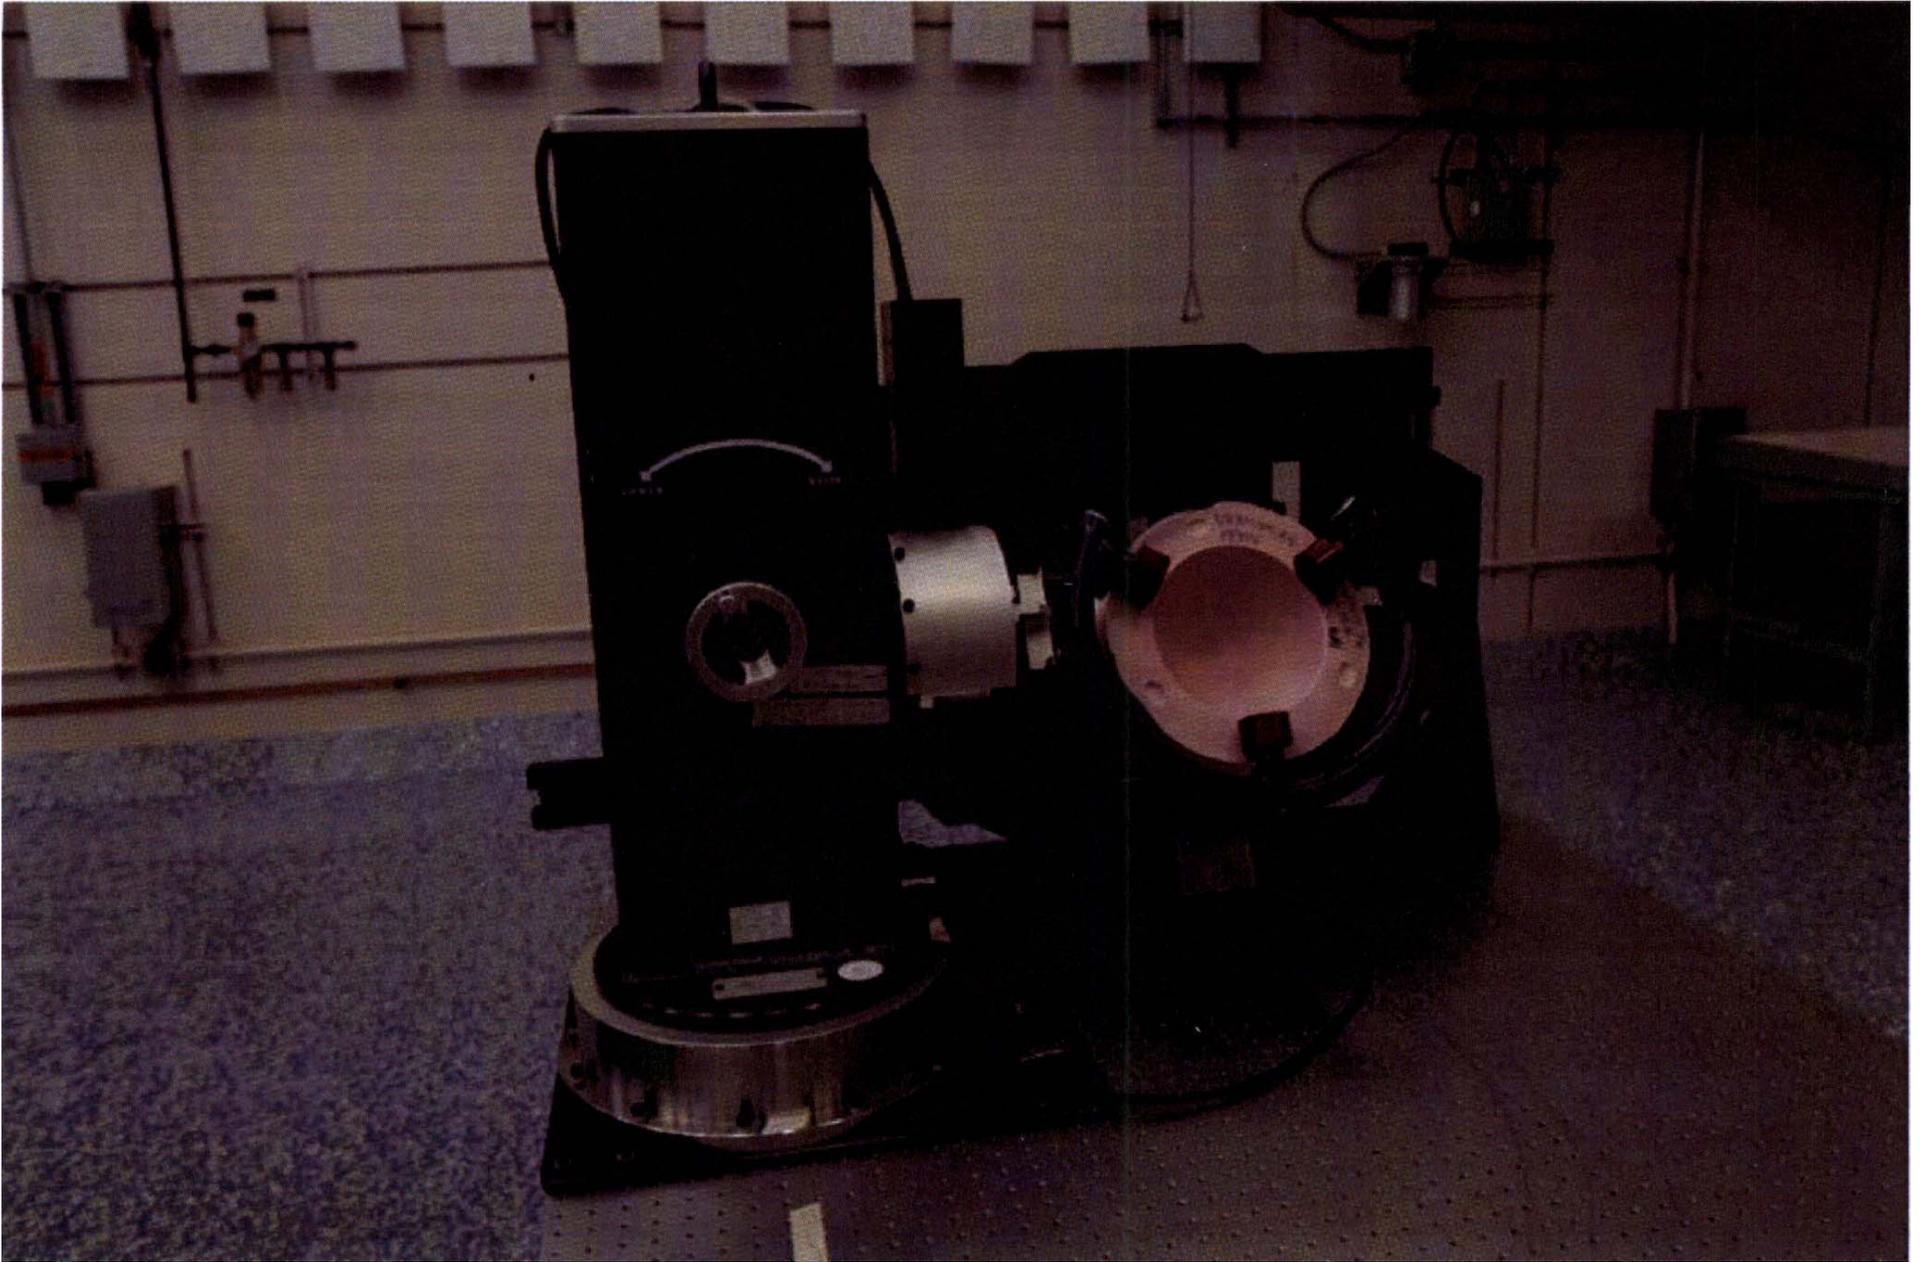
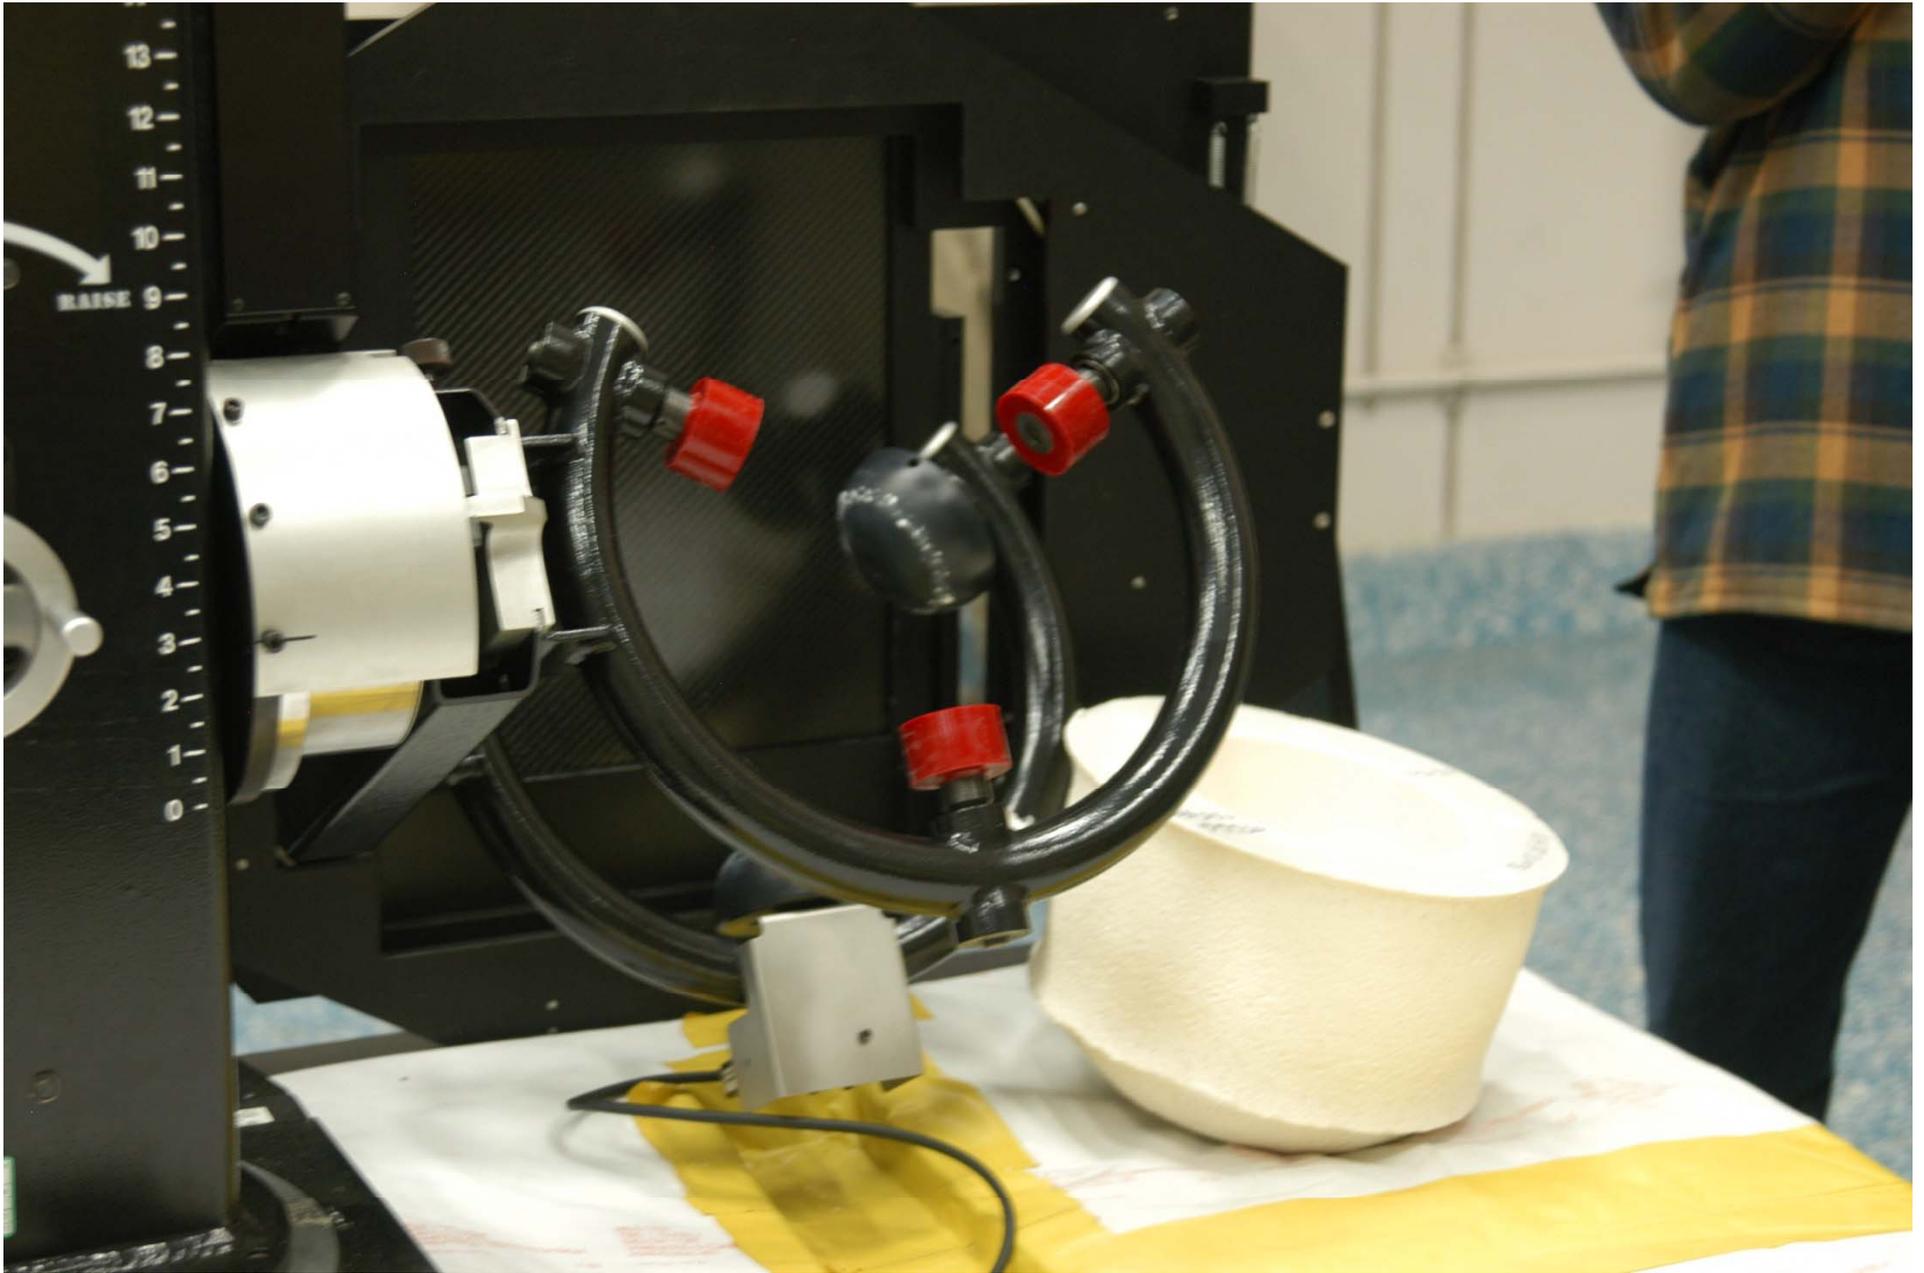
- The roller on the fixture rolled into an undulation in the HE surface and allowed the HE Part to drop enough to become dislodged.
- The Holding Fixture did not prevent the HE Part from falling to the table.
