**U.S. Department of Energy  
Office of Health, Safety and Security**

**Accident Investigation Report**

**Plutonium Contamination in the  
Zero Power Physics Reactor Facility  
at the Idaho National Laboratory,  
November 8, 2011**

**January 2012**

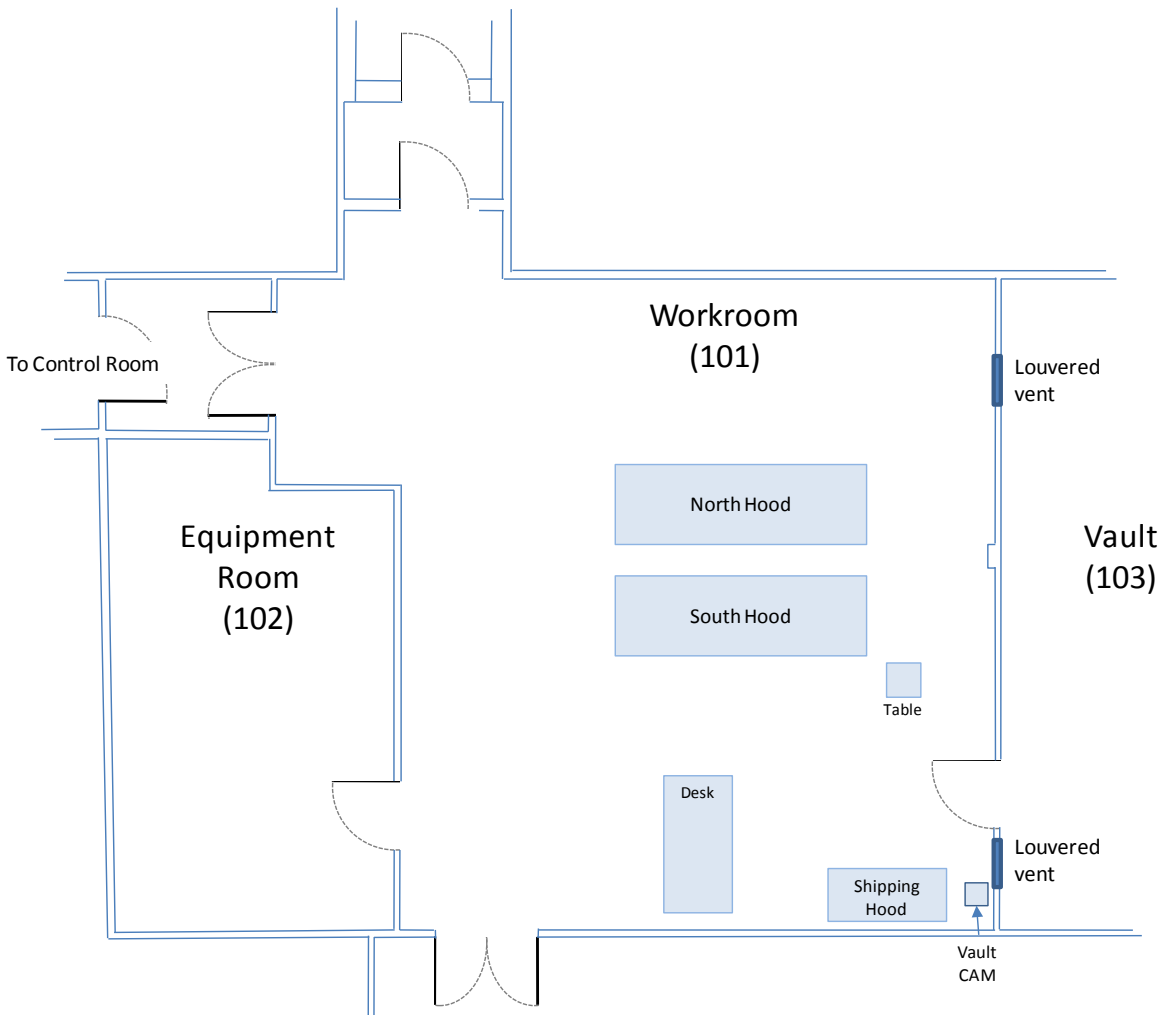
**Figure 2-1. Diagram of ZPPR Workroom**

During the planned fuel packaging operation, workers were instructed to open Pu ZPPR reactor fuel plate storage containers called “clamshells” after removing them from ZPPR Vault storage. After removing four clamshells from the Vault, but before bringing them into the ZPPR Workroom for the operation, the workers noted that two of the clamshells had atypical labels reading “*CAUTION: RADIOACTIVE MATERIAL,*” indicating potential abnormalities with the fuel plates located inside. The immediate SS and the NFM for the work were consulted, and a decision was made to proceed with the packaging operation. The four clamshells were then taken to the ZPPR Workroom (Figure 2-1) and placed in the South Hood (Figure 2-2).

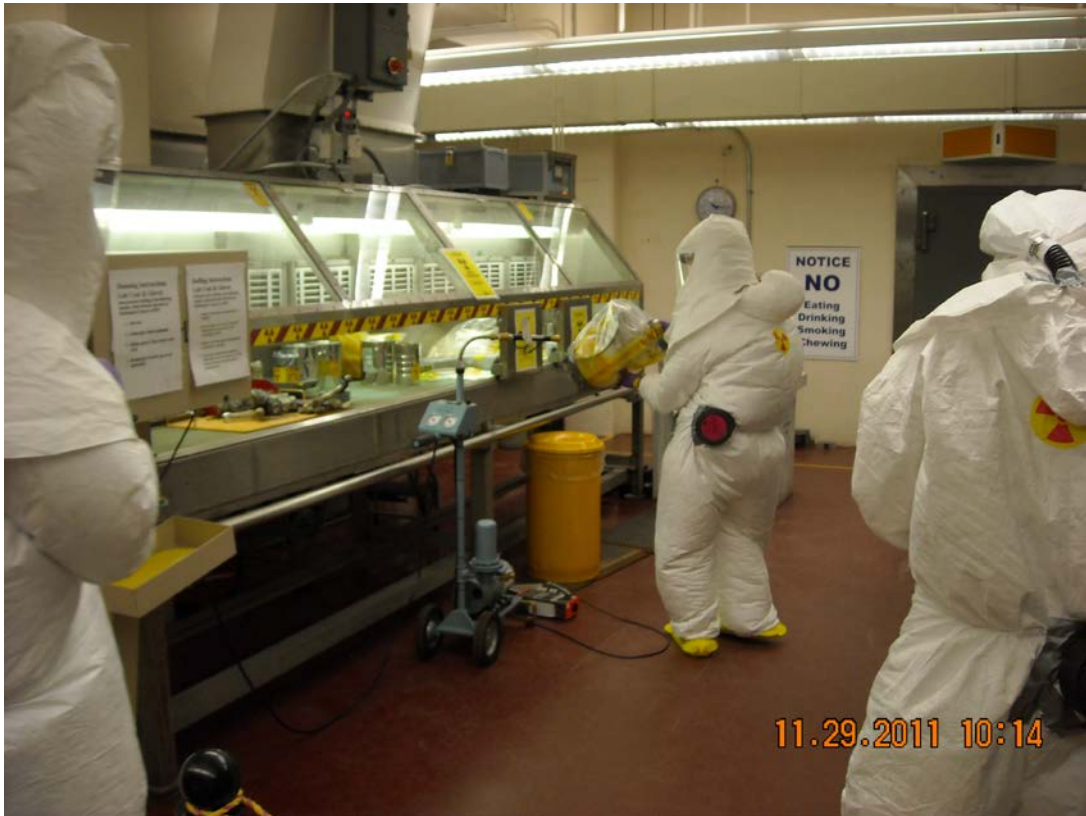
**Figure 2-3. Re-Entry Activities Supporting Collection of Evidence**

Due to the levels of contamination expected in the ZPPR Workroom and the methods that had been used to isolate the Workroom and ZPPR Facility, a controlled re-entry to the Facility was needed to allow further collection of evidence (Figure 2-3). The re-entry, overseen by DOE-ID and executed by BEA, was conducted in phases in order to ensure a safe approach for assessing the facility condition. The removal and examination of evidence at the scene were synchronized with re-entry phases.
