Office of Health, Safety and Security

Monthly Analysis of Electrical Safety Occurrences

February 2012

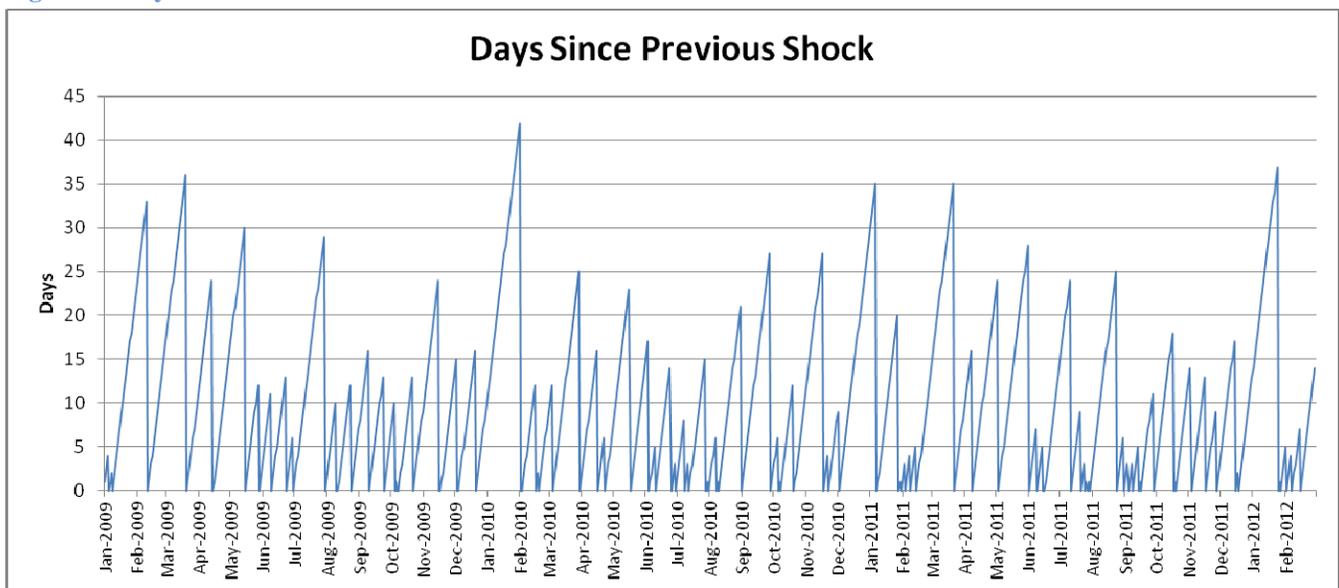
Figure 1 - Days since Previous Shock

Figure 1 shows the number of days since the previous electrical shock for the DOE complex. The present interval is 14 days. The longest interval was 42 days on February 1, 2010.

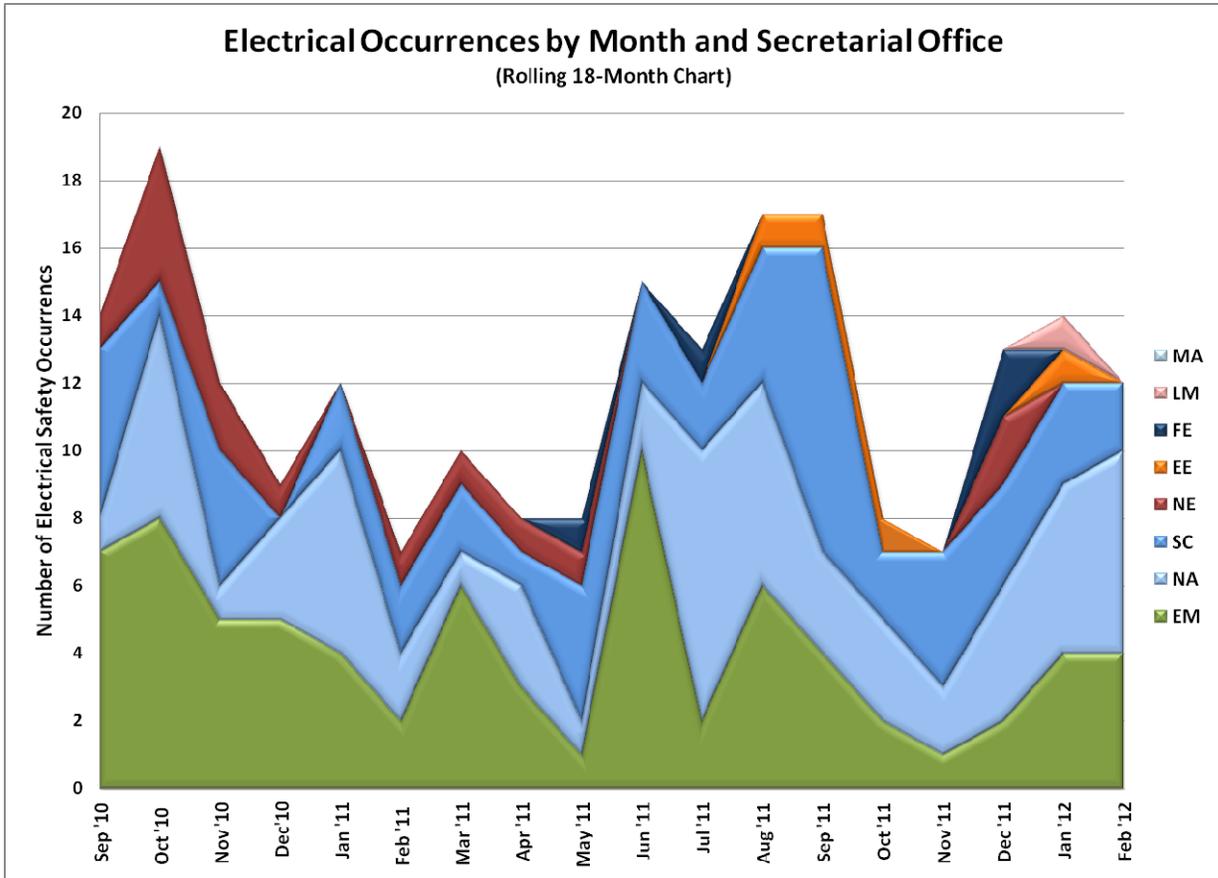
Figure 2 - Electrical Occurrences by Month and Secretarial Office

Figure 2 shows the distribution of electrical safety occurrences by Secretarial Office. The Office of Environmental Management (EM), the Office of Science (SC), and the National Nuclear Security Administration (NA) typically report the most occurrences of all the offices. Over the past several months, EM and NA have increased and SC decreased.

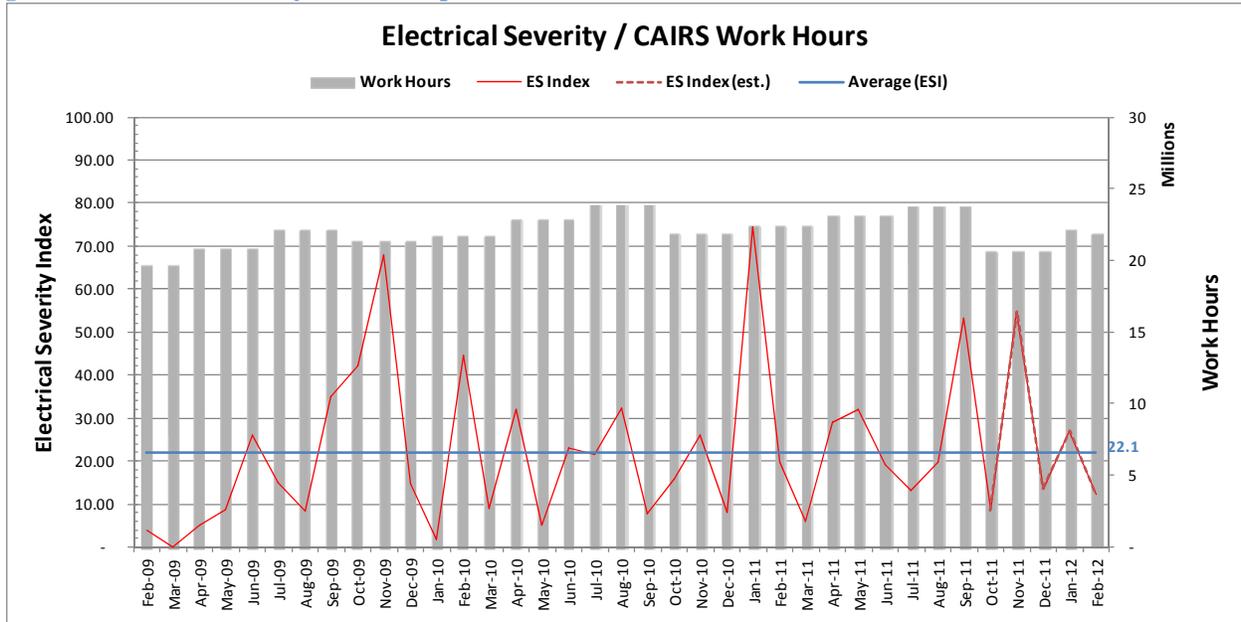
Figure 3 - Electrical Severity Index Compared to Work Hours

The Electrical Severity Index (ESI) is a performance metric that was developed to normalize events against organizational work hours. The ESI is calculated monthly and trended. Figure 3 shows a calculated ESI for the DOE complex and Table 4 shows the ESI and how it has changed from the previous month.

Note: An estimated ESI is calculated until accurate CAIRS man-hours are available. The chart is updated monthly.

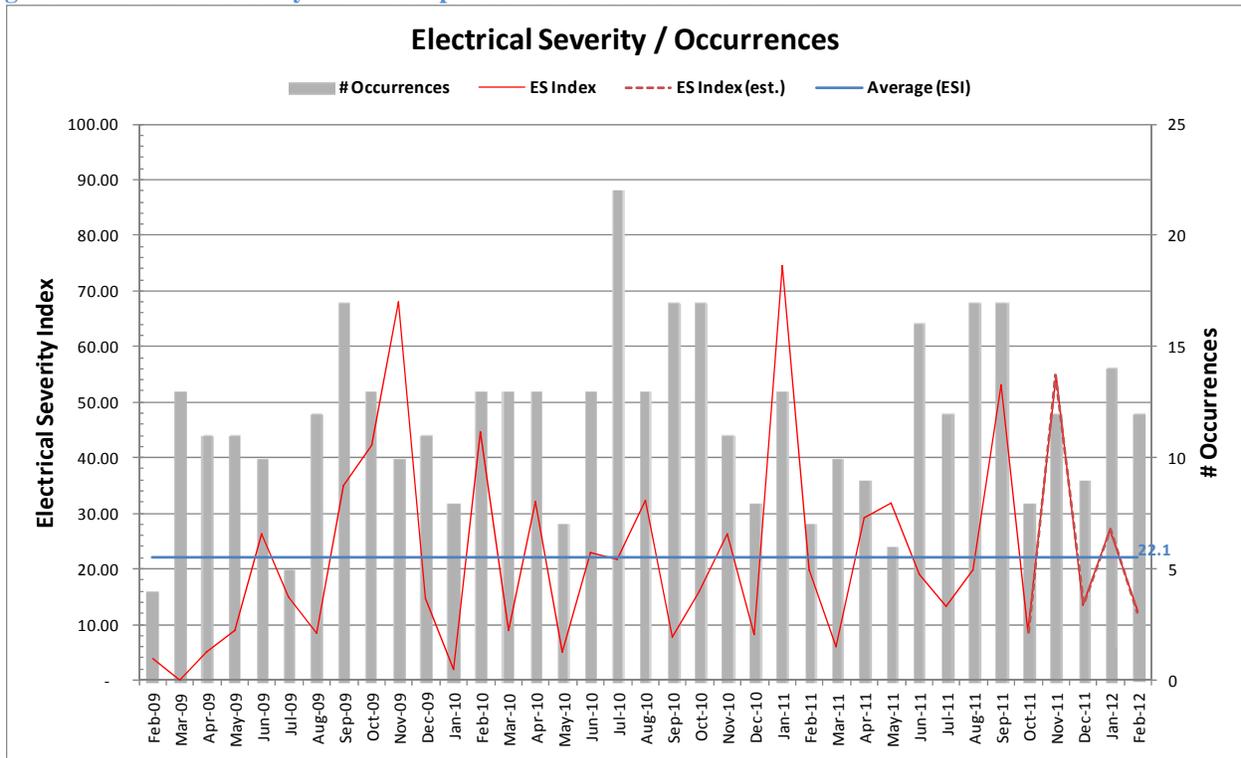
Figure 4 - Electrical Severity Index Compared to Number of Occurrences

Figure 4 shows the ESI with the number of Occurrences instead of Work Hours.

The average ESI (22.1) has remained fairly constant over the past several months but showed a decrease this month. The lowest average ESI was 19.2 in June 2010.

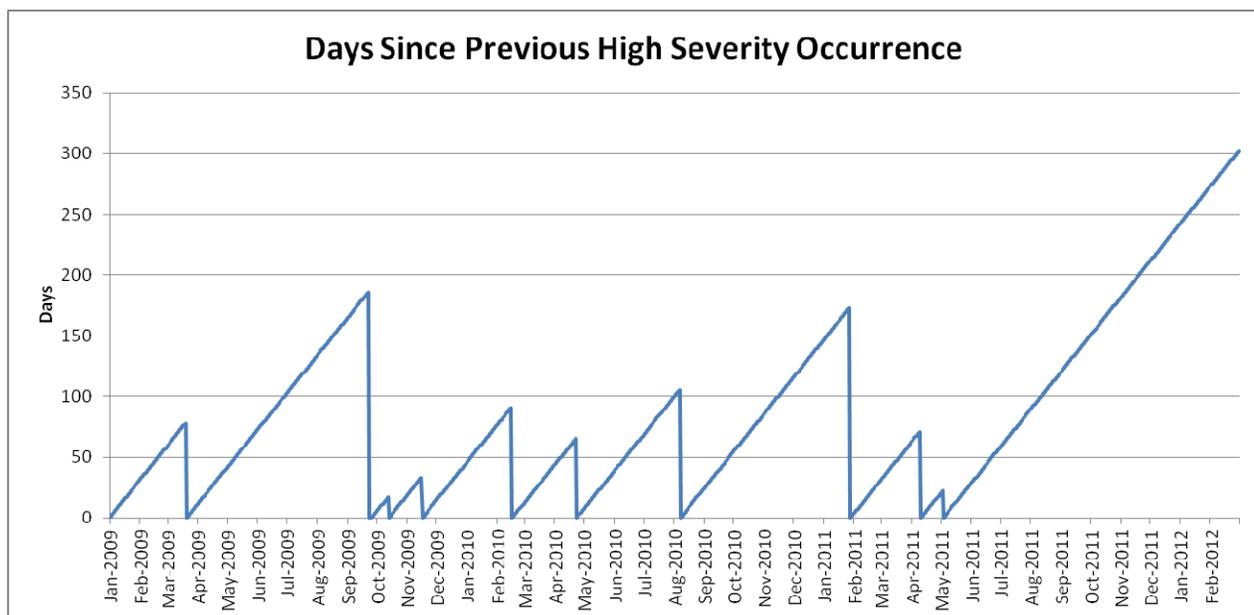
Figure 5 - Days since Previous High Severity Occurrence

Figure 5 shows the number of days since the previous high severity occurrence. The present interval is 302 days as of February 29, 2012. The previous longest interval was 181 days in 2009.

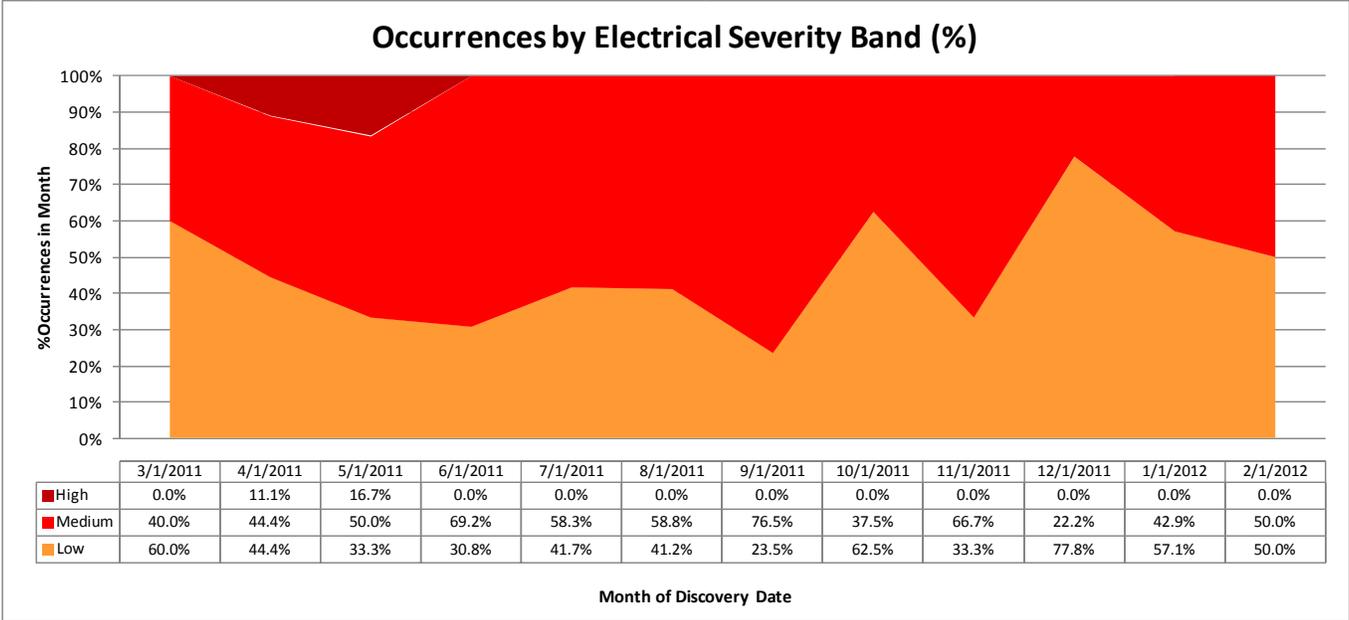
Figure 6 - Occurrences by Electrical Severity Band (Percentage)

For the interval February 2011 through February 2012 (current month and the past 12), Figures 6 and 7 summarize occurrences by severity band and month of discovery date by percentage of total occurrences in month and number of occurrences in month.

What can be seen from the previous two charts is that the number of occurrences with High electrical severity scores has remained at zero for the past nine months and that the number of occurrences with Medium scores has remained the same and equal to the number of Low severity occurrences.

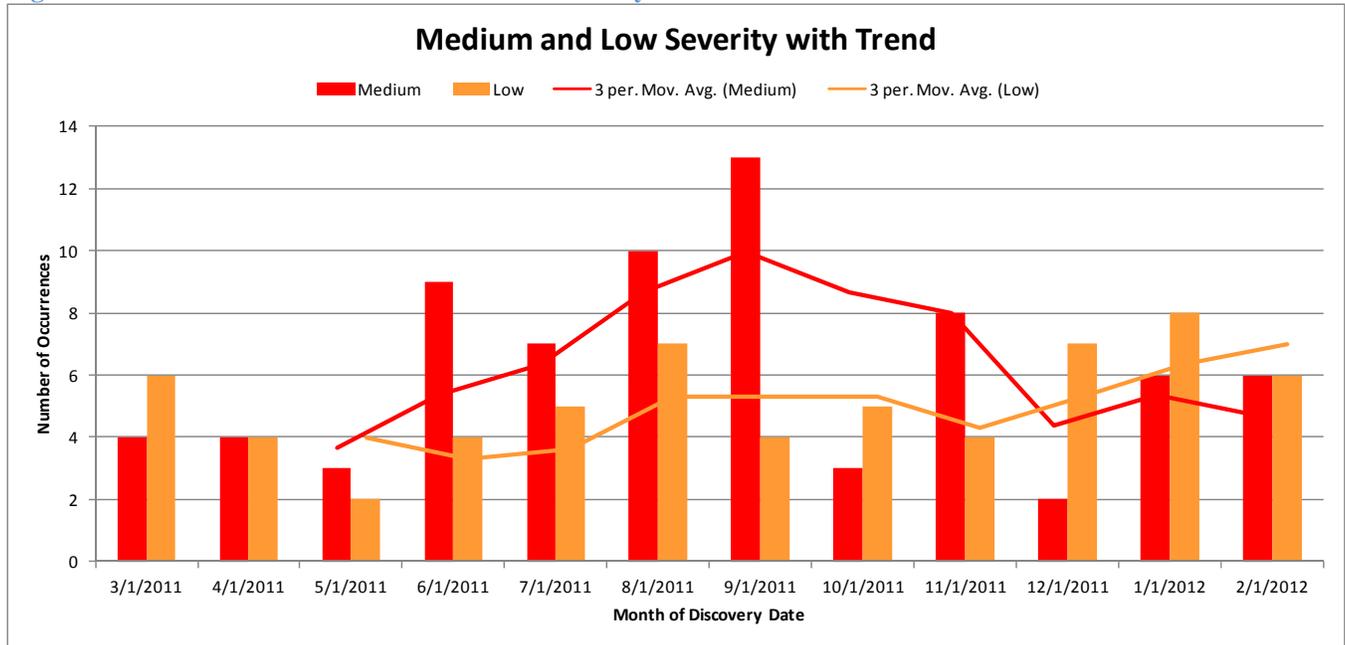
Figure 8 - Trend of Medium and Low Electrical Severity Occurrences

Figure 8 focuses on the Medium and Low severity data series for February 2011 through February 2012. Trend lines are included for each, using a 3-month moving average.

The 3-month moving average shows a decreasing trend in the Medium severity occurrences since September 2011. The figure also shows an increase in Low severity occurrences.
