Office of Health, Safety and Security

Monthly Analysis of Electrical Safety Occurrences

May 2012

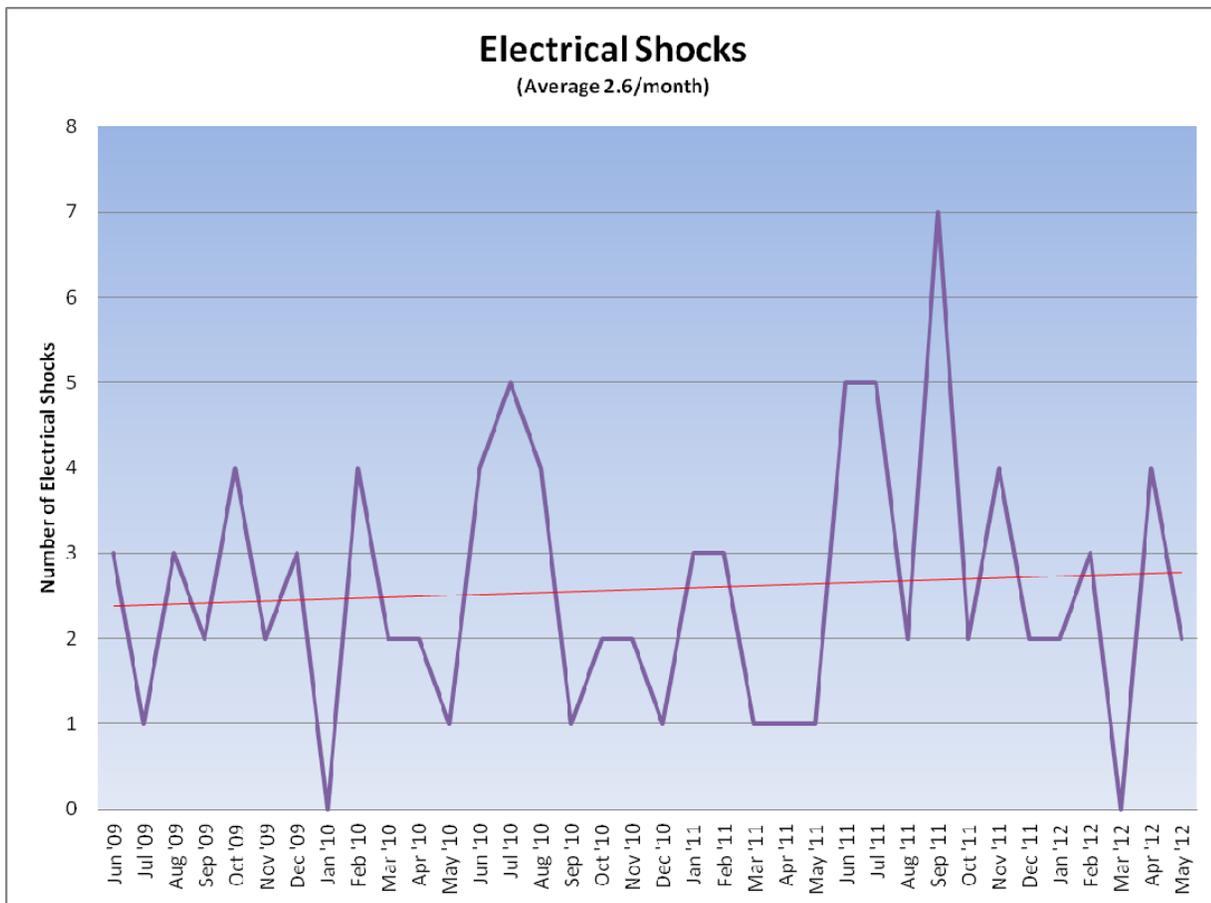
Figure 1 – Three-Year Trend of Electrical Shocks

Figure 1 shows a 3-year trend of electrical shocks for the DOE complex. During this period, the average number of electrical shocks has remained below three per month. The majority of shocks (about 75 percent) involve non-electrical workers.

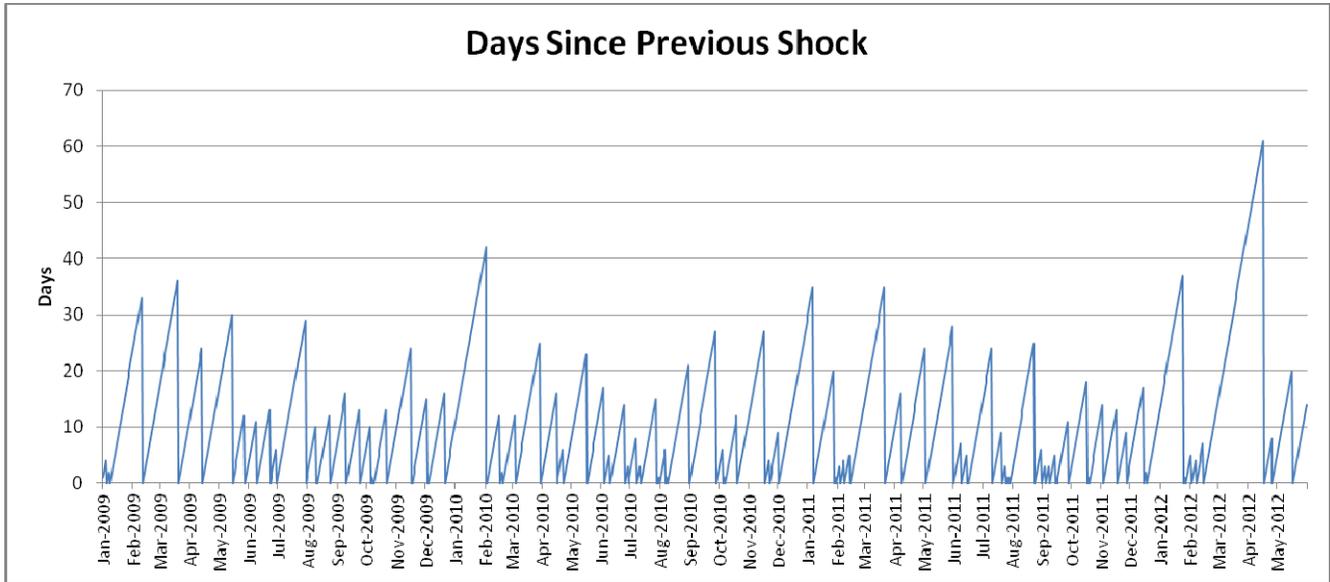
Figure 2 - Days since Previous Shock

Figure 2 shows the number of days since the previous electrical shock for the DOE complex. The longest interval was 61 days (April 16) and the present interval is 14 days as of May 31.

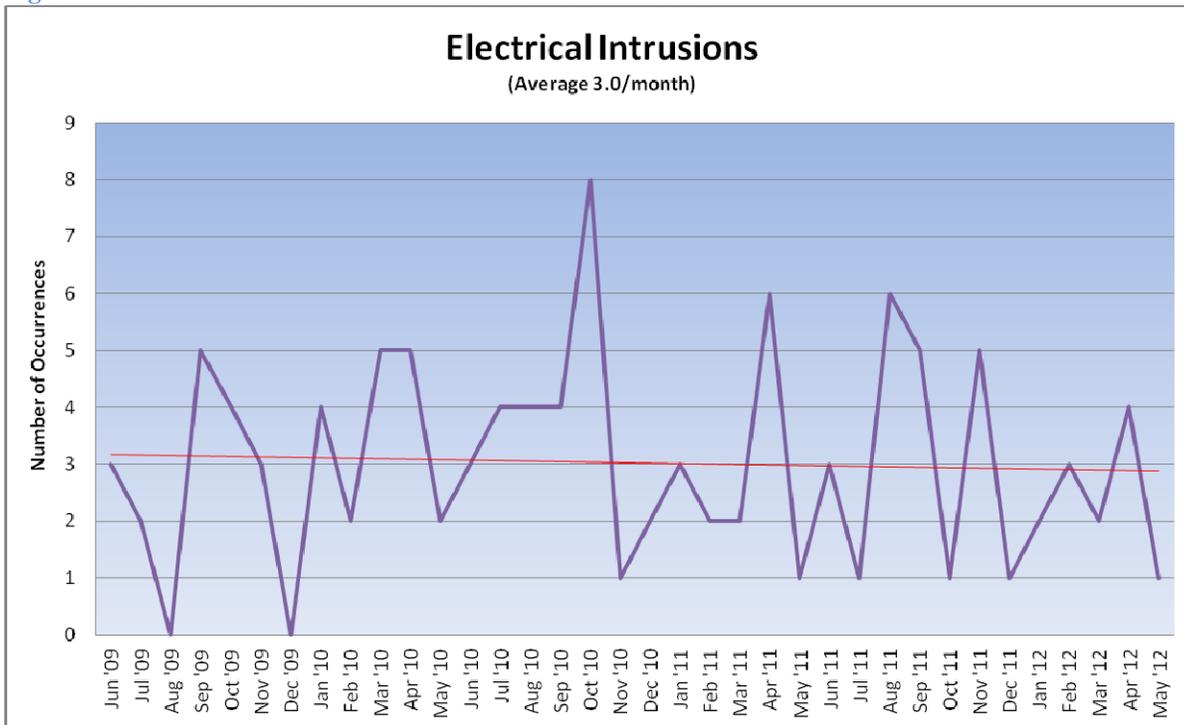
Figure 3 – Three-Year Trend of Electrical Intrusion Occurrences

In May, the number of electrical intrusion occurrences (i.e., cutting/penetrating, excavating, or vehicle contact of electrical conductors) decreased from four in April to one this month. This occurrence involved relocating a motion sensor at the entrance of a building. An employee drilled through a junction box and metal stud located below an Exit sign and accidentally drilled through a conduit, hitting a 110-volt line that provided power to the automatic door system. Figure 3 shows a 3-year trend of electrical intrusion occurrences for the DOE complex. During this period we can see a slight decrease in the overall trend.

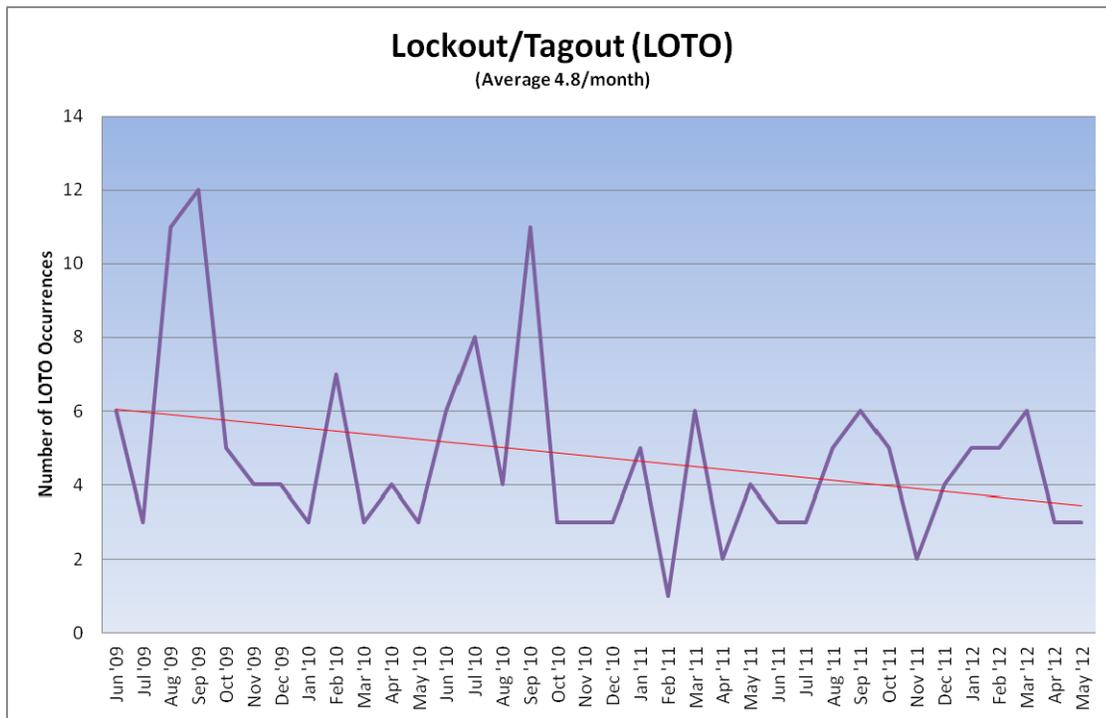
Figure 4 – Three-Year Trend of Lockout/Tagout Occurrences

Figure 4 shows a 3-year trend of LOTO occurrences for the DOE complex. During this period we have seen a general decrease in the number of occurrences involving the implementation of lockout/tagout for electrical work.

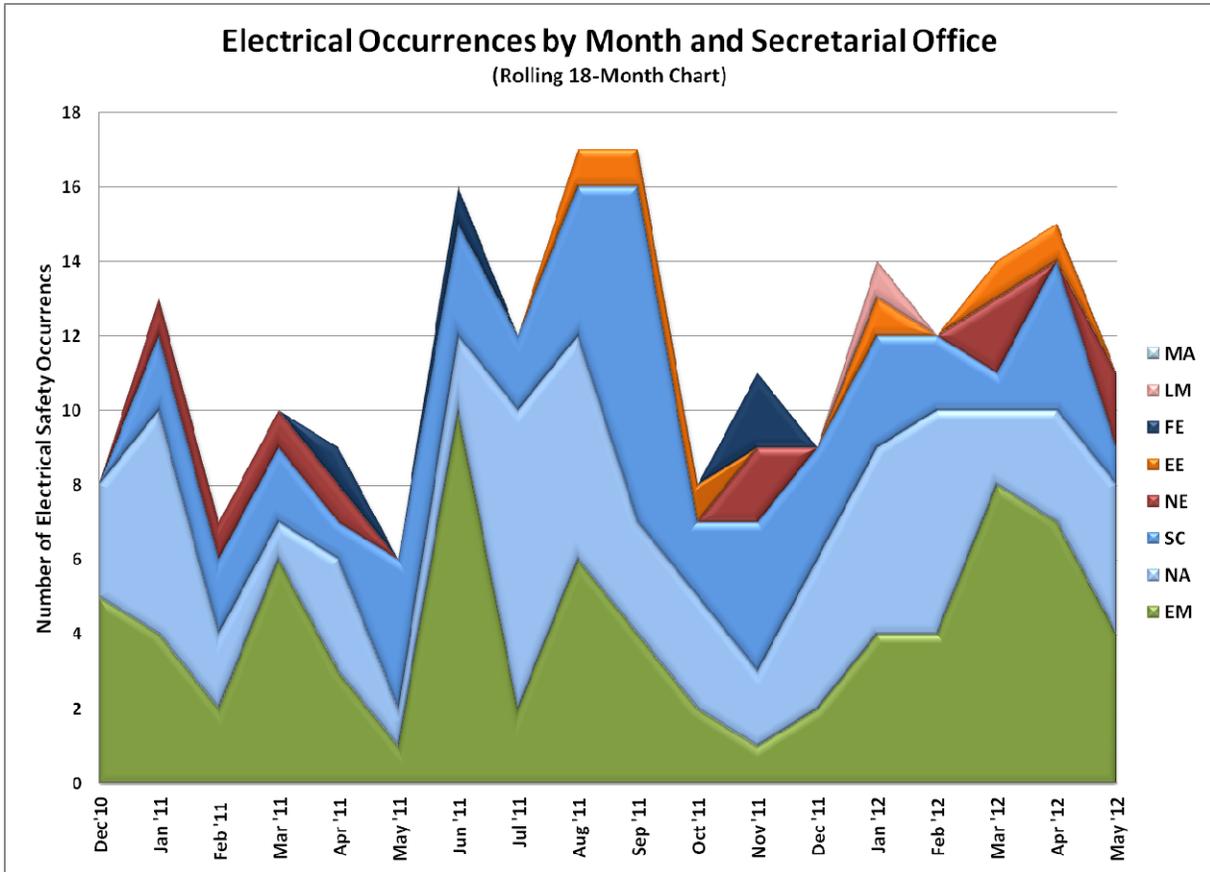
Figure 5 - Electrical Occurrences by Month and Secretarial Office

Figure 5 shows the distribution of electrical safety occurrences by Secretarial Office. The Office of Environmental Management (EM), the Office of Science (SC), and the National Nuclear Security Administration (NA) typically report the most occurrences of all the offices. Since March, EM has shown a decrease in the number of occurrences, while NA increased slightly and SC decreased. The Office of Nuclear Energy, which did not have any occurrences in April, reported occurrences in May.

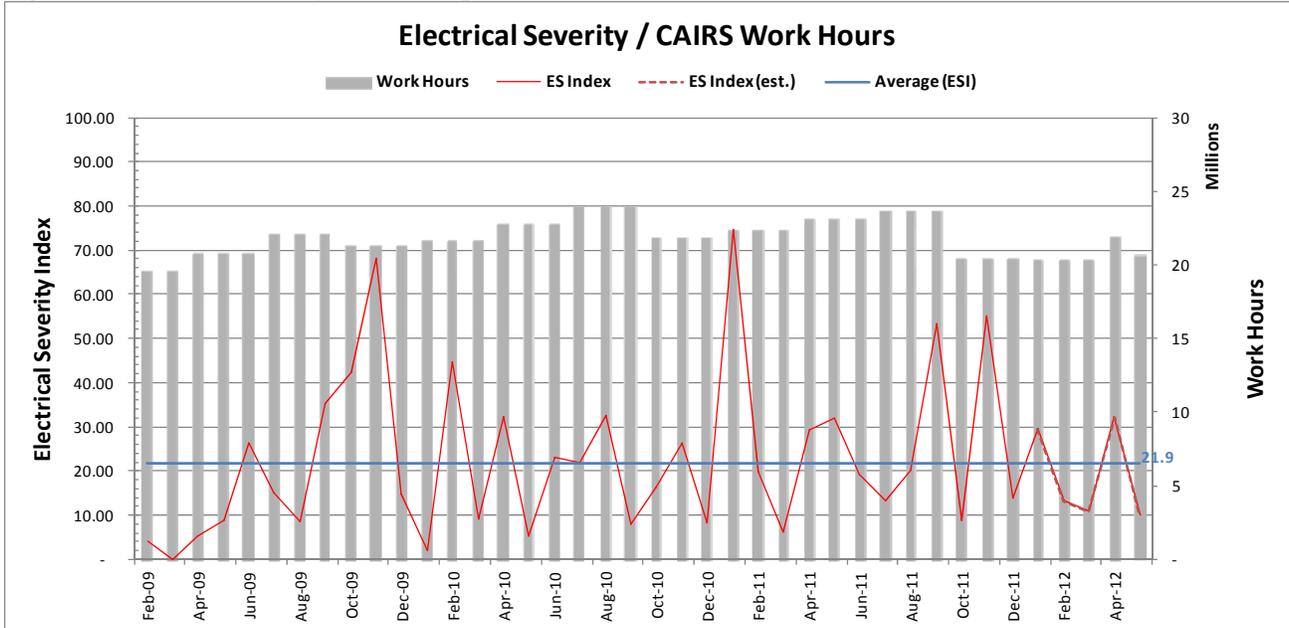
Figure 6 - Electrical Severity Index Compared to Work Hours

The Electrical Severity Index (ESI) is a performance metric that was developed to normalize events against organizational work hours. The ESI is calculated monthly and trended. Figure 6 shows a calculated ESI for the DOE complex and Table 4 shows the ESI and how it has changed from the previous month.

Note: An estimated ESI is calculated until accurate CAIRS man-hours are available. The chart is updated monthly.

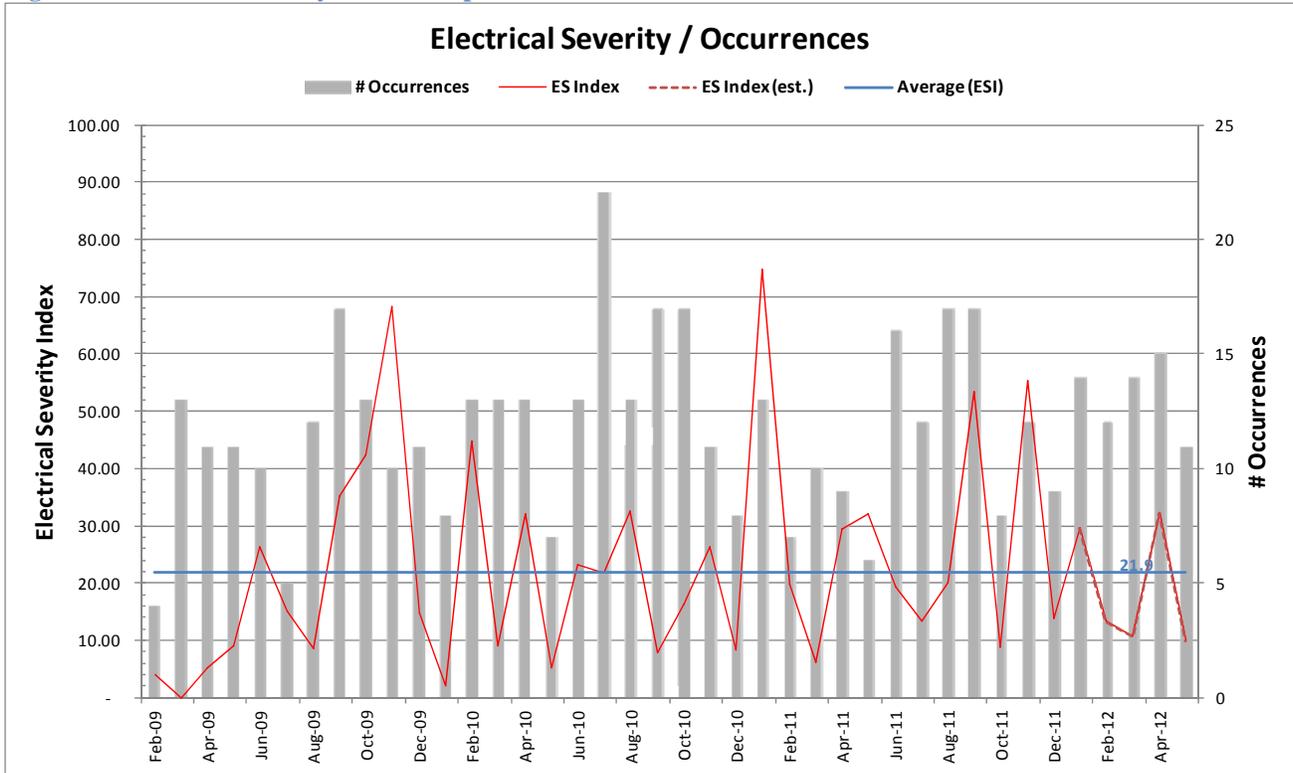
Figure 7 - Electrical Severity Index Compared to Number of Occurrences

Figure 7 shows the ESI with the number of Occurrences instead of Work Hours.

Following a slight increase last month, the average ESI (21.9) has decreased. The lowest average ESI was 19.2 in June 2010. Figure 8 shows the number of days since the previous high severity occurrence. The present interval is 394 days as of May 31. The previous longest interval was 181 days in 2009.

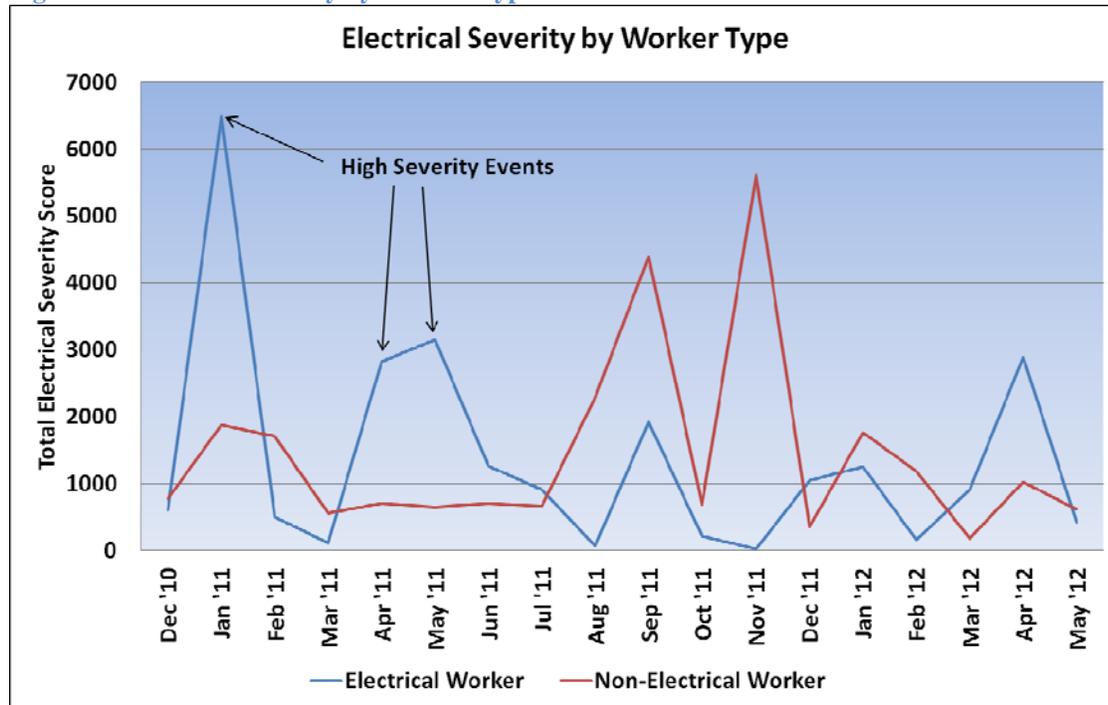
Figure 9 – Electrical Severity by Worker Type

Figure 9 shows the total electrical severity score by worker type for each month.

Electrical Workers were involved in the fewest number of occurrences but had three High-Severity events. Events involving Non-Electrical Workers usually have Low to Medium electrical severity scores but have a higher total score per month because of more occurrences.

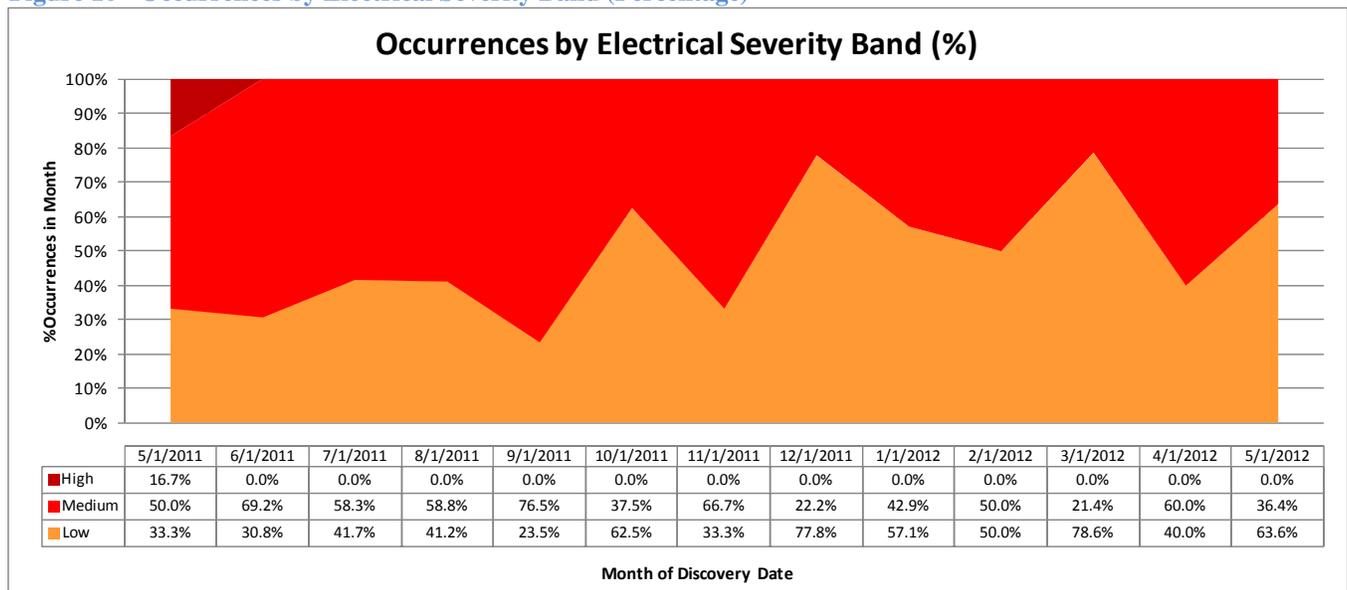
Figure 10 - Occurrences by Electrical Severity Band (Percentage)

For the interval May 2011 through May 2012 (current month and the past 12), Figures 10 and 11 summarize occurrences by severity band and month of discovery date by percentage of total occurrences in month and number of occurrences in month.

What can be seen from the previous two charts is that the number of occurrences with High electrical severity scores has remained at zero for the past 12 months and that the number of occurrences with Medium scores has decreased below the number of Low severity occurrences.

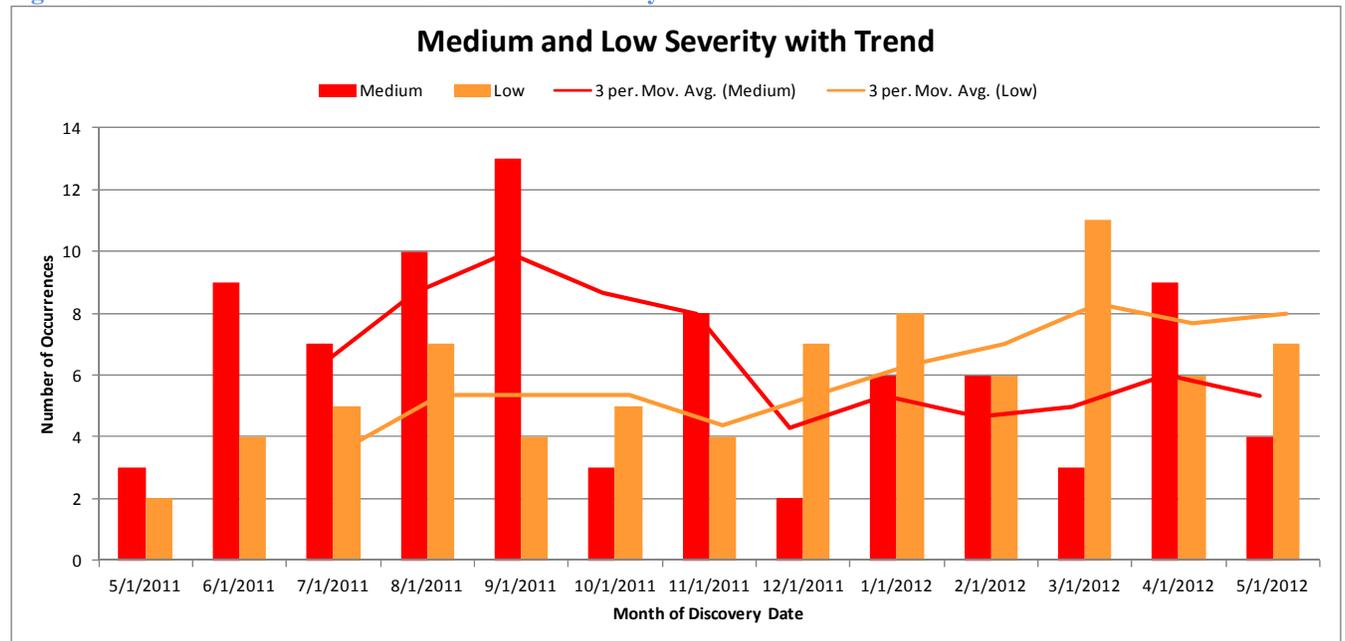
Figure 12 - Trend of Medium and Low Electrical Severity Occurrences

Figure 12 focuses on the Medium and Low severity data series for May 2011 through May 2012. Trend lines are included for each, using a 3-month moving average.

The 3-month moving average shows an increasing trend for Low severity occurrences while Medium severity occurrences decreased since last month. A higher percentage of Low severity occurrences is preferred.
