SAFETY NOTICE

DOE/EH-0560

Issue No. 99-01

MICROPROCESSOR – BASED FIRE PROTECTION SYSTEM TESTING

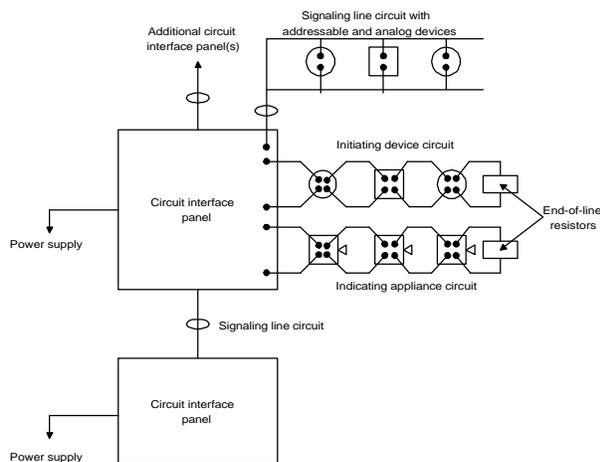
Figure 1. Typical Multiplex System

Multiplex systems consist of master control units connected to circuit interface panels by signaling line circuits. Signaling line circuits are usually self-monitored at a preset time interval to ensure the circuits are being monitored and will activate an alarm if a device in the system is not detected. A simplified schematic of a typical multiplex system is shown in Figure 1.
