Hydrogen Peroxide Paint Stripping

The helium tank farm and ancillary equipment, which supports Brookhaven National Laboratory's (BNL's) RIHC facility, needed to be stripped down to bare metal and repainted. Standard options would have included either grit blasting the paint off or using hazardous methylene chloride based strippers. The manpower costs, safety concerns and hazardous materials disposal costs, made these standard methods economically unfeasible for the 47 helium tanks and associated equipment.

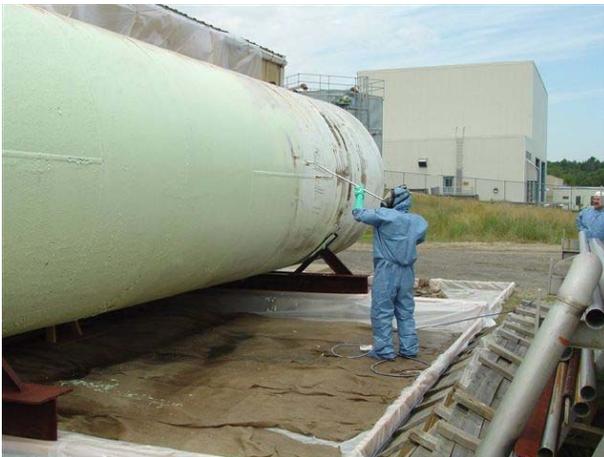
Photo #1 – Spray on application of the hydrogen peroxide stripper – notice the containment structure to capture the water from the power wash process and the burlap to capture the paint chips.

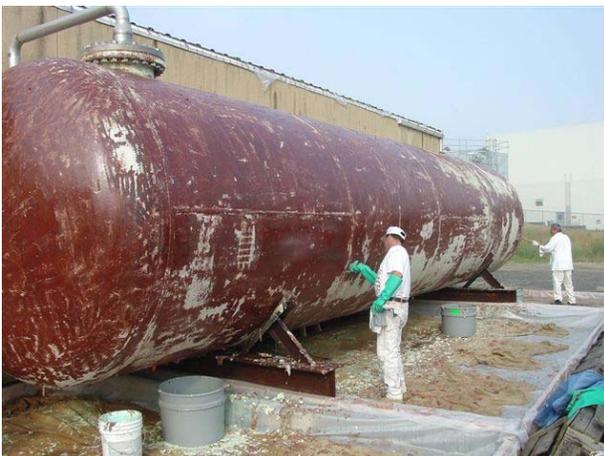
Photo #2 – paint chip removal process with a squeegee – notice the ease of removal and the minimal necessary PPE (work clothes, eye protection and gloves.)

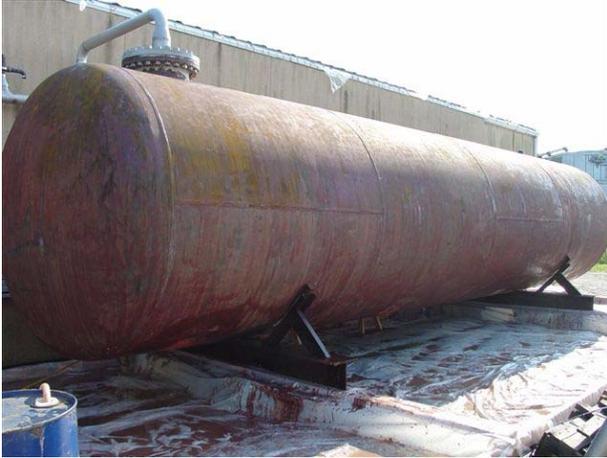
Photo #3 – Completely stripped tank – ready for priming and painting

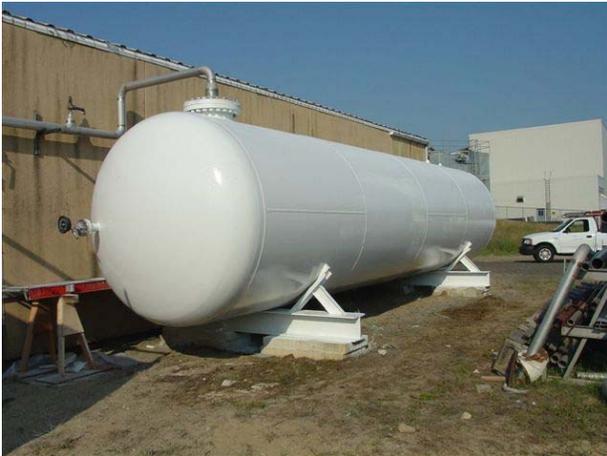
Photo #4 Completed tank

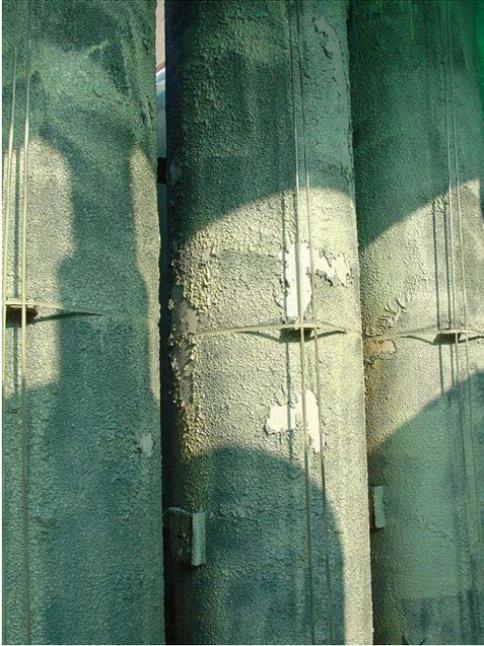
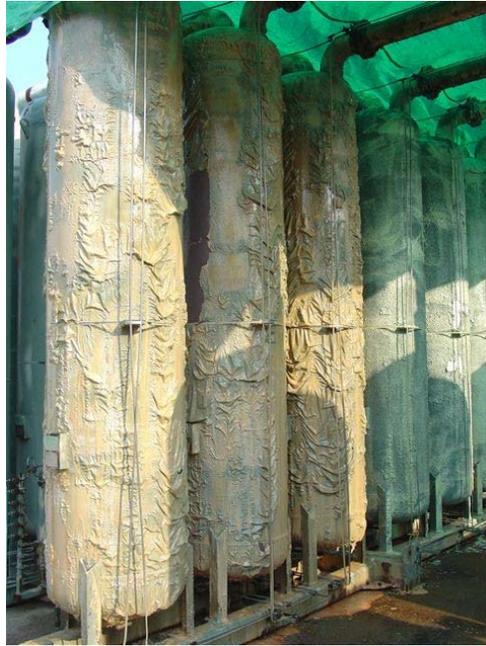
Photos #5 & #6 - Application of the hydrogen peroxide stripper to the oil mist eliminators and the efficacy of the product over time.

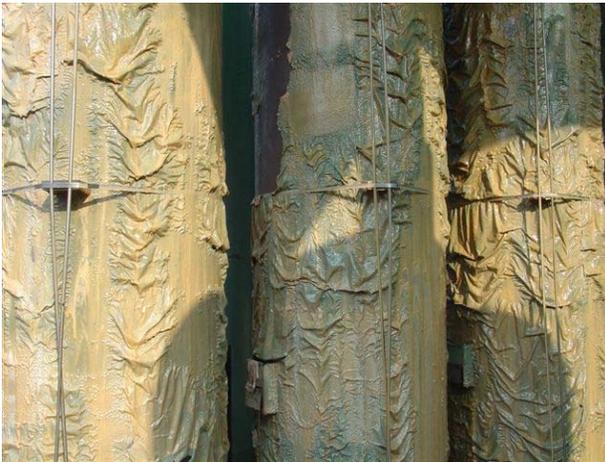
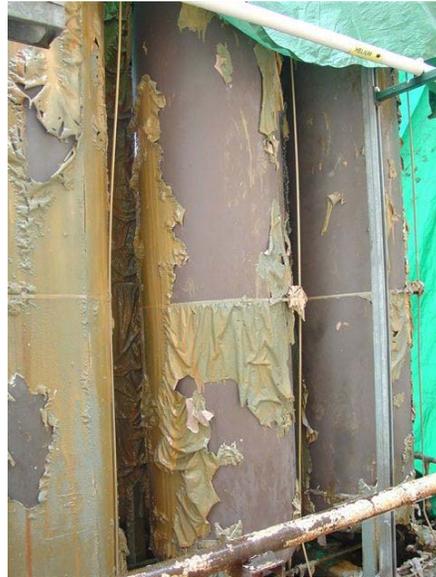
Photos #7 & #8 - Oil mist eliminators ready to be squeegeed

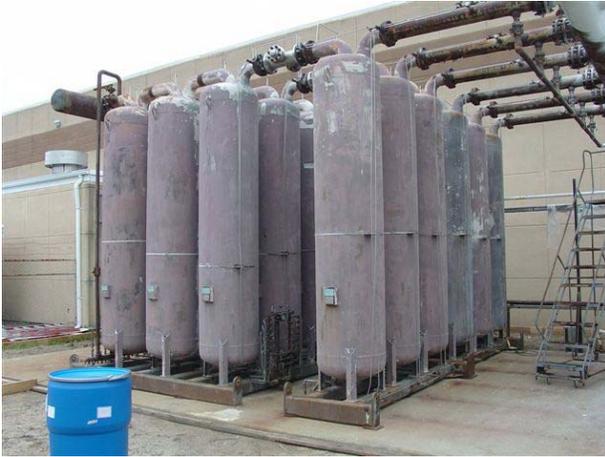
Photo #9 – Completely stripped oil mist eliminators – ready for priming and painting – note the limited spacing between columns and how difficult it would have been to use conventional methods to remove the paint.

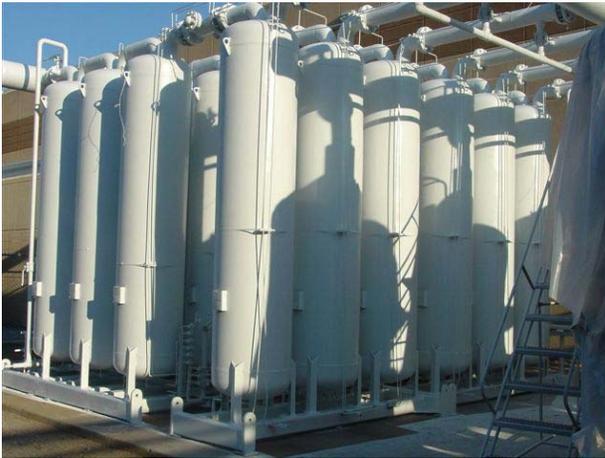
Photo #10 Completed oil mist eliminators.
